# Confidential Inspection Report

4th St  
Glennallen, AK 99588

DATE:  
Monday, April 13, 2026

Inspected By: Benjamin Crowley  
License #135839  
Ridgeline Inspections LLC  
(907) 795-6212  
office@ridgelinealaska.com

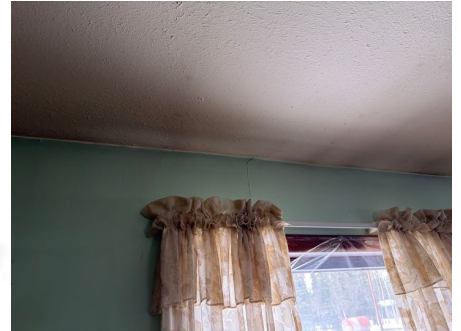
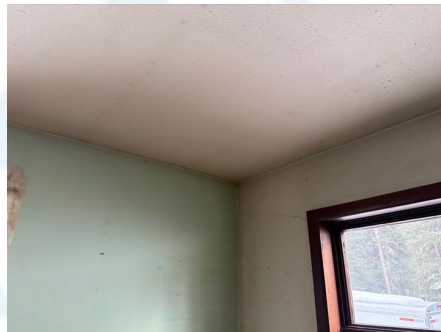
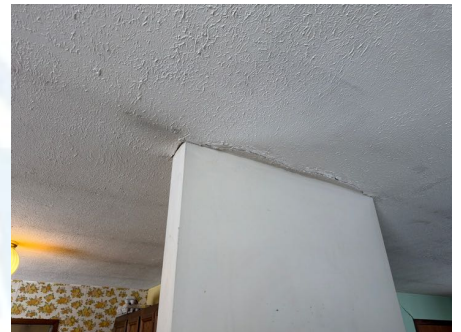
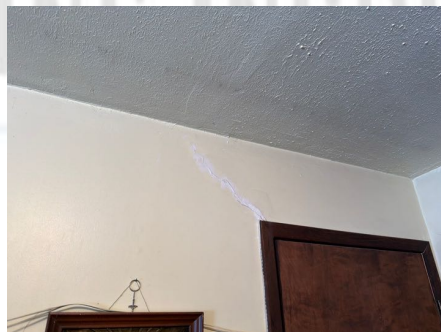
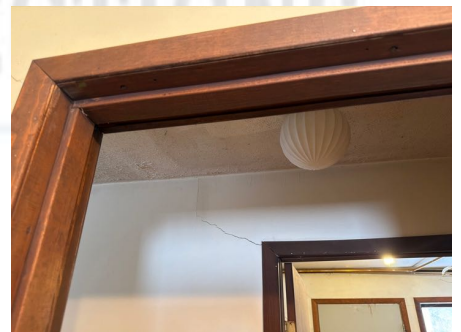
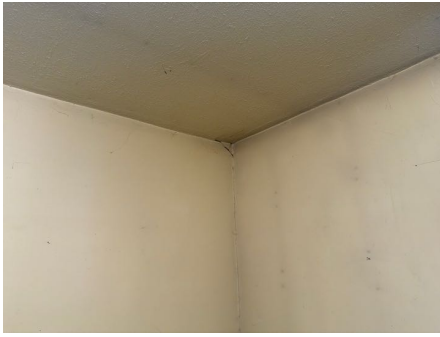
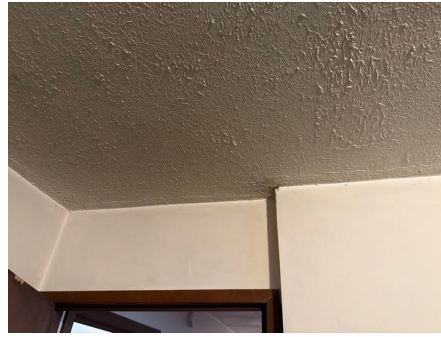
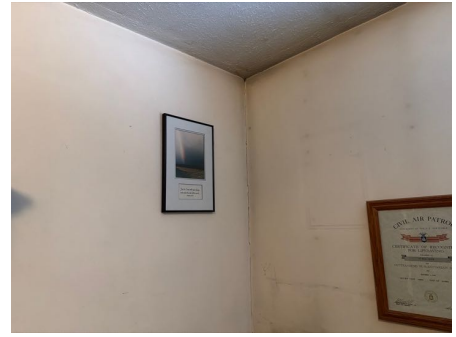
**PRM** There were signs of possible structural movement in interior walls/floors. It was not evident whether this is ongoing or past damage only. This is common for this area of Alaska that is affected by permafrost. This should be further evaluated by a structural engineer to determine structural integrity and the likelihood of continuing damage.

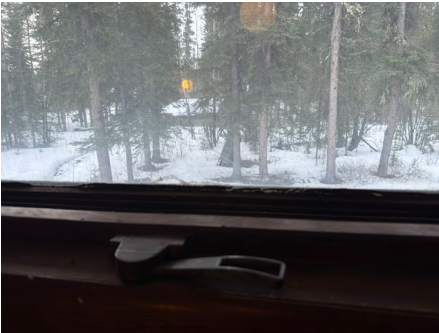
**PRM** A window in the bathroom was cracked.  
Replacement recommended.

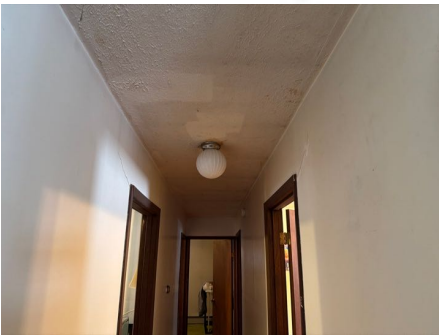
Hall

**MTN** Some interior light fixtures did not respond to the switch.  
Bulb replacement recommended. If the light still fails to respond, there may be a problem with the switch, wiring or light fixture.

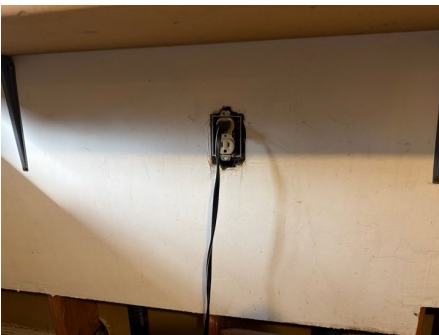
Laundry room

**H&S** Cover plates for outlets or switches were damaged / missing.  
This condition may expose electrical components to touch, a shock/electrocution hazard.  
Replacement recommended.

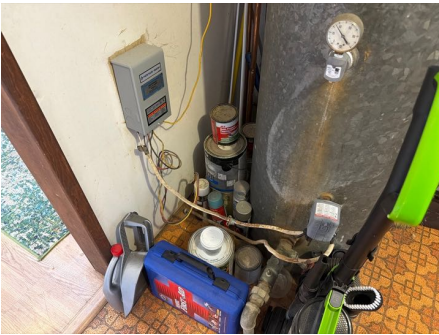
**H&S** There were exposed or improperly terminated wires in some areas. Exposed electrical wires are a fire/shock hazard. All wires should be properly routed and terminated within a junction box or appropriate fixture.

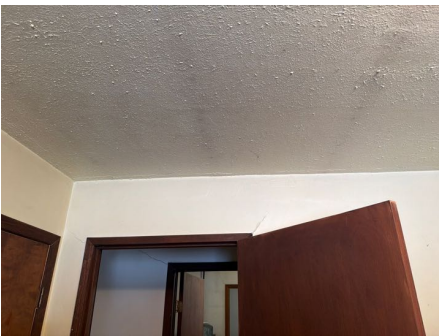
First front bedroom

**H&S** Smoke detectors were missing in some places. Smoke detectors are typically required in each bedroom, in hallways leading to bedrooms, and in general living areas (at least one on each level). Refer to manufacturer's recommendations for further detail.

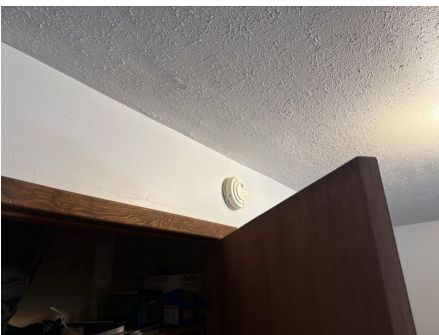
Second front bedroom

**H&S** Smoke detectors protecting living areas were old and not functional. Smoke detectors older than 10 years should be replaced. Detectors should be tested and maintained, upgraded or replaced as needed.

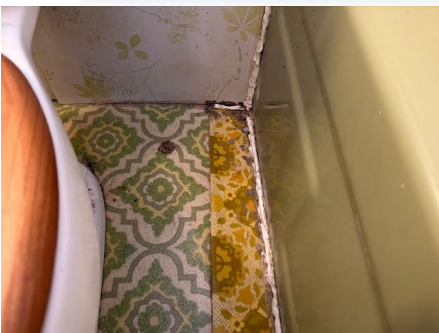
The bathroom

**PRM** There was a soft spot in the floor of the bathroom between the tub and the toilet.

This is likely old water damage. Further evaluation of the subfloor and any necessary repairs are recommended.

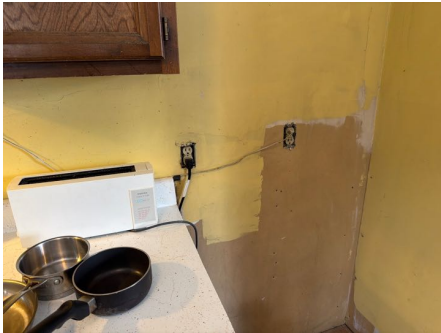
**H&S** Kitchen electrical outlets were missing GFCI protection. For safety reasons, outlets should be GFCI protected at kitchen countertops and within 6ft of any water fixture, such as sinks, dishwashers, and refrigerator ice makers.

**H&S** Kitchen electrical receptacles were missing cover plates. This condition left energized electrical components exposed to touch; cover plates should be installed.

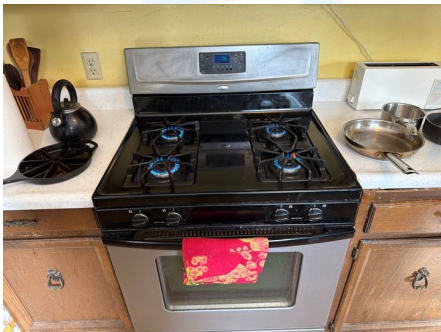
**H&S** The anti-tip device for the kitchen range was missing/not installed. This is a life-safety issue because a child climbing on an open oven door could overturn the range. Installation of an approved anti-tip device is recommended.

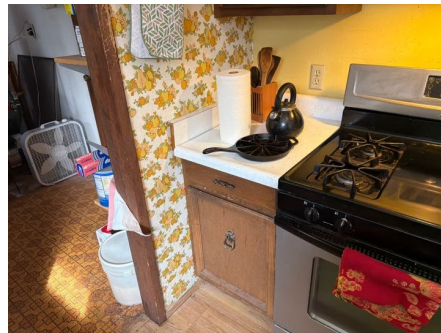
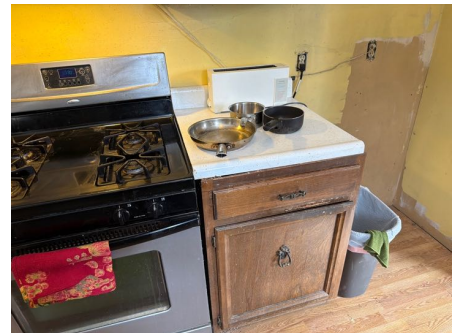
**MTN** Kitchen counters/cabinets had moderate damage visible. Repair/replacement recommended.

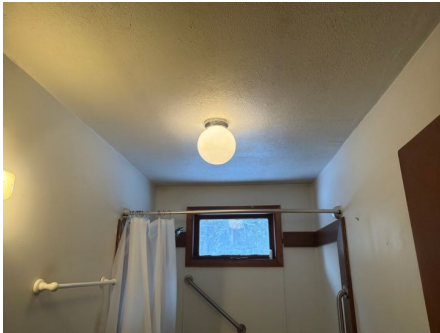
**PRM** No room ventilation was provided for the bathroom.

To avoid poor conditions resulting from excessively moist air, an exhaust fan should be installed.

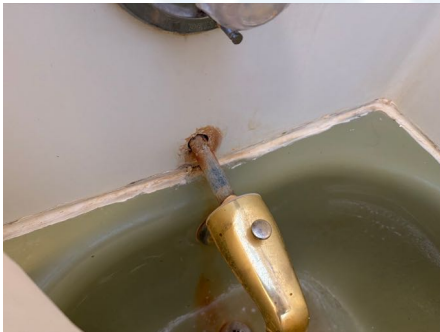
The bathroom

**MTN** Sealant around the tub in the bathroom was missing.

This may allow damage from moisture intrusion of the wall assembly.

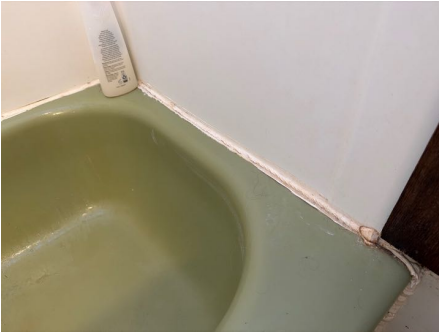
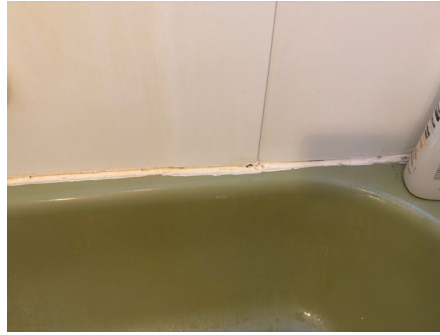
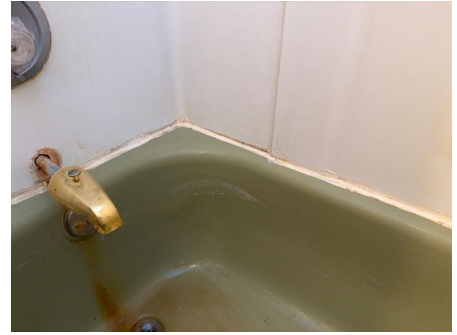
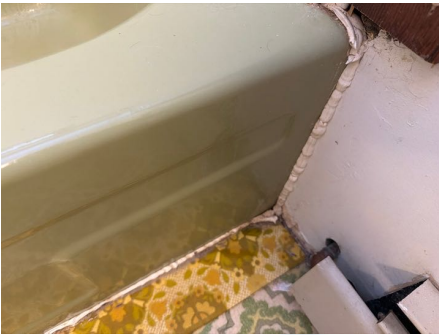
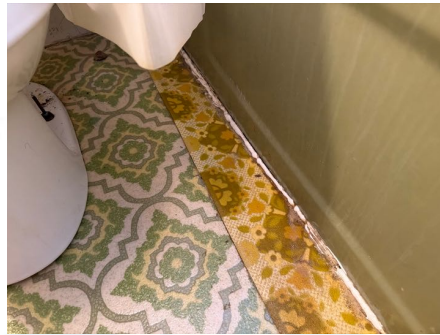
**MTN** Sealant around the tub in the bathroom had minor cracks.  
Re-sealing recommended to prevent moisture damage.

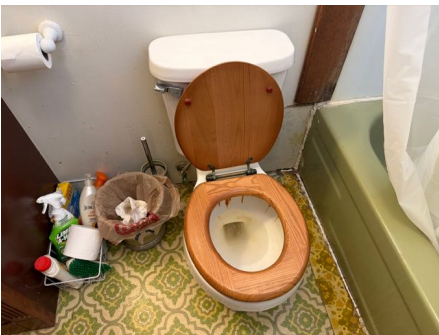
The bathroom

**PRM** Toilets pictured below were loose at the floor.  
This may allow for water to penetrate the floor structure, and any loose toilets should be re-attached.

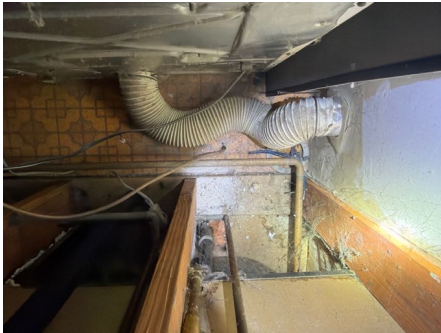
The dryer vent line was plastic.

Plastic vents used for dryers are liable to melt. Replacement with a proper listed vent line is recommended.

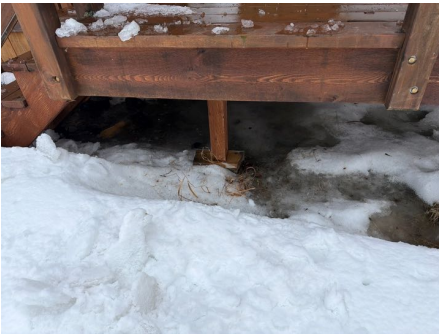
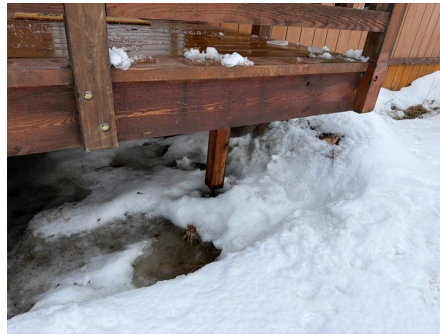
**H&S** Foundation piers supporting the porch appeared to be unstable. Unstable foundations can eventually lead to a collapsed porch and should be corrected by a qualified contractor.

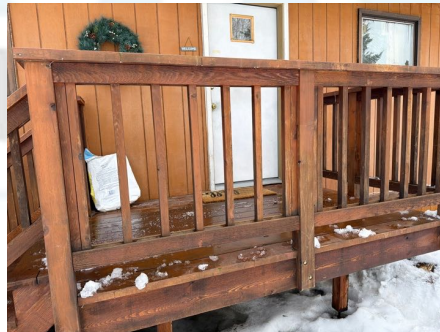
**H&S** Spaces between porch guardrail balusters were too wide. Safe building practices dictate that a 4 inch sphere may not pass through the guardrail at any point. This condition may be hazardous to small children. All corrections should be made by a qualified contractor.

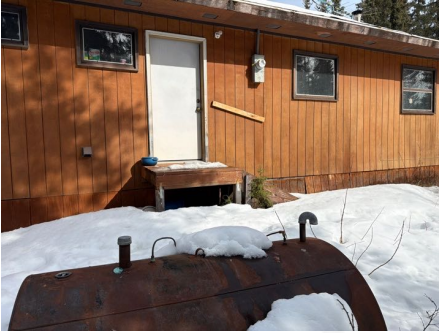
**H&S** The steps to the back door were not properly constructed and may not be safe to use. Replacement is recommended.

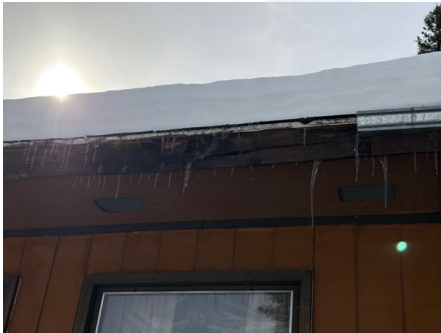
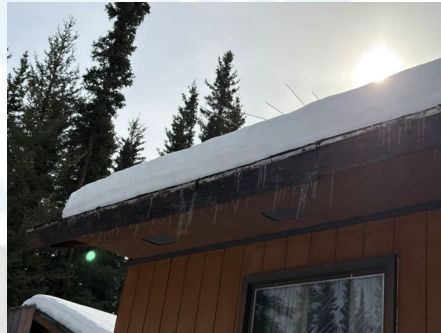
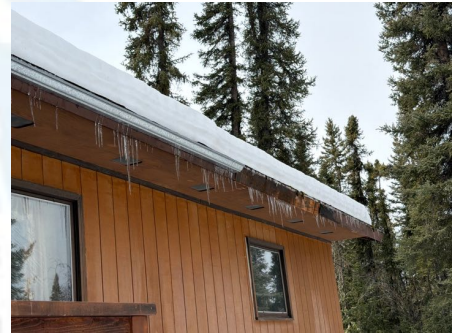
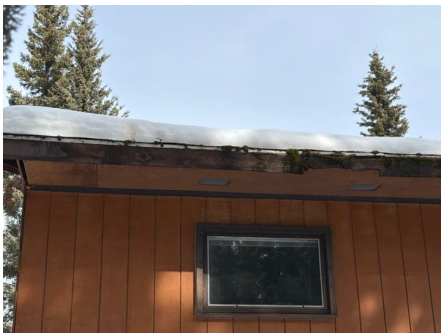
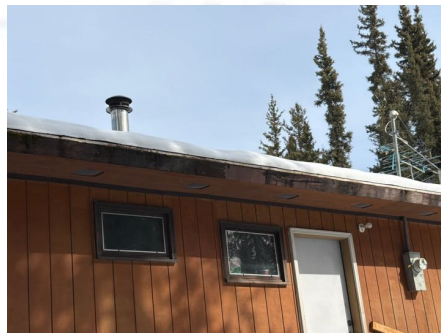
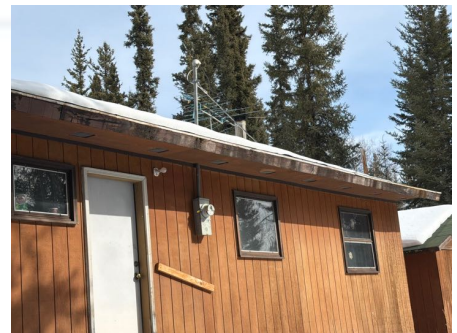
**PRM** Exterior fascia was damaged in some places.  
Repair/replacement recommended.

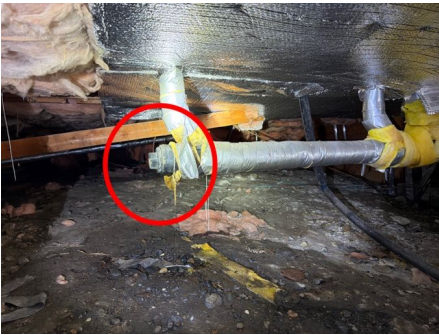
**H&S** A drainpipe was leaking in the crawlspace.

Repair is recommended to prevent further moisture damage and unhealthy conditions. Any wet or damaged components should be properly dried/cleaned or replaced.

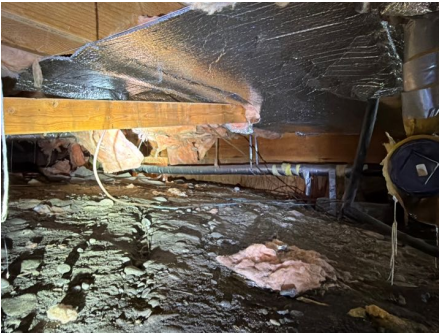
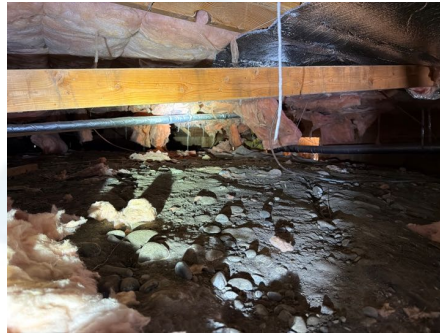
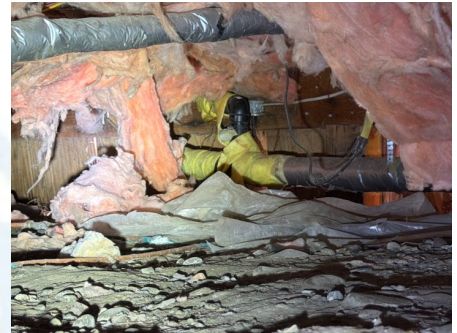
**PRM** Drain pipes visible in the crawlspace were improperly sloped.

This condition may result in improper drainage, pipe blockage, or damage. Correction recommended.

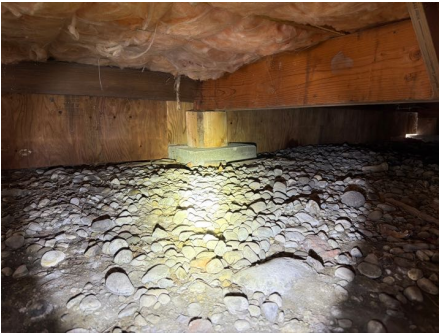
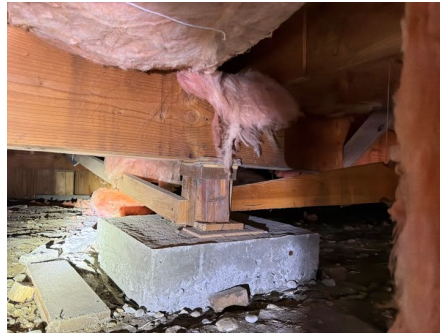
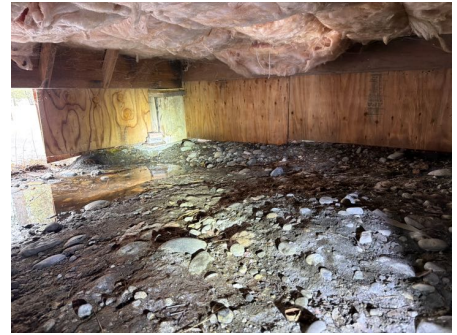
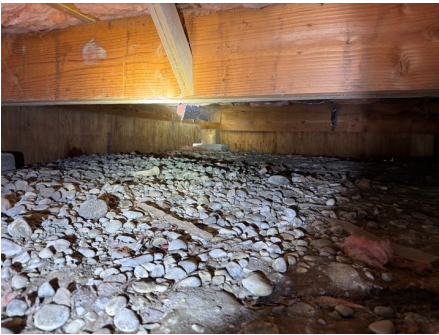
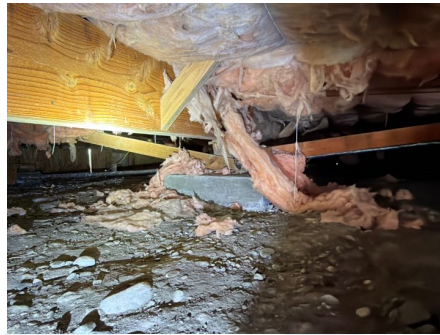
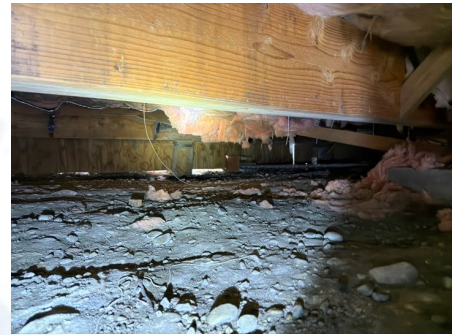
**PRM** Foundation support posts did not have adequate strapping. Strapping should be installed at the beam and concrete pads.

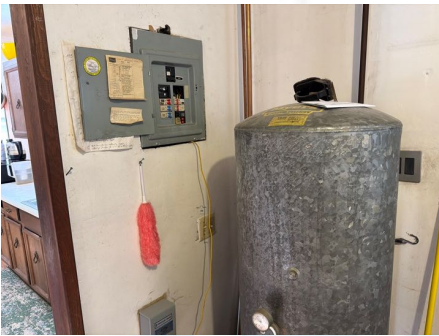
H&S The service panel did not have proper clearances. The clear working space required in front of a panel is 30" wide by 36" deep with a minimum headroom clearance of 6 feet-6 inches. This should be corrected to provide quick access in case of emergency.

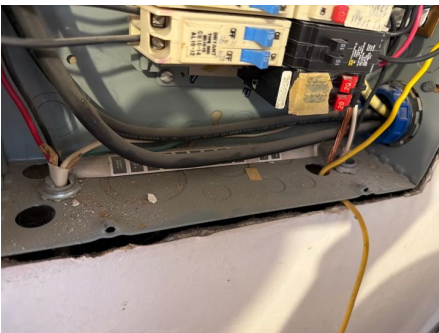
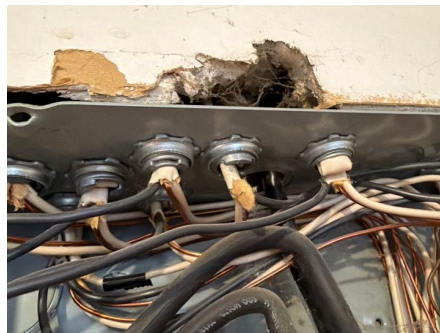
H&S Bushings were missing where conductors entered holes in the service panel. Without a protective device, the sharp edges of sheet metal may damage the conductors.

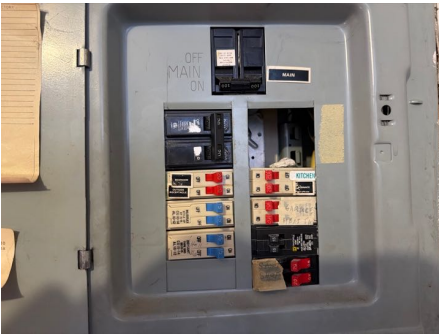
**H&S** There were gaps in the dead front cover of the service panel. These should be filled with "blanks". Open spaces may allow a person to come into contact with energized electrical components, which is a potential shock/electrocution hazard.

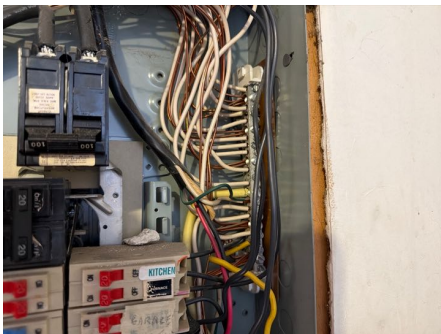
**H&S** Grounds and neutrals shared the same bus bar in the electrical panel. This is a potential electrical hazard; they should be separated by a qualified electrical contractor.

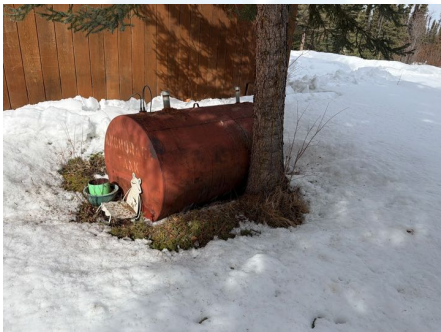
Cabin

The heating oil tank was not resting on a proper stand. Tanks should rest on a proper, stable stand on a level surface to prevent them from damage, falling, or rolling.

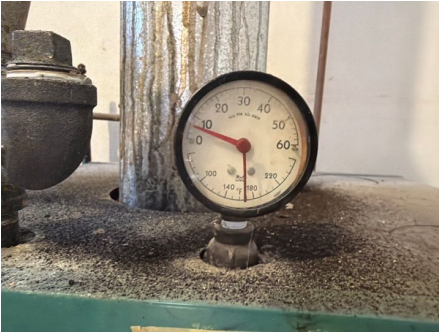
**PRM** According to the installed system pressure gauge, boiler pressure was low. The generally accepted minimum limit is 12 pounds per square inch (PSI). Service by a qualified HVAC contractor is recommended.

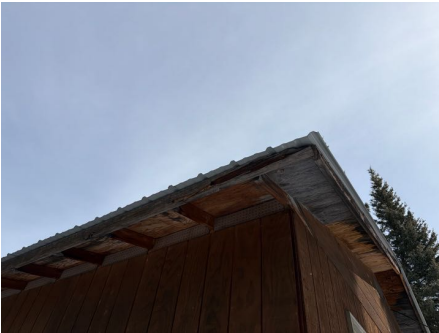
Cabin

**MTN** Outbuilding fascia was damaged in some places.  
Repair/replacement recommended.

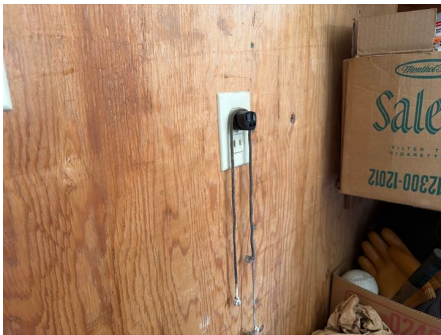
**H&S** The outbuilding contained outdated, ungrounded 2-prong electrical receptacles. For safety reasons, these receptacles should be replaced to meet current standards.
