ENGINEER'S INSPECTION REPORT
RE: 1271 Kuykendall St. Fairbanks, AK

Inspected by: Timothy Henry, P.E.
Inspection date: January 27, 2026

Sellers: 0426 Tish Trust
Sellers Licensee: Gary Gallemore – Walden Home Group

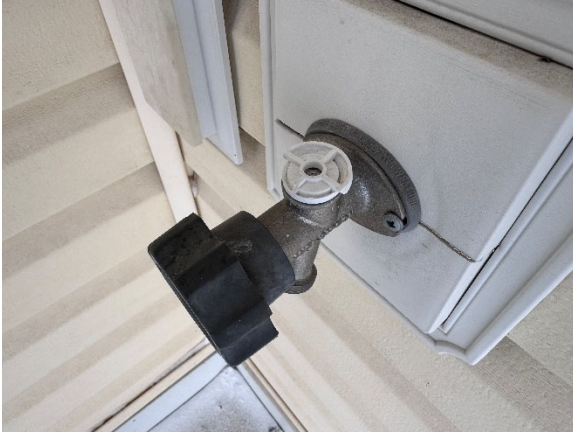
-
-
2. **Exterior Hose Bib Vacuum Breaker** - Replace the damaged vacuum breaker on the front exterior hose bib with a new, code-compliant unit.

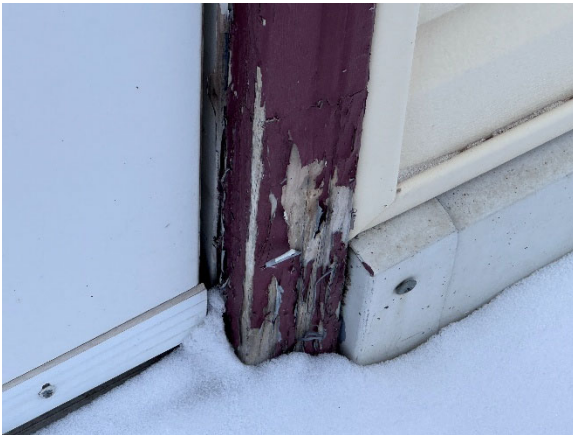
3. **Garage Entry Door Frame Base Trim** - The exterior door frame base trim at the garage is decayed. Remove the affected trim, inspect for underlying decay or damage, replace with new material, and ensure proper painting/sealing for moisture protection.

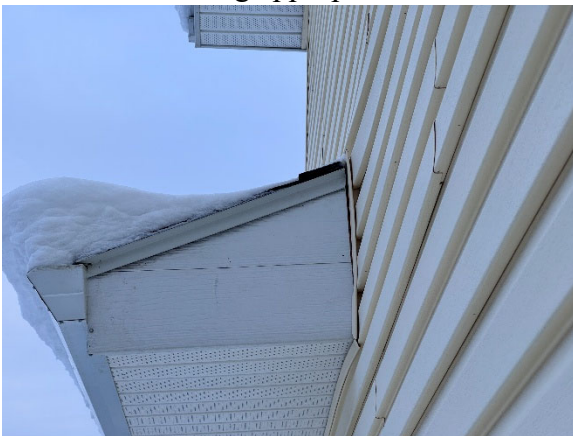
4. **Short Awning Roofs** - The small awning roofs have shifted and are pulling away from the wall framing at the top. Engage a licensed contractor to open the soffits as needed, resecure the structures using appropriate structural wood screws and metal brackets.

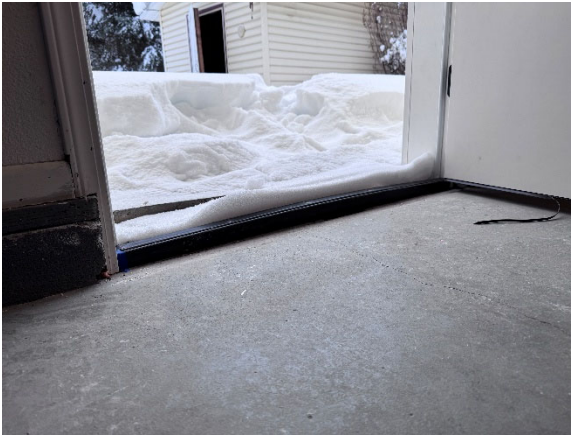
-
-
5. **Garage Man Door Threshold** - The rear garage man door has a warped threshold causing binding and jamming. Repair or replace the threshold to ensure smooth operation without binding or gaps.

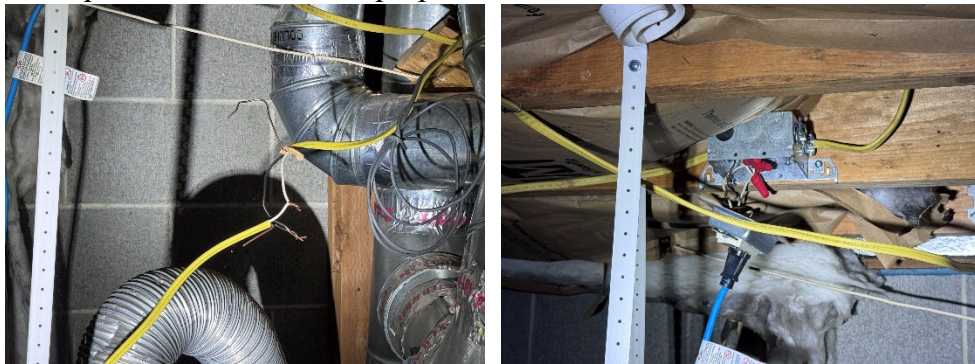
- a. Install GFCI protection to all exterior electric receptacles. Ensure they all have “in use type” weather seal covers. *Reference NEC 210.8(A)(3).*
- b. Confirm there is proper GFCI protection for the master jet tub. *Reference NEC 680.21(A)(C).*
- c. At each electric breaker panel, install handle ties between each of the circuit breakers of the multiwire branch circuits that share a neutral conductors as required by *NEC 210.4(B)*. *each multiwire branch circuits shall be provided with the means that will simultaneously disconnect all ungrounded conductors at the point where the branch circuit originates.*
- d. Install all open electrical throughout the crawl space into a junction box with cover plate installed. Ensure proper wire nuts are installed on each conductor.

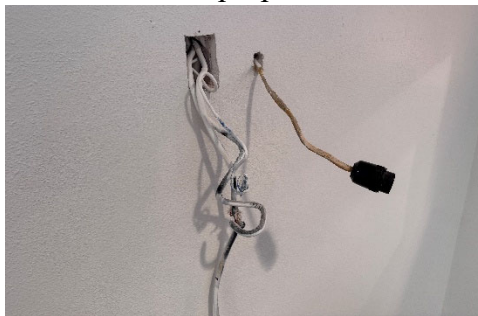
- e. Restore functionality to all of the garage ceiling lights.
- f. Eliminate the improper and unsafe wiring along the wall in the living room area.

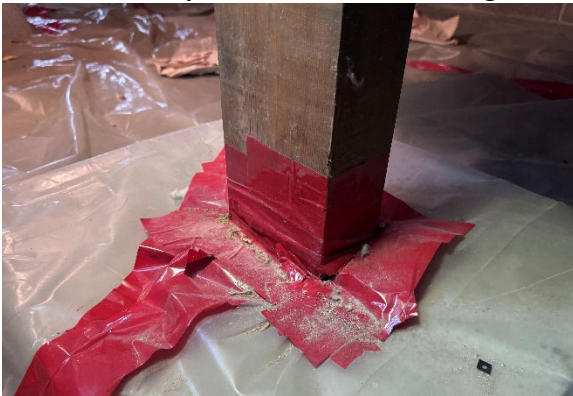
19. Crawl Space Vapor Barrier at Columns - Trim and remove vapor barrier material from around untreated wood support columns to prevent ground moisture contact. Seal the vapor barrier securely to the concrete footings.

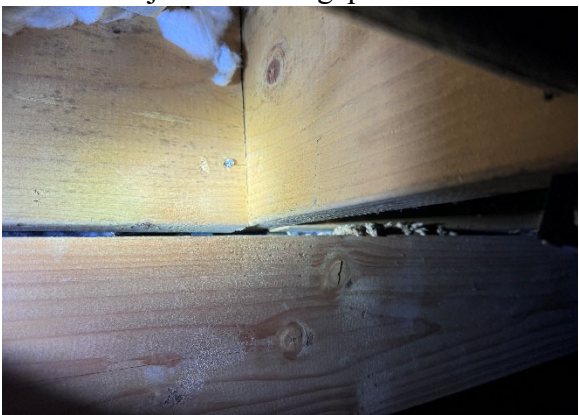
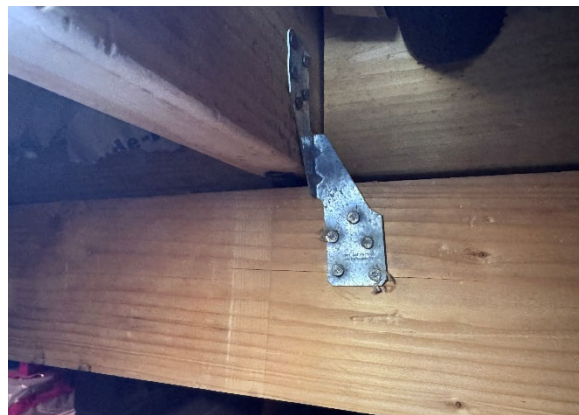
20. Crawl Space Floor Joist Support - Many floor joists are gapped above supporting beams due to shrinkage, relying solely on brackets. Install shims to achieve tight, positive bearing under each joist with no gaps.

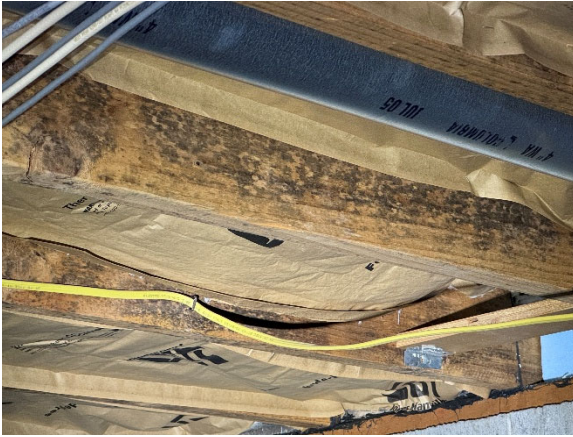
22. Crawl Space Mildew - Scrub and disinfect areas of mildew on floor joists.

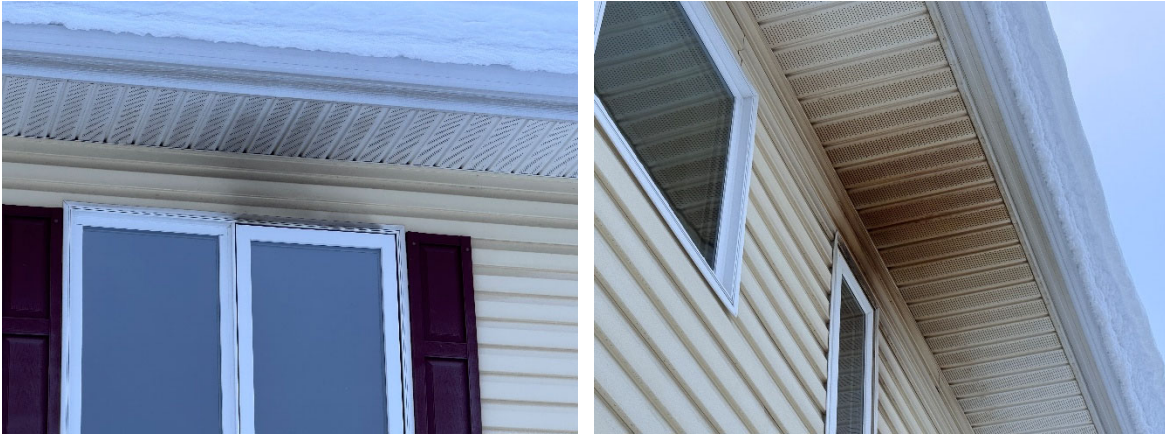
A. As illustrated in the photos below the staining coming out of the master bedroom windows illustrate the amount of smoking that occurred in this room. It is also evident when opening up the HRV ducting as there is heavy tar accumulation.

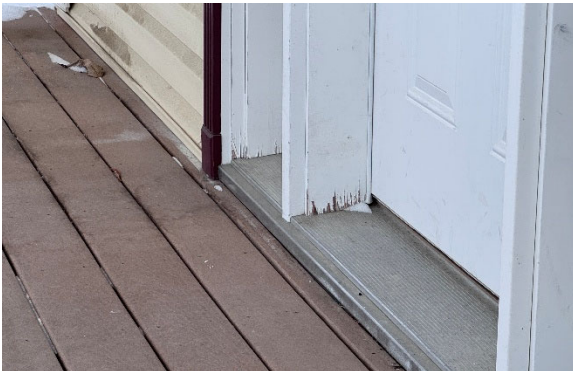
B. In the summer when weather permits, recommend refinishing the exterior door frames.

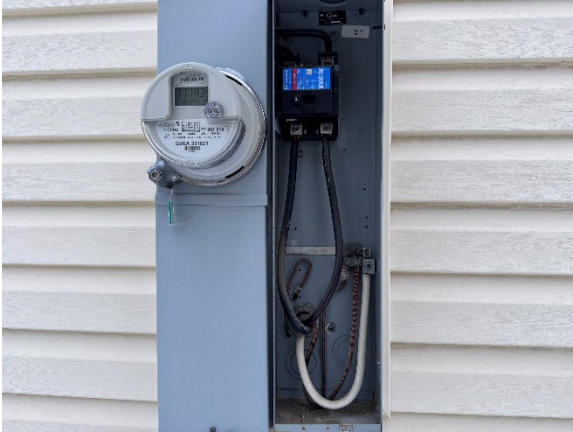
- D. The exterior electric service panel was evaluated and appears to be NEC compliant with appropriately sized copper conductors for the 200 amp service.

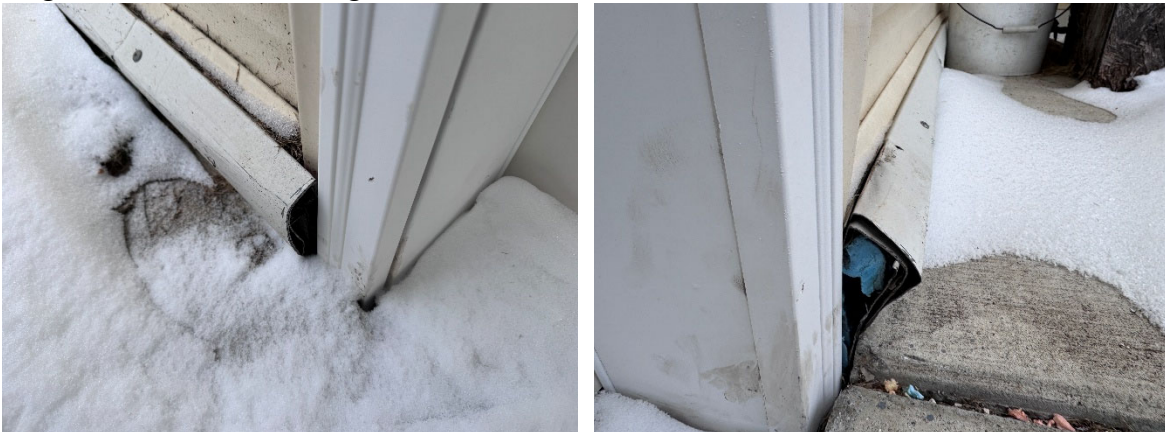
- E. The metal flashing at the exterior is frost heaved, this is somewhat common in this neighborhood due to the high moisture content in the soil.

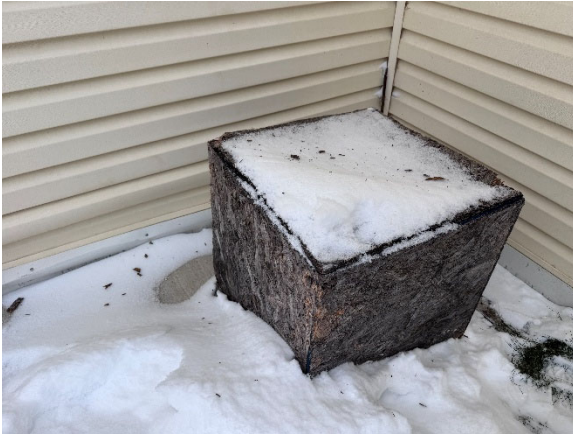
-
-
- F.** There is OSB plywood covering the mini split air conditioning system along the back of the garage. If this unit is going to remain it really should have a proper cover built for it to protect it during the winter. The cover of course needs to come off in the summer when the unit is in use.

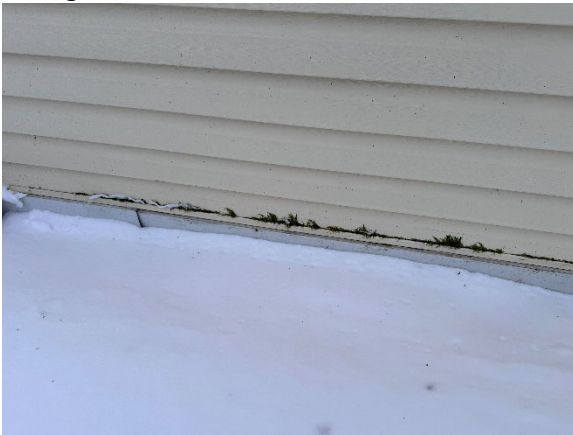
- H.** Recommend pressure washing and cleaning the moss and debris out of the J trim of the vinyl siding at the exterior of the house.

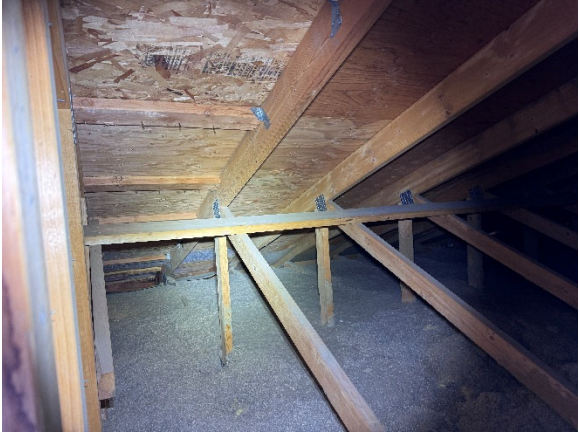
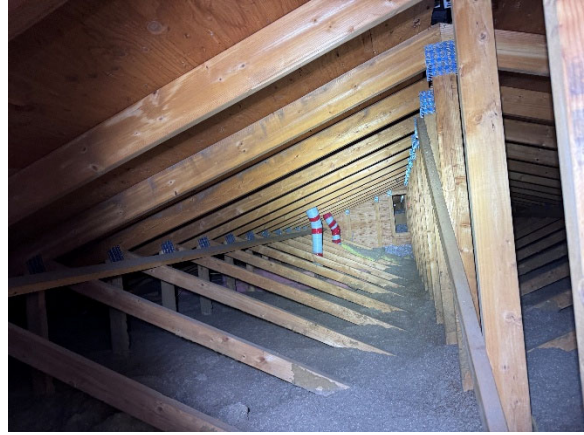
- I.** The roof framing consists of Engineered trusses with steel gusset plates. These are generally considered load capable of the full Fairbanks design snow load and under normal conditions shoveling the roof should not be necessary. Attic insulation consists of blown cellulose and was measured at around 8 inches thick. Recommend adding an additional 8 inches of blown fiberglass taking care not to block the eave vents.

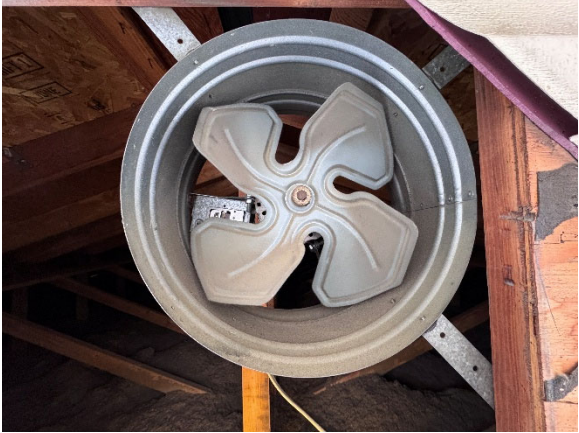
- J.** There is an exhaust fan in the attic space. This fan is likely not needed since the ridge vent has been added.

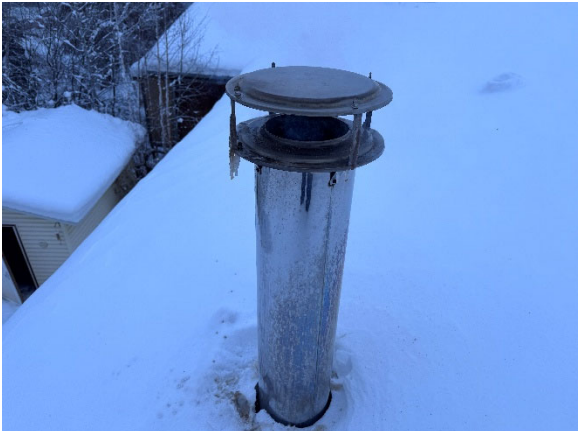
- K.** The boiler chimney appears to have been replaced and was found to be in acceptable condition. Recommend checking this annually as part of the boiler servicing.

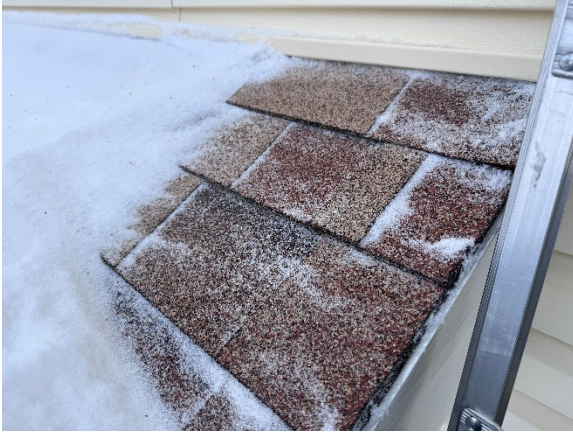
-
-
- L.** It is very difficult to evaluate roof condition during the winter with so much snow and ice cover. I was able to clear some snow and the shingles appear to be in good condition. These are an architectural type fiberglass reinforced shingle that have a design life of 30+ years. It is my understanding that these were replaced during a renovation in approximately 2005.

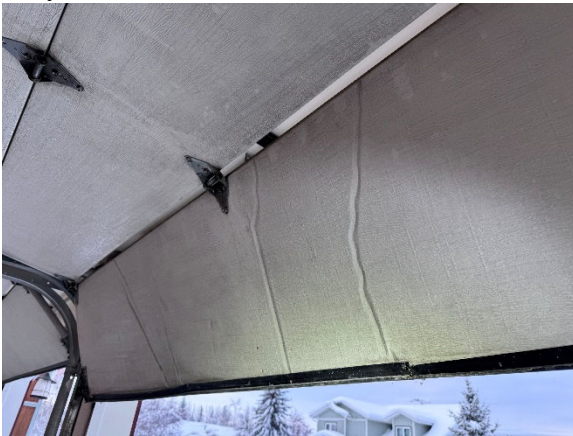
- M.** The garage overhead door panels are bent from a vehicle strike but they do still seem to be fully functional.

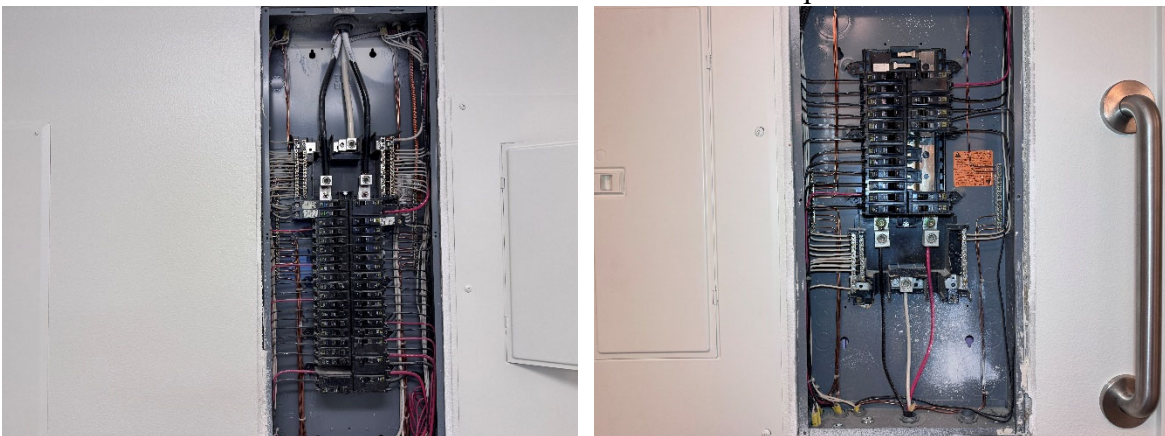
- N.** Both electric breaker panels were evaluated and look good. Besides needing handle ties for the multibranch wire circuits these were found to be NEC compliant.

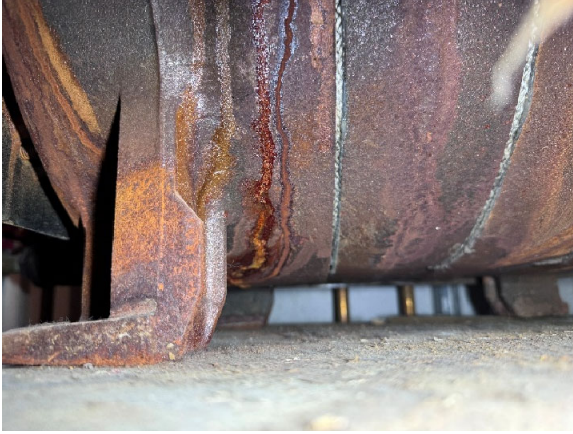
P. I did not find any active leaking on the boiler but there is staining underneath as shown below. This boiler appears to be original from 1995 and would be considered at or near the end of its design life.

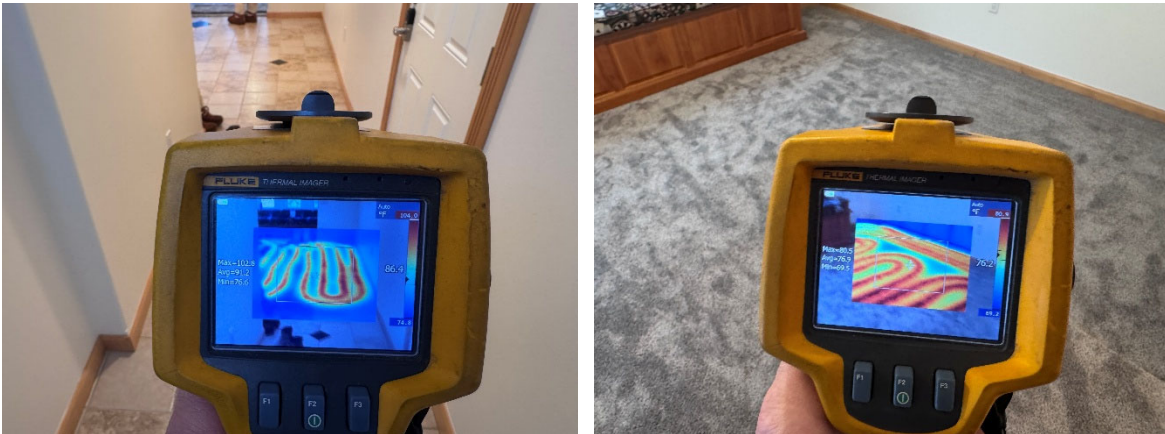
Q. All of the in floor heat was confirmed fully functional using a thermal imager. There was no glycol in the system but it consists of just straight water. There was dirt and debris observed in the hydronic fluid so it would be best to consider flashing this out and at minimum and installing fresh distilled water.

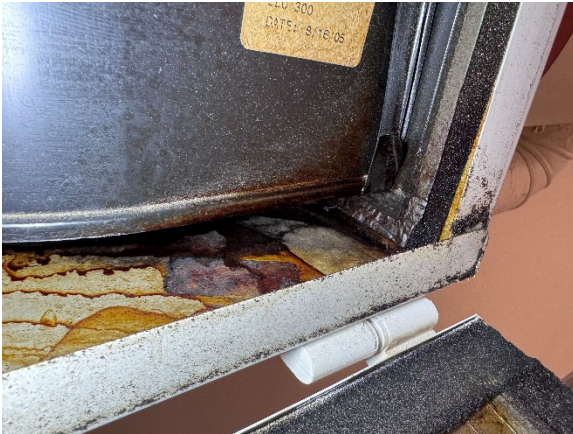
R. Below are photos inside the nonfunctioning HRV. There is heavy tar staining from smoke.

8. **Heat Recovery Ventilator (HRV)** - The HRV receives power but is non-functional due to heavy tar accumulation from prior smoking. Replace the unit with a new one installed by a qualified professional. Professionally clean all associated ductwork. Verify that bathroom boost switches function properly.

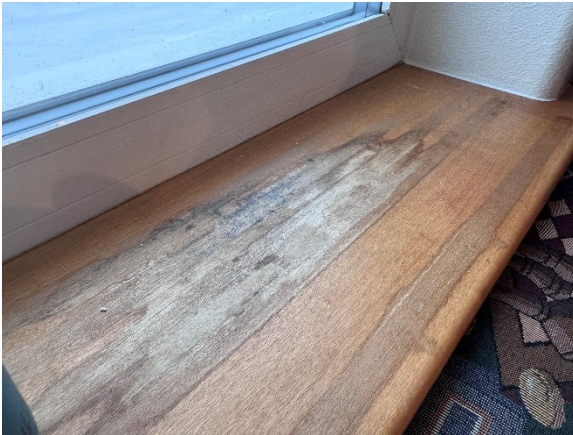
S. Recommend refinishing the windowsills throughout the house and re-caulking the windows at the interior as needed to ensure they are each tightly sealed.

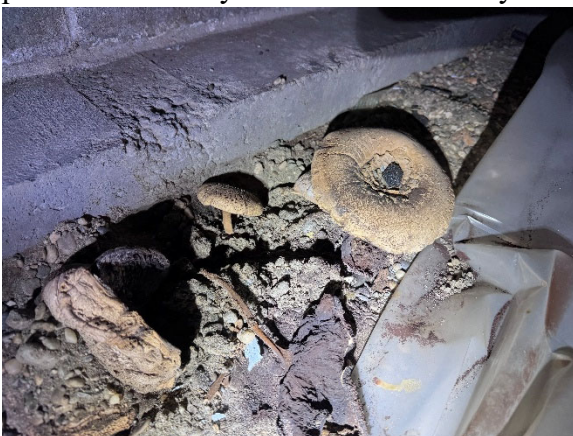
U. There were mushrooms observed under the plastic vapor barrier in the crawl space which further confirms the high moisture condition of the soil in this area. There is known for permafrost nearby but I did not find any evidence of settlement or movement on this house.
