Professional Home Inspections

Home Inspection Report

8861 E.Kiva Way, Palmer, AK 99645

3290

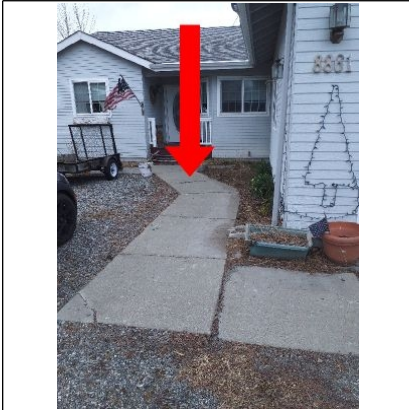
Comments Recommend evaluation for repair of the deteriorating Concrete service walk leading from the garage to the porch located on the front of the home.

Recommend evaluation for repair of the deteriorating Concrete service walk leading from the garage to the porch located on the front of the home.

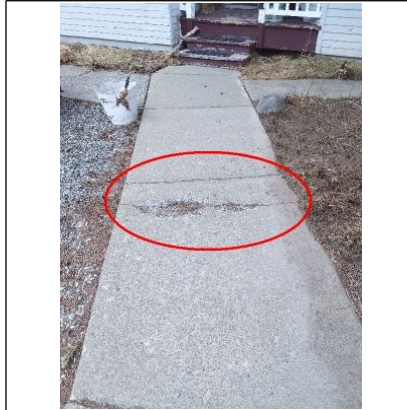
Recommend evaluation for repair of the deteriorating Concrete service walk leading from the garage to the porch located on the front of the home.

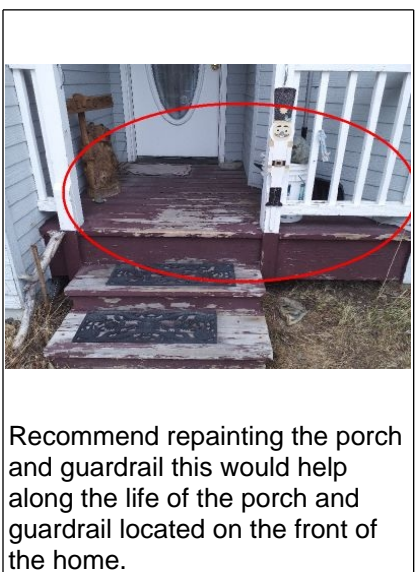
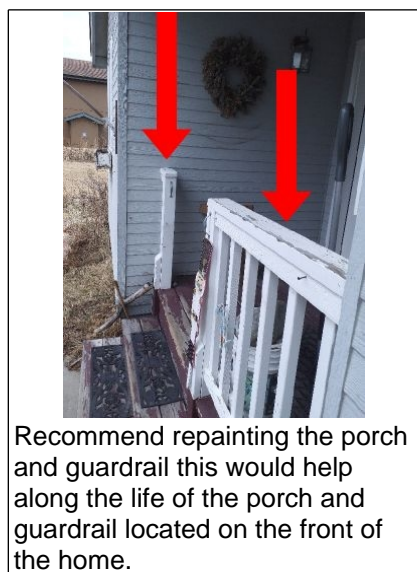
Recommend repainting the porch and guardrail this would help along the life of the porch and guardrail located on the front of the home.

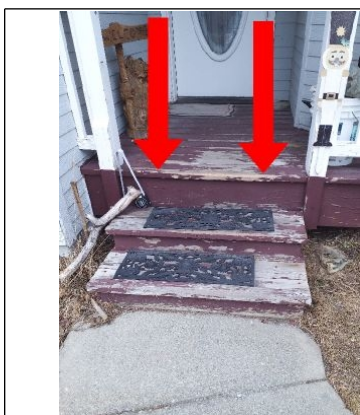
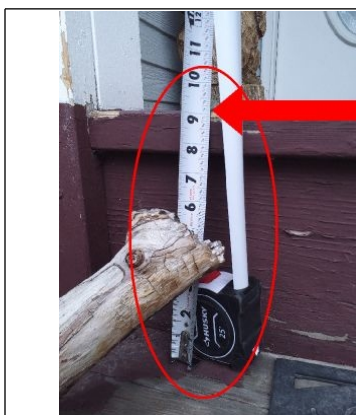
- Comments** Recommend installing an additional step for steps leading to the porch located on the front of the home when the distance from the step floor to the porch floor is more than 7 and 3/4 in. and additional step is required.

Recommend installing an additional step for steps leading to the porch located on the front of the home when the distance from the step floor to the porch floor is more than 7 and 3/4 in. and additional step is required.

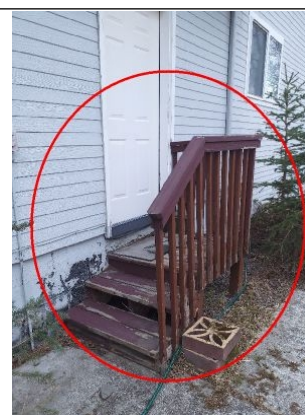
- Recommend evaluation for repair or possible replacement of the stoop and steps located on the right hand side of the home leading to the garage, the floorboards for the stoop are rotted and the handrail and guardrail located around the stoop are very loose and the support posts supporting the stoop need to be metal bracketed to the actual stoop and the stoop is leaning in towards the home.

Recommend evaluation for repair or possible replacement of the stoop and steps located on the right hand side of the home leading to the garage, the floorboards for the stoop are rotted and the handrail and guardrail located around the stoop are very loose and the support posts supporting the stoop need to be metal bracketed to the actual stoop and the stoop is leaning in towards the home.

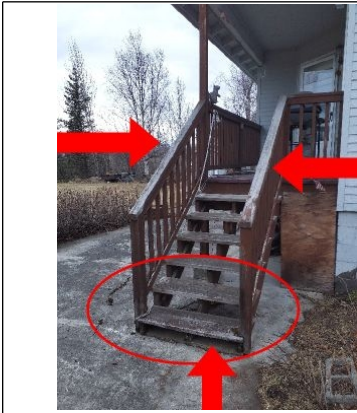
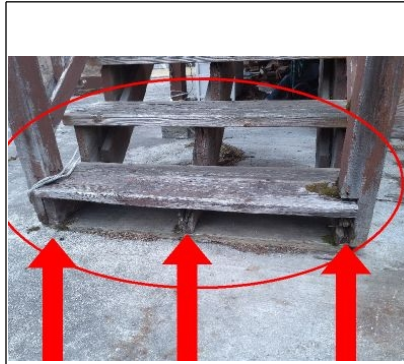
- Recommend evaluation for replacement for repair are the moisture damaged material located on the stairs leading to the deck located on the back of the home, at the time of the inspection the stringers for the first two steps is moisture damaged and the first two floorboards are moisture damaged and the handrails are very loose and wobbly and grippable handrails need to be installed on top of the top rails of the existing handrail and the stairs and handrails need to be repainted.

Recommend evaluation for replacement for repair are the moisture damaged material located on the stairs leading to the deck located on the back of the home, at the time of the inspection the stringers for the first two steps is moisture damaged and the first two floorboards are moisture damaged and the handrails are very loose and wobbly and grippable handrails need to be installed on top of the top rails of the existing handrail and the stairs and handrails need to be repainted.

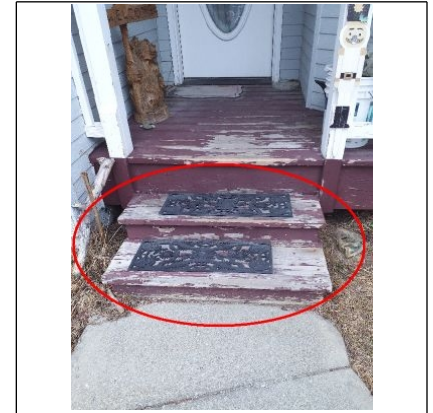
Recommend repainting the steps leading to the porch located on the front of the home this would help prolong the life of the steps.

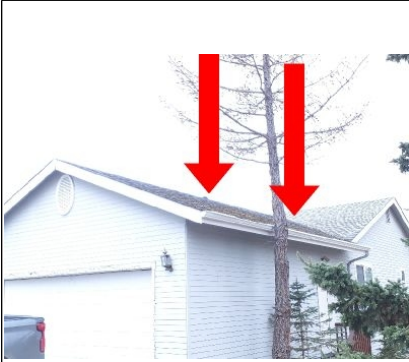
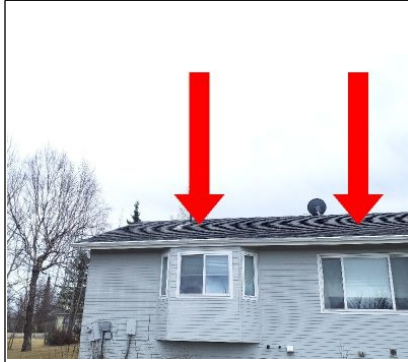
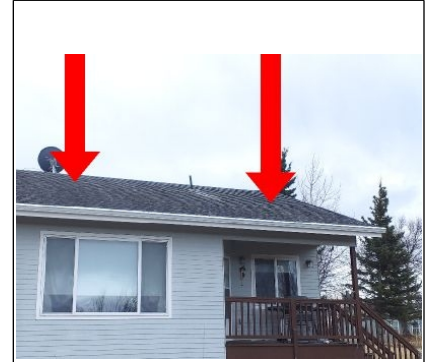
Recommend evaluation by a licensed roofing contractor for the removal of the moss growth occurring on the roof located on the right hand side of the garage and the backside of the roof.

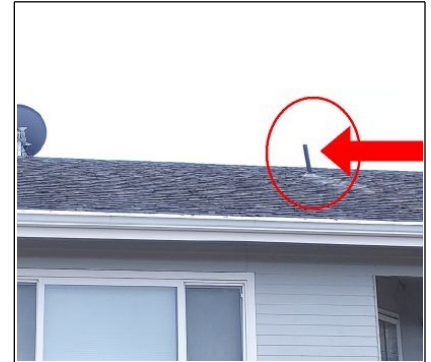
Recommend evaluation by licensed plumber for the repair of the plumbing vent located on the back side of the roof the right hand side of the satellite dish at the time the inspection you can see that the Plumbing vent is leaning to left hand side and it's no longer pointing straight up.

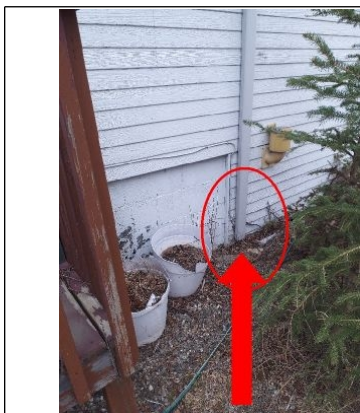
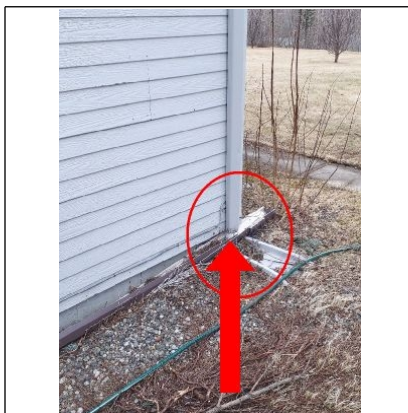
Comments Recommend adding downspout extensions to discharge water away from the home. 5-6' extensions recommended on the two downspouts located on the right hand side of the home to the right hand side of the stoop and steps and the back corner of the home.

Recommend adding downspout extensions to discharge water away from the home. 5-6' extensions recommended on the two downspouts located on the right hand side of the home to the right hand side of the stoop and steps and the back corner of the home.

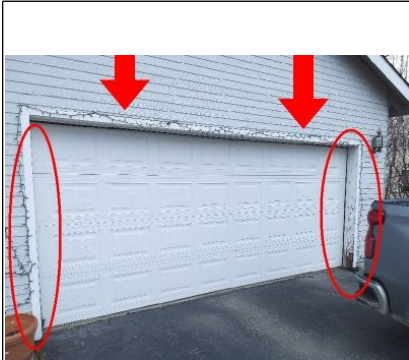
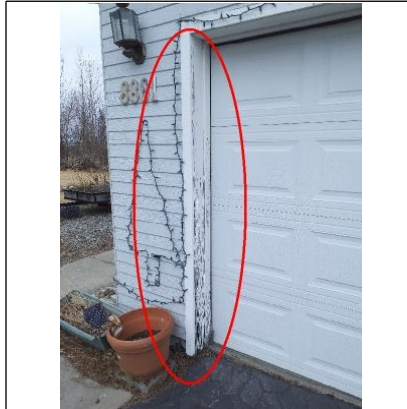
Recommend repainting the exterior wood trim located on the left and right hand sides of the garage door and installing caulking along the top exterior wood trim of the garage door there is no caulking installed at the time of the inspection which could allow for moisture to get behind the exterior wood trim.

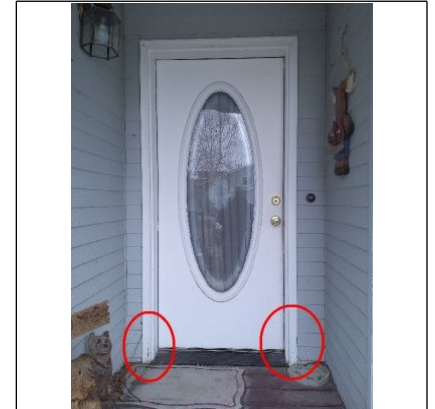
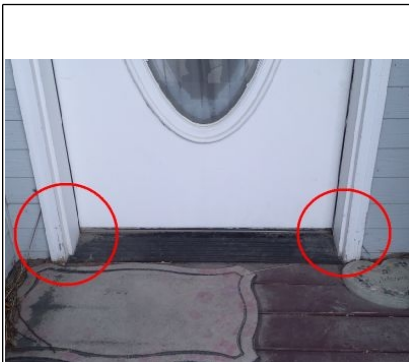
Recommend repainting the exterior wood trim located on the lower left and right hand side of the main entry door.

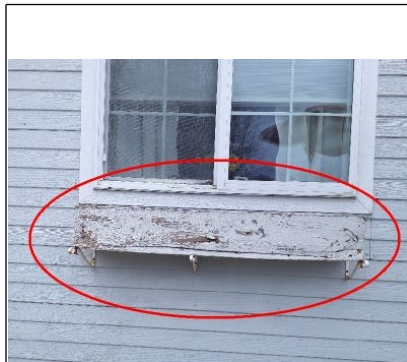
Recommend removal or replacement of the moisture damaged plant box located on the front of home to the left hand side of the porch.

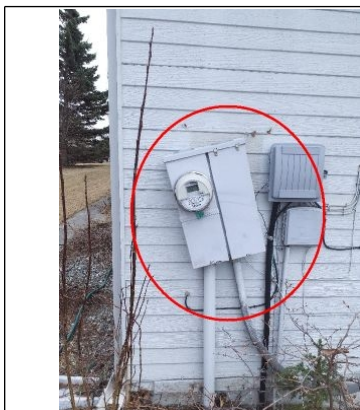
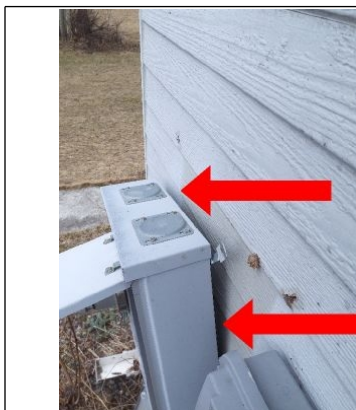
Recommend a licensed electrician remount the service entry and disconnect panel and electric meter properly to the home at the time of the inspection the service entry and disconnect panel and electric meter are detach from the home and leaning to the left hand side this could be a safety hazard.

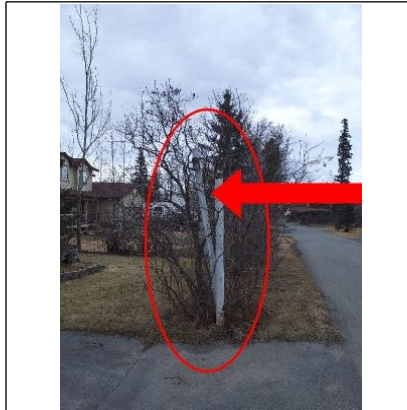
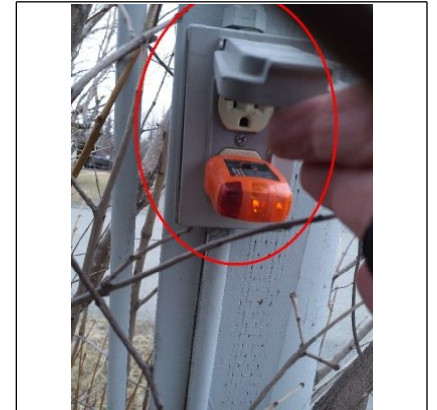
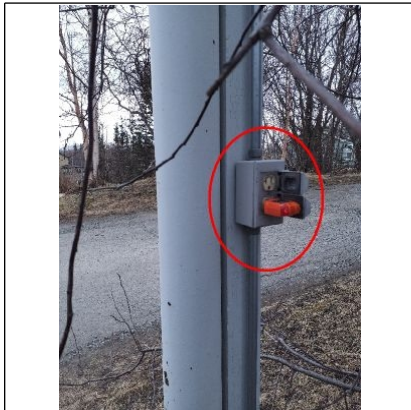
Recommend replacing the two exterior electrical outlets located on the two light poles on either side of the driveway with GFCI protected Outlets and the Light Pole located on the right hand side of the driveway needs to be restraighted its leaning in towards the home which could cause a problem with the electrical wiring.

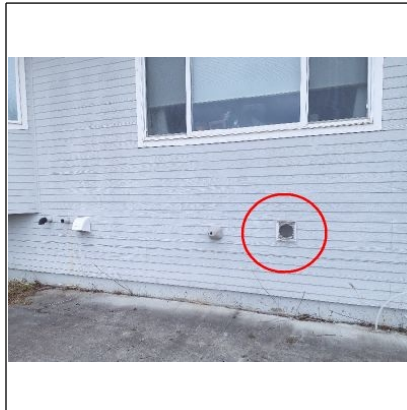
Recommend installing the missing vent cover for the exhaust vent located on the back of the home to the left hand side of the deck.

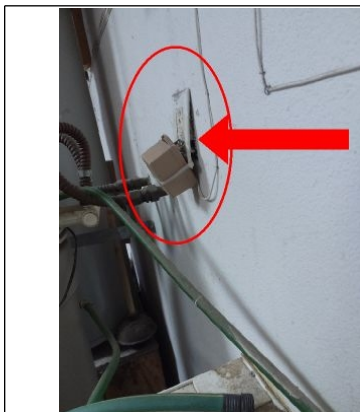
Recommend properly installing the electrical outlet located on the back wall of the garage to the left hand side of the sink at the time of the inspection the electrical outlet is protruding from the wall this is a safety hazard.

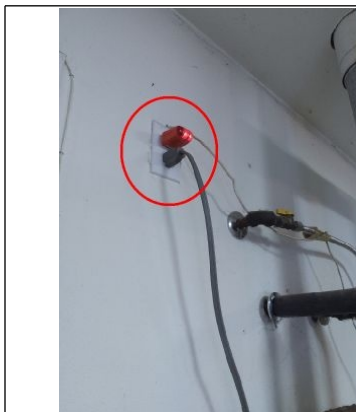
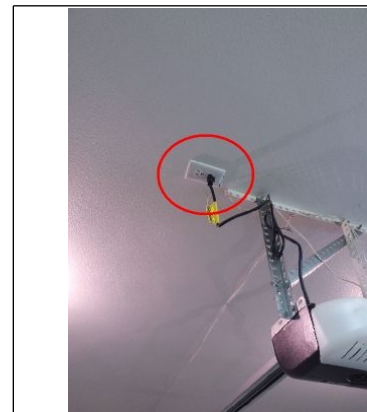
Recommend replacing the electrical outlets running the gas space heater located on the back garage wall and the garage door opener located on the garage ceiling with GFCI protected Outlets.

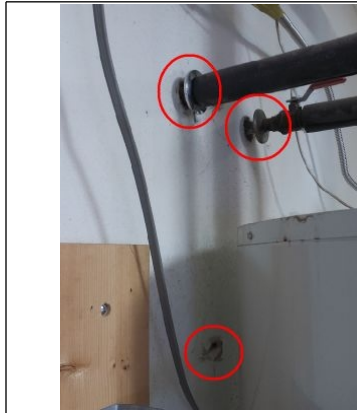
Recommend installing fire rated caulking around the openings where the water lines for the water heater penetrate the back garage wall and fire rated caulking needs to be installed into the opening located directly behind the water heater also.

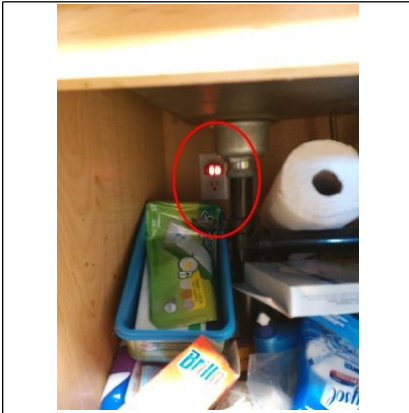
Recommend replacing the electrical outlet under the kitchen sink with a GFCI protected outlet.

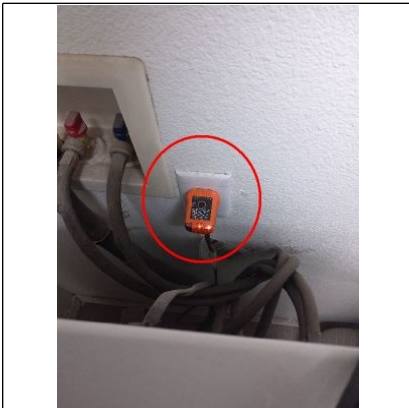
Recommend replacing the electrical outlet located in the laundry room behind the washer and dryer with a GFCI protected outlet.

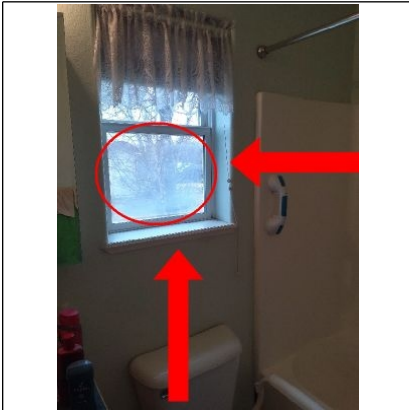
The seal has become broken on the insulated glass window located in primary bathroom, this has allowed moisture to become trapped between the glass window panes, recommend a window or glass company evaluate for repair or replacement and the window also needs safety film installed on it because the window is within 5 ft horizontally from the tub and shower and 5 ft vertically of the floor.

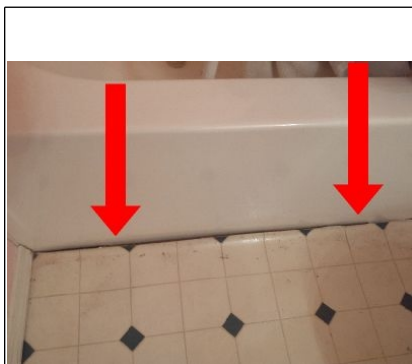
Recommend installing some form of floor base trim and caulking where the flooring meets the tub surround located in bathroom 2 at the time of the inspection the flooring is curled up where floor meets the tub.

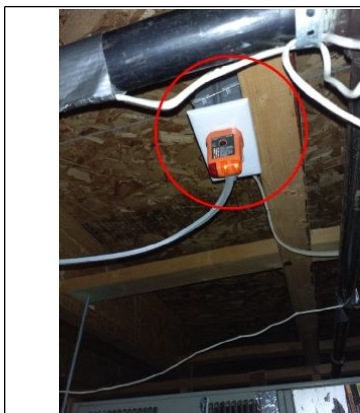
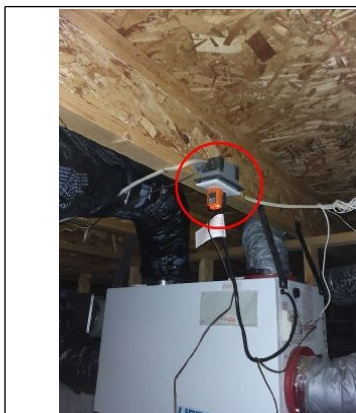
Recommend replacing the electrical outlets located in the crawl space running the furnace and the HRV system with GFCI protected Outlets.

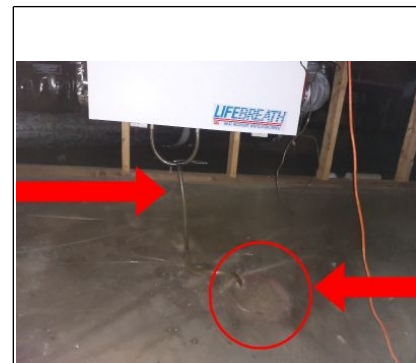
Recommend installing a condensation pump for the HRV system located in the crawl space at the time of the inspection the HRV system is draining water into a bucket underneath the Vapor Barrier located in the crawl space.

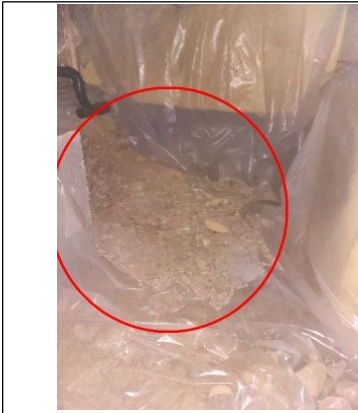
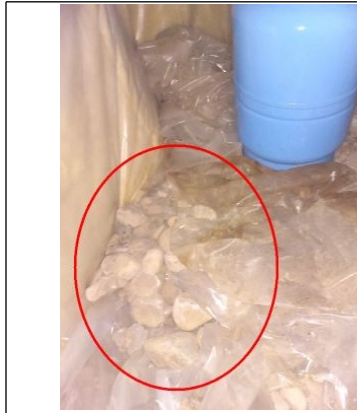
Recommend restretching and sealing the seams and the perimeter of the poly sheeting on the floor in the crawlspace around the well pressure tank there should be no exposed dirt.

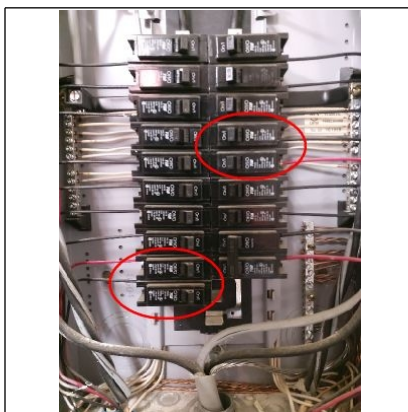
Two Handle ties are needed in the electrical panel, Whenever two breakers are sharing the same neutral they require a handle tie.
