STATE FARM FLORIDA INSURANCE COMPANY TAMPA, FLORIDA

**SUBSIDENCE INVESTIGATION**

**LLC JUST LIKE HOME PROPERTY**  
**9474 MISSISSIPPI RUN**  
**WEEKI WACHEE, FLORIDA**

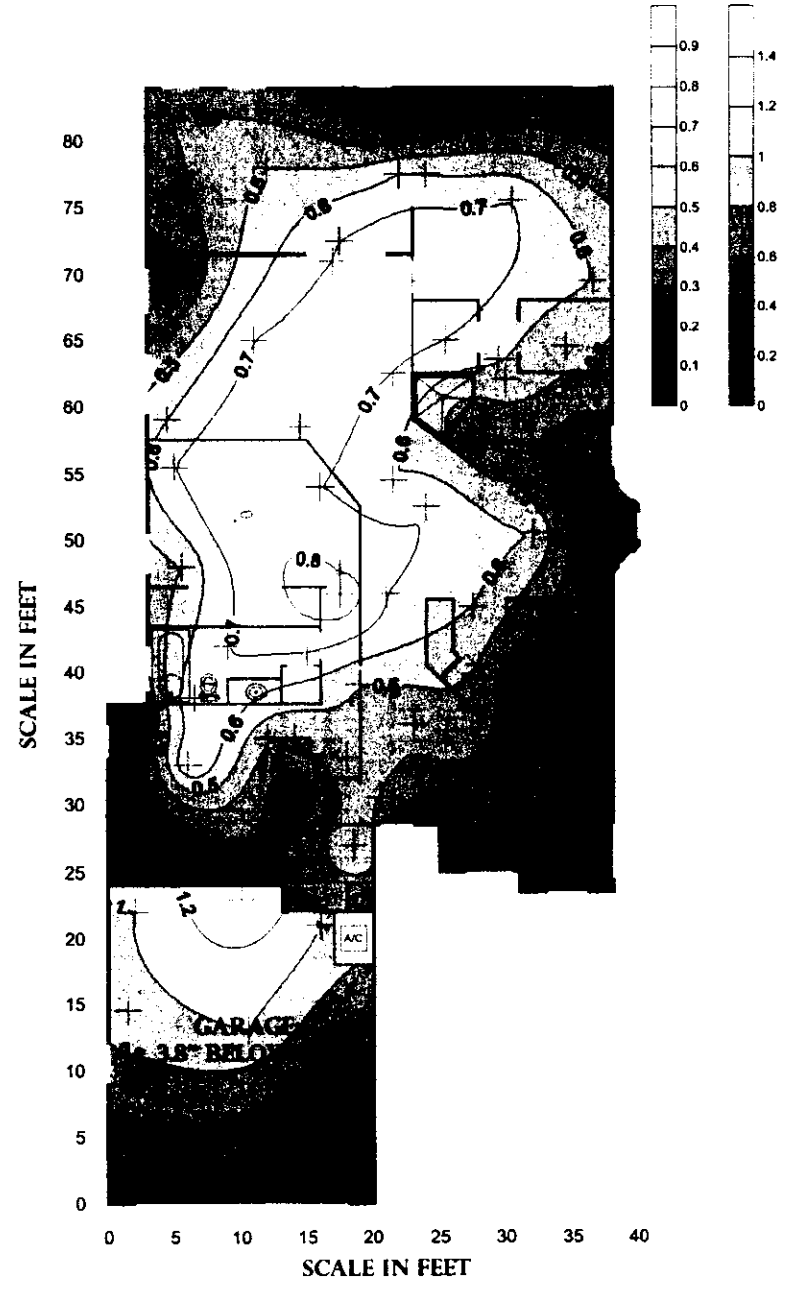
<b>RELATIVE FLOOR ELEVATION CONTOUR MAP</b>		
		LLC JUST LIKE HOME PROPERTY WEEKI WACHEE, FLORIDA		
		FIELD DATA: LL CHECKED BY: THF DRAWN BY: LAR	PROJECT NO.: 3027229 DRAWING NO.: 7229-5 DATE: 12/22/10	FIGURE <div style="font-size: 2em; font-weight: bold; text-align: center;">5</div>

The floor elevation map indicated that there was a total elevation difference of approximately 0.9 inches across the floor slab of the main living area of the residence. The highest elevation was recorded at the central portion of the floor slab, and the floor elevations generally decreased toward the northwest corner of the residence. The pattern of elevation change of the floor slab of the residence is consistent with minor differential foundation movement.

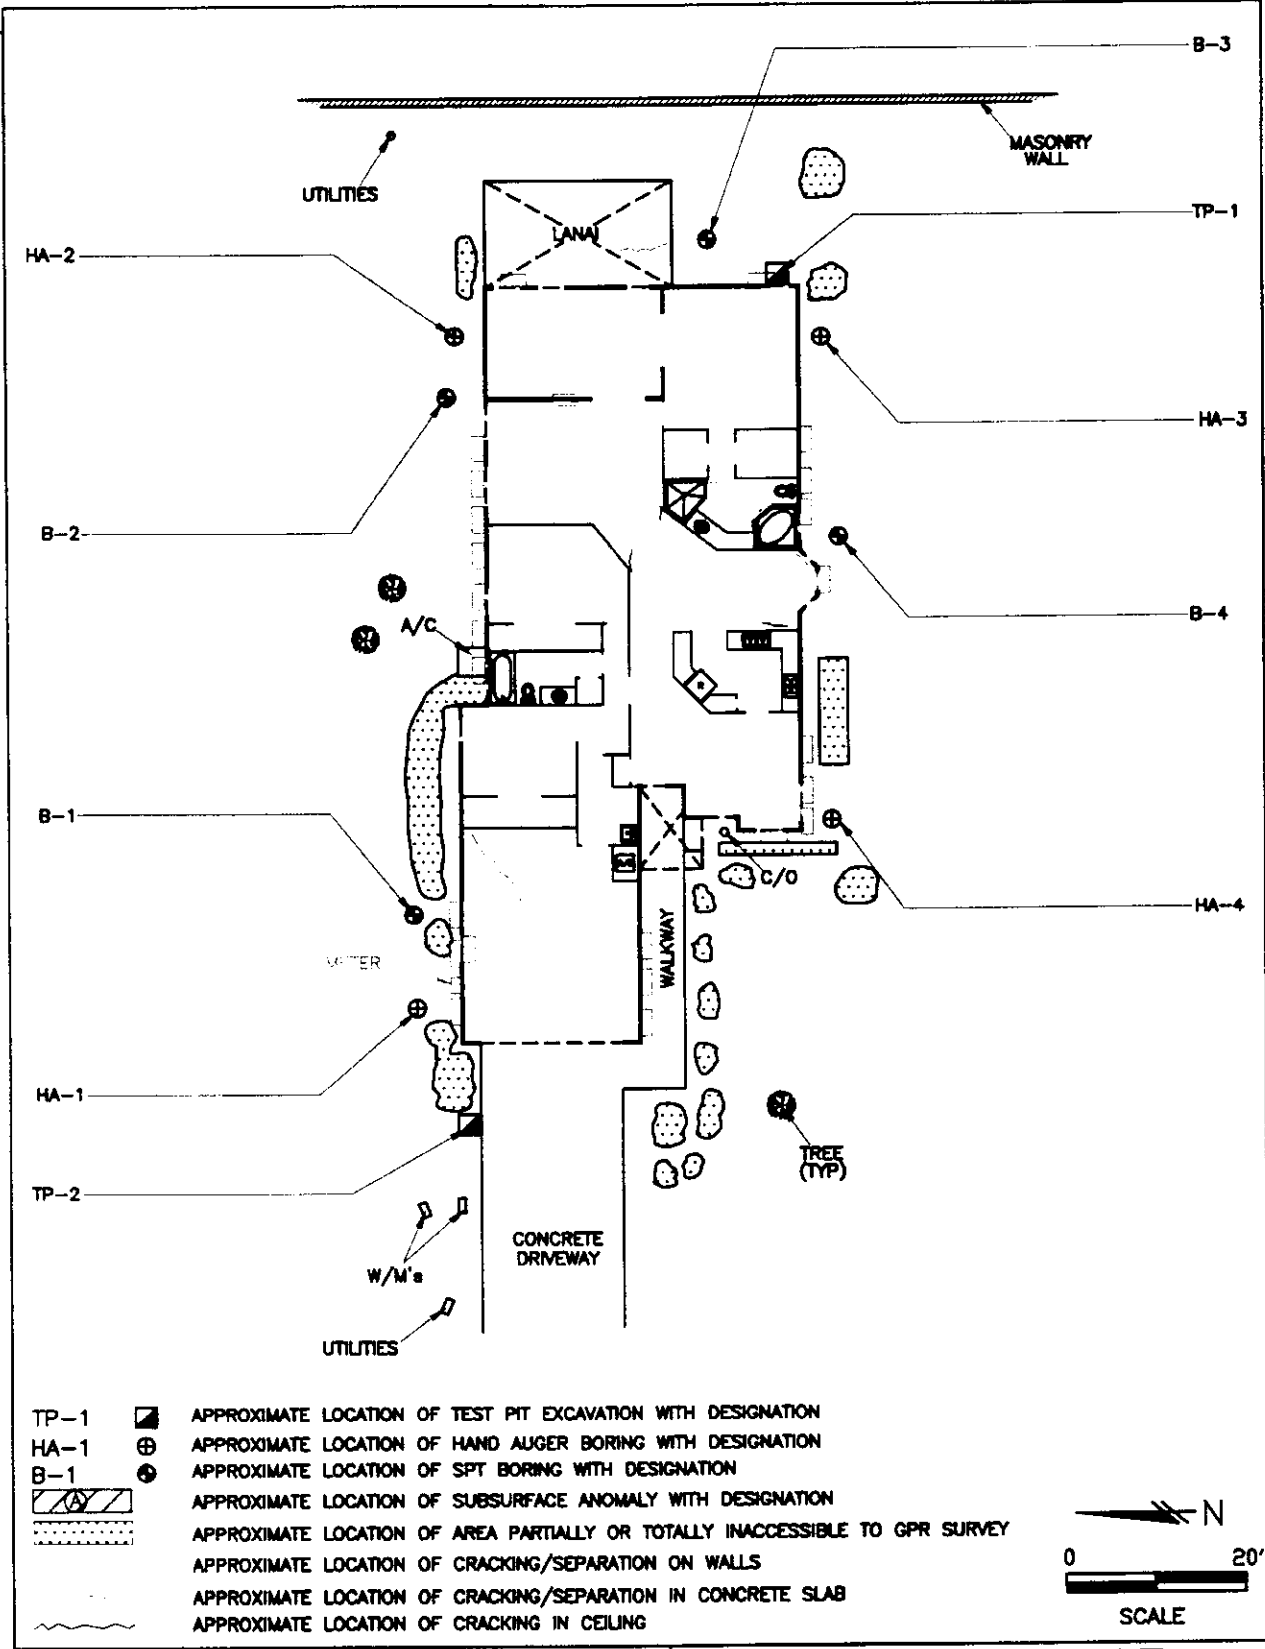
<b>SITE PLAN SHOWING APPROXIMATE LOCATION OF FIELD TESTS</b>		
		<b>LLC JUST LIKE HOME PROPERTY WEEKI WACHEE, FLORIDA</b>		
		DESIGNED BY: MDZ CHECKED BY: SU CREATED BY: SMS	PROJECT NO.: 3027229 DRAWING NO.: 7229-4 DATE: 12/22/10	FIGURE <b>4</b>

Test pit (TP) excavations were performed along the perimeter of the main structure and the driveway to directly observe the foundation construction and geometry. For approximate locations of the test pit excavations, see Figure 4.

The results of TP-1 indicate that the foundation of the main structure consists of a concrete slab-on-grade with a thickened edge monolithic footing. The footing was embedded 10 inches. The top of the slab was 3 inches above the existing ground surface, for a total footing thickness of 13 inches. The current Florida Building Code (1805.2) states that the minimum depth of footings below the undisturbed ground surface shall be 12 inches. An improperly embedded foundation is more susceptible to movement caused by consolidation of near-surface soils as a result of lack of adequate soil confinement.

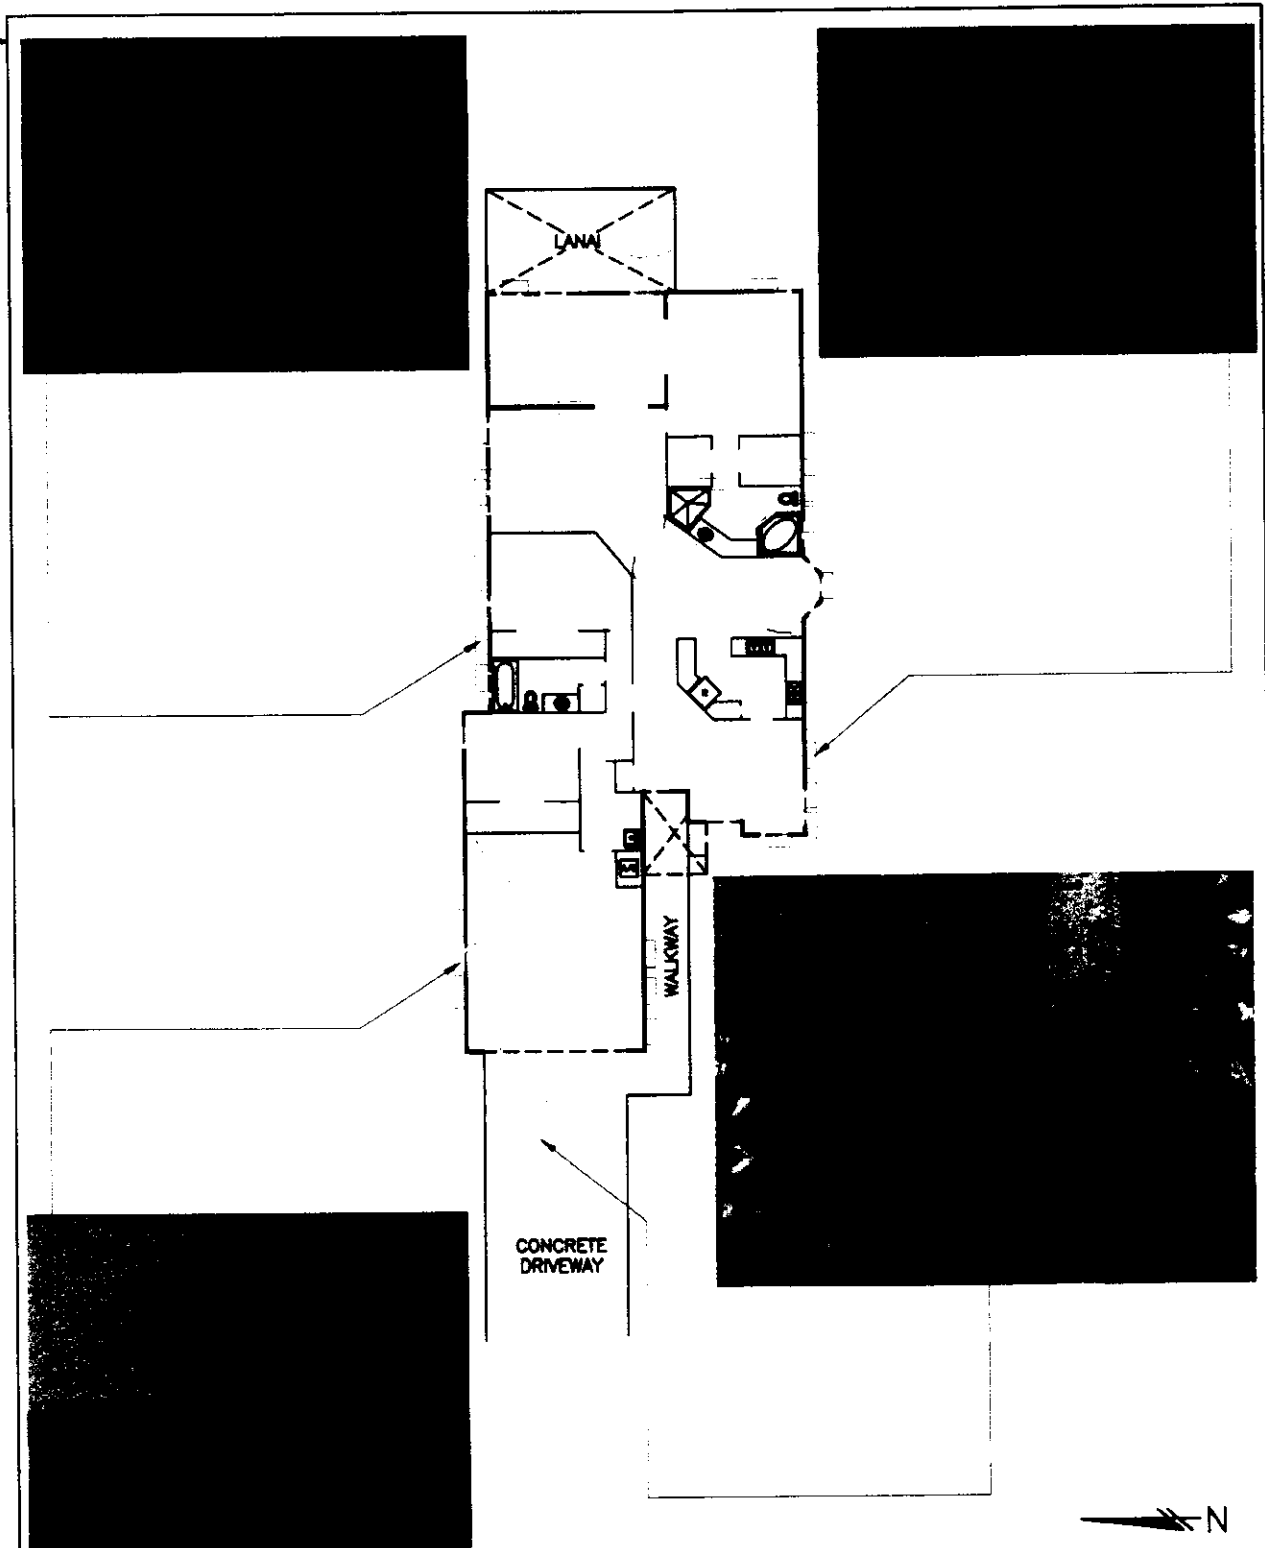
| STATE FARM FLORIDA<br>INSURANCE COMPANY<br>TAMPA, FLORIDA | | SITE PLAN SHOWING APPROXIMATE LOCATION<br>AND EXAMPLES OF OBSERVED DAMAGE | | |

openings, at or near changes in geometry of the framing, and at or near abrupt changes or corners of a drywall panel. These separations and cracking resulting from minor differential foundation movement, long-term deflection, and post-construction settlement have no bearing on the structural integrity of the structure.

The separation of the kitchen cabinets from the adjacent ceiling is consistent with inadequate fastening of the cabinets. Kitchen cabinets are typically supported from the back wall utilizing wood screws through the rear of the cabinet into the wood studs of the wall. The cabinets are not supported from the ceiling and thus are cantilevered outward from the back wall. It is not uncommon for elevated cabinets to deflect downward at their outward face due to their cantilevered support condition. SDII recommends that additional support screws be installed in the affected cabinetry and that the wood trim piece placed at the top of the cabinets be removed and repositioned once the additional support is provided.

The nail head protrusion noted in the wall of the living room was unrelated to differential movement of the foundation. The protrusion of nail heads above the drywall surface is typically caused by lumber shrinkage due to initially high moisture content. As the lumber dries and shrinks, the nail is forced slightly out of the penetration resulting in the protrusion of the nail head above the drywall surface. The loose attachment of the drywall to the framing, improperly aligned, twisted, or warped framing, and improper fastener length also result in nail head protrusions.

The observed cracking on the interior of the garage and exterior of the residence is consistent with minor differential settlement of shallow, and mildly reinforced, conventional foundations constructed on loose soils. This minor differential foundation settlement has resulted in horizontal and stair-step pattern cracking in the masonry-block walls. Material shrinkage of the masonry and/or stucco and the effects of thermal stress have further exacerbated the exterior cracks. Material shrinkage cracks frequently occur in residential masonry construction and typically appear as vertical cracking at those locations in which the wall is most susceptible to cracking, such as at window openings and corners. Movement resulting from cyclical thermal volume change exacerbates existing cracks and may induce additional cracking. The degree of movement associated with thermal stress is a function of the building materials, the length of the wall, and the amount of temperature change. Minor differential movement of the foundation appears to have further aggravated this damage. See Section 2.0 "Geologic and Geotechnical Evaluation" for further discussion of soil conditions encountered at the site that may have initiated the differential movement of the foundation. These damages do not have a significant impact on the structural integrity or required design capacity of the walls.

The observed cracking in the concrete slabs of the garage, lanai, and driveway is consistent with concrete shrinkage and/or the effect of thermal expansion and contraction. Concrete slabs on grade shrink after construction initially due to thermal volume change as the hydration process (curing) slows. The slab will also continue to shrink after construction due to drying shrinkage as free water (water not chemically bound during the hydration process) leaves the slab. Both of these shrinkage mechanisms are inherent in the concrete curing/aging process. Construction joints and control joints are typically used in commercial construction to control the random curing/shrinkage cracking; however, the use of construction and control joints in residential

tiles in the shower of the north bathroom, and between the wall tiles and the bathtub in the master bathroom. There were also cracks in the concrete slab of the garage.

On the exterior, SDII noted cracks in each of the wall elevations. There were stair-step pattern cracks in the north and south walls of the residence. There were also cracks in the concrete slabs of the lanai and driveway.

On the interior of the residence, SDII observed cracks in the ceilings of the breakfast nook and hallway. Cracks were noted in the walls of the master bathroom and garage. A nail head protrusion was observed in the wall of the living room. Separation was noted between the cabinets and the ceiling in the kitchen. There were cracks in the grout joints between the wall
