**CITIZENS PROPERTY INSURANCE CORPORATION  
 SINKHOLE FILING WORKSHEET AND COVER**

**Executive Summary - Claim Report**  
**Citizens Property Insurance Corporation**  
**Claim Number 445670**

Hagen Property  
Subsidence Investigation  
MEG Project No. 9798

**Hagen Property, Hudson, Florida**

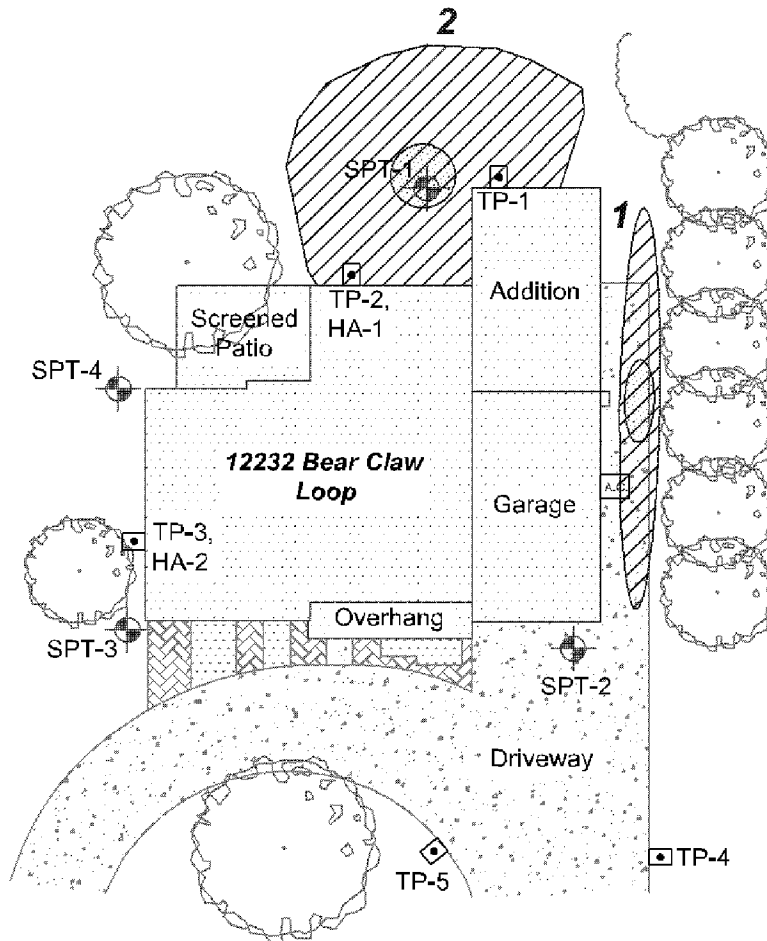
Five shallow test pits, TP-1 through TP-5, were excavated during the site inspection to evaluate the type and condition of the foundation beneath the structure and associated slabs. The test pit locations are shown on **Figure 3**.

*GPR Anomaly 1 is elliptical in shape with total area of approximately 150 square ft. The anomaly is located south of the residence. The apparent vertical relief of the upper portion of the anomaly area is 3 to 4 ft as characterized by the observed downwarping of the GPR reflector set. A localized increase in the depth of penetration of the GPR signal was also observed within the anomaly area. The apparent center of the feature is characterized as the area of maximum downwarping of the previously referenced GPR reflectors.*

*GPR Anomaly 2 is irregular in shape with total area of approximately 650 square ft. The anomaly is located east of the residence. The apparent vertical relief of the upper portion of the anomaly area is 1 to 2 ft as characterized by the observed downwarping of the GPR reflector set. A localized increase in the depth of penetration of the GPR signal was also observed within the anomaly area. The apparent center of the feature is characterized as the area of maximum downwarping of the previously referenced GPR reflectors.*
