**Post Stabilization Monitoring Report**

Claim No. 457413  
Cazier Residence  
6307 Kingway Lane  
Spring Hill, Hernando County, Florida

By:  
Geo-Technologies, Inc.  
1016 SE 3<sup>rd</sup> Avenue  
Ocala, Florida 34471

May 2, 2013  
Geo-Tech Project No. 12-4503.137.2

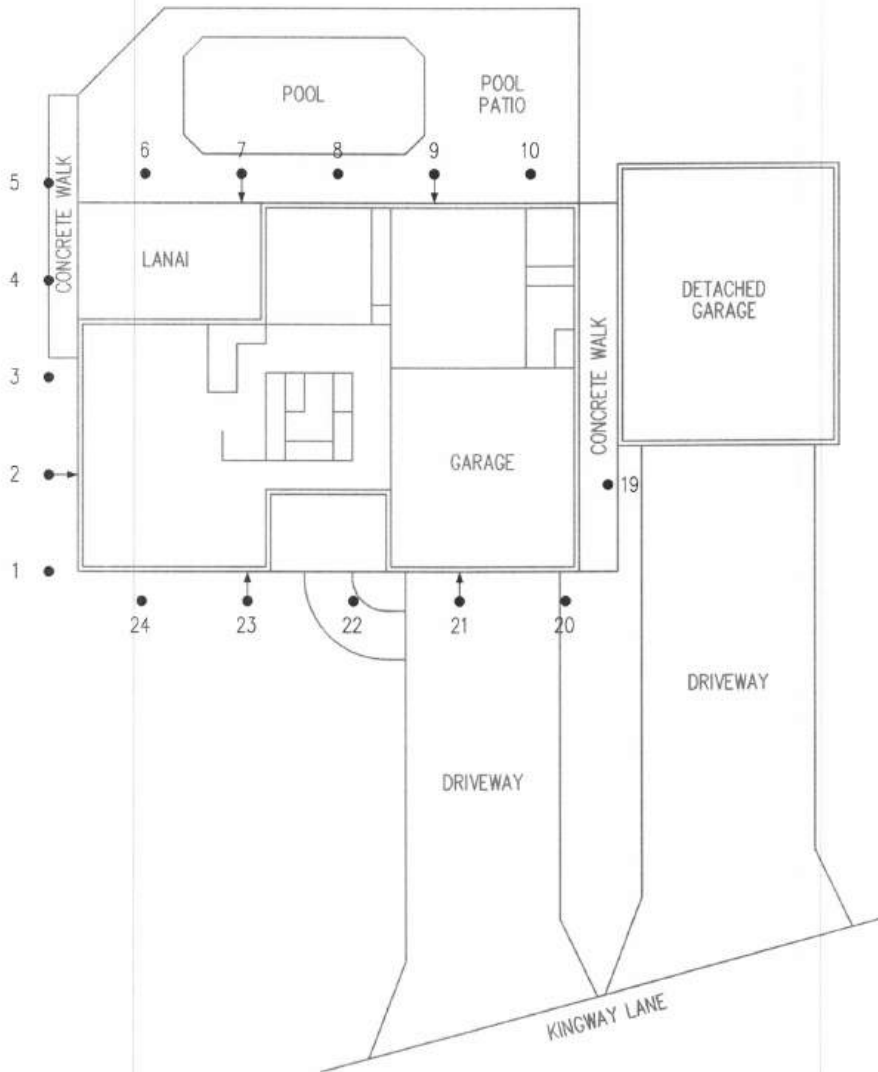
FIGURE: 1

Drilling of the sixteen (16) injection points were performed on March 1, 4 and 5, 2013. Injection locations on the detached garage, No. 11 thru No. 18, were omitted per Citizens. It is Geo-Tech's understanding the detached garage was handled on a different policy. Cumulative drill depths for all sixteen (16) injection points totaled one thousand four hundred and fifty-one (1,451) linear feet including redrills. Injection locations No. 7 and No. 10 had to be redrilled due to sand locking up the pipe during drilling. The original estimate for the total linear feet of injection pipe to be installed was two thousand three hundred and four (2,304) feet.

Compaction grouting was performed on March 12 and 13, 2013. Cumulative compaction grout quantities for all sixteen (16) injection points totaled twenty-one and one-half (21.5) cubic yards. The original project estimate was anticipated to range between two hundred fifty (250) to three hundred fifty (350) cubic yards. On the final day of grouting, March 13, 2013, the last truck was sent back with an estimated three and one-half (3.5) cubic yards. Remaining grout was sent back due to the job being completed before the last truck was empty. The grout quantities were substantially lower than estimated and it appears that the area of concern was in the vicinity of injection pins No. 1, 2, 3, 9 and 22. Based on the grout intake volume the loose zones were fairly isolated around the residence. Shipping tickets of all grout supplied are on file and can be forwarded to you upon request.

COMPACTION GROUT INJECTION MAP

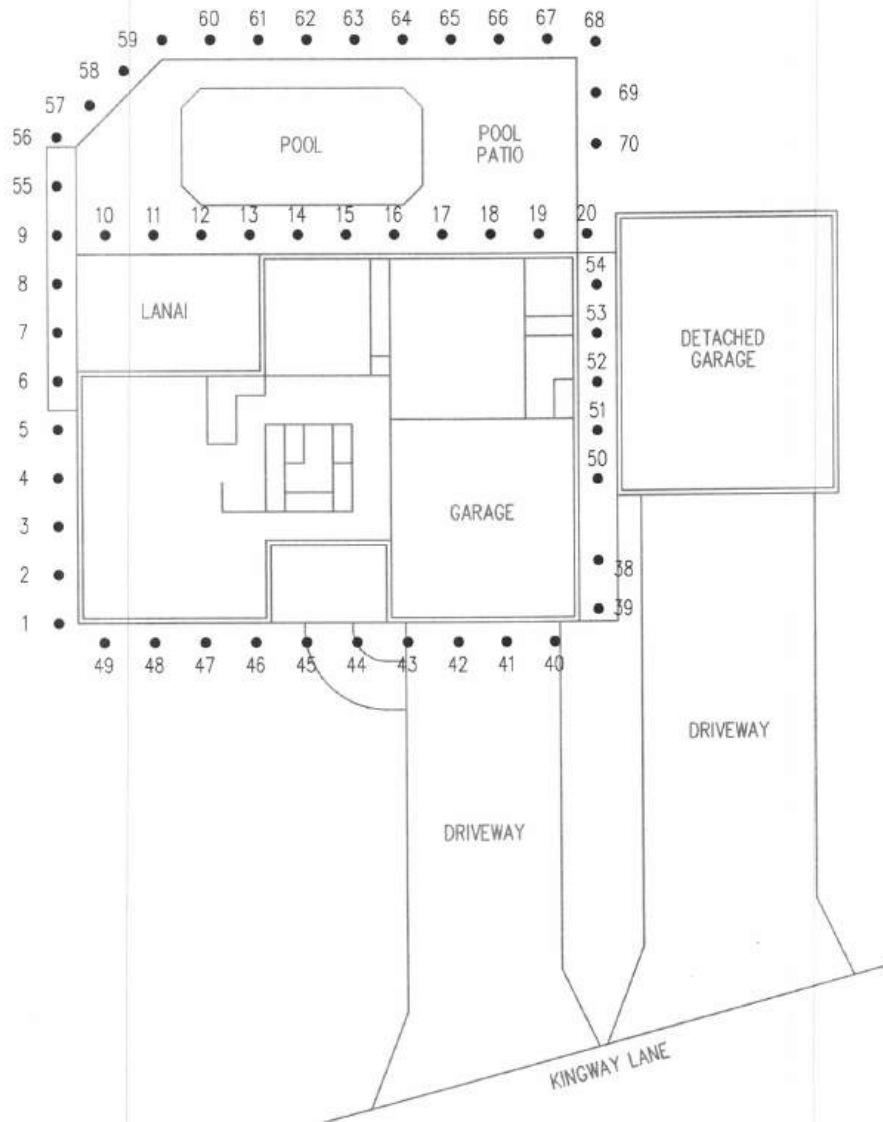
FIGURE: 2

Drilling and grouting of the fifty-three (53) injection points were performed on April 29 and 30, 2013. All injection points were drilled to a depth of nine (9) feet.

Cumulative chemical grout quantities for all fifty-three (53) injection points totaled one thousand one hundred eighty-six and thirty-eight hundredths (1,186.38) pounds. The original estimate for the project was anticipated to be approximately one thousand four hundred (1,400) to one thousand seven hundred fifty (1,750) pounds of chemical grout.

CHEMICAL GROUT INJECTION MAP

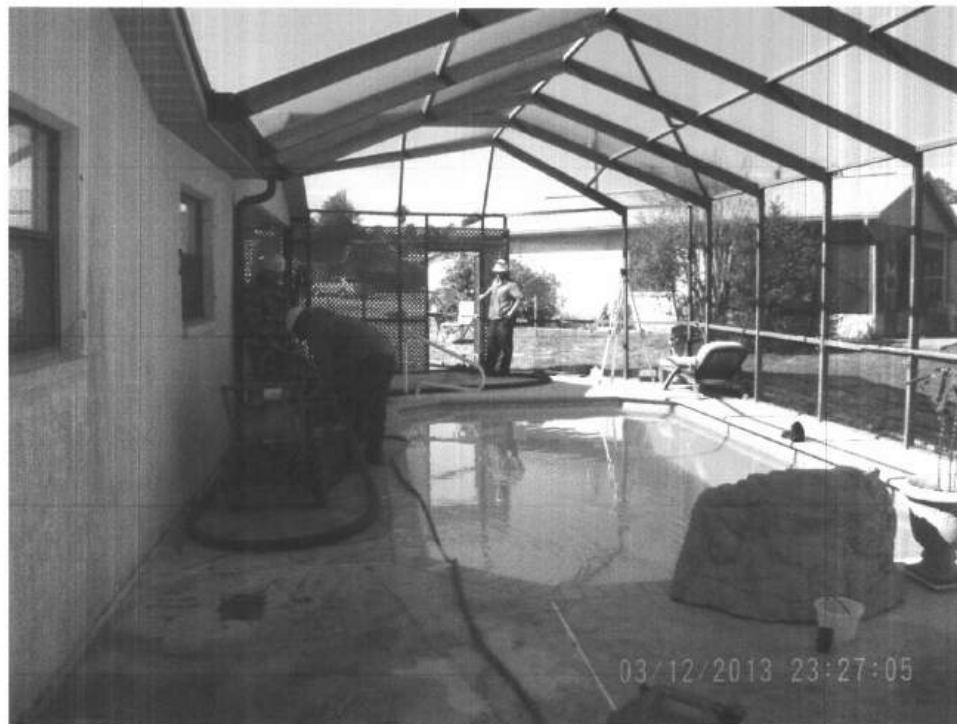
Picture 4: Rear elevation with grouting process on pool deck

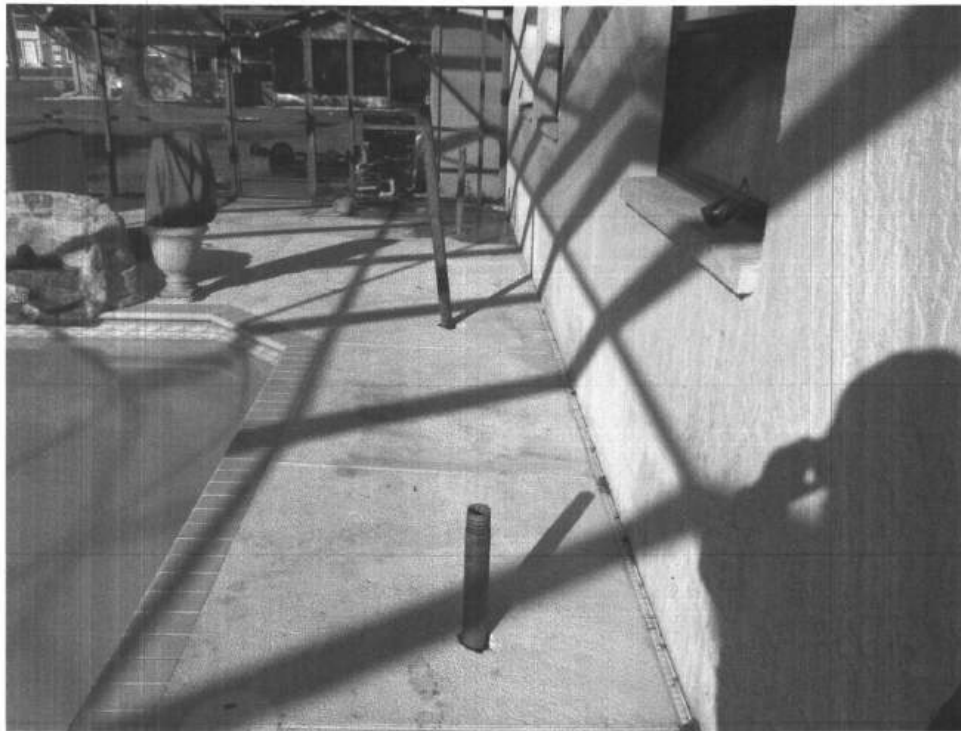
Picture 5: Core holes in pool deck

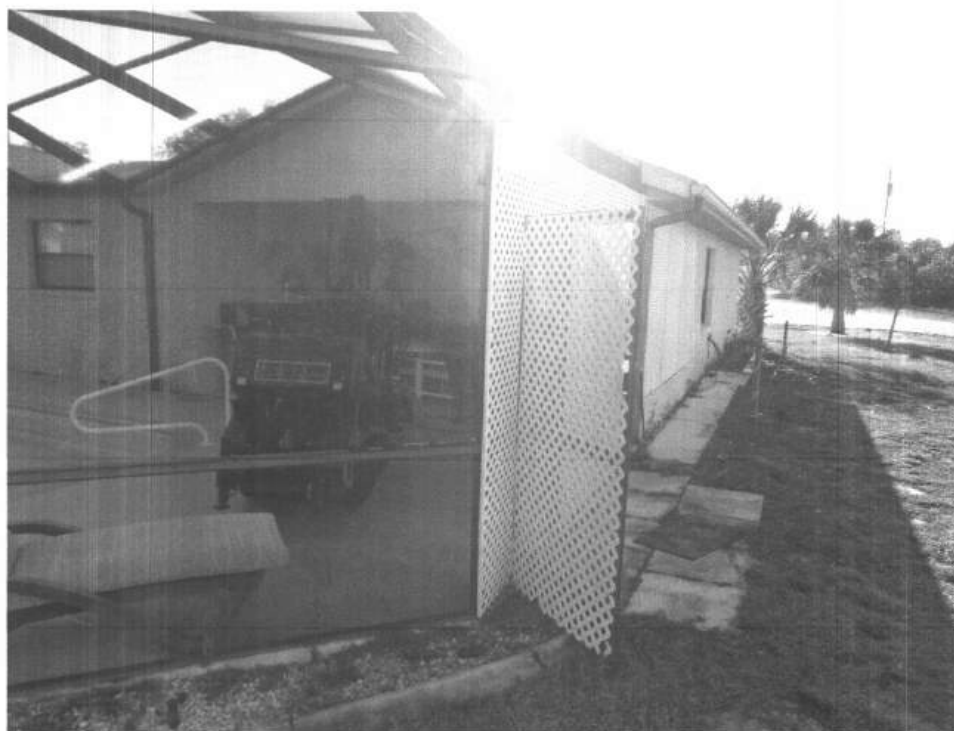
Picture 7: Drilling process on pool deck

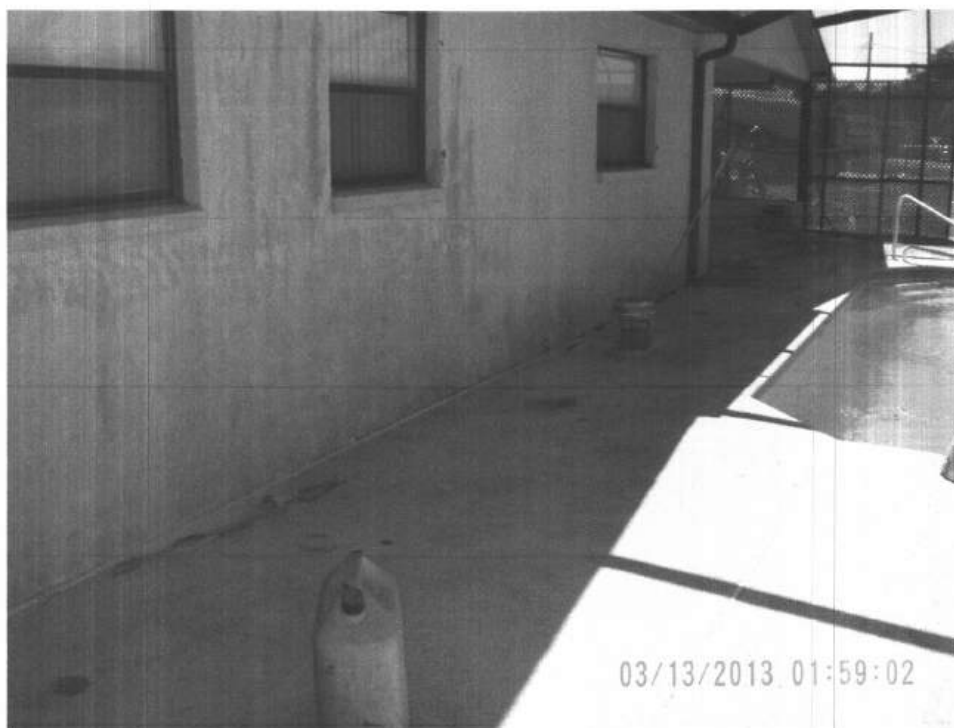
Picture 8: Filled core holes on pool deck

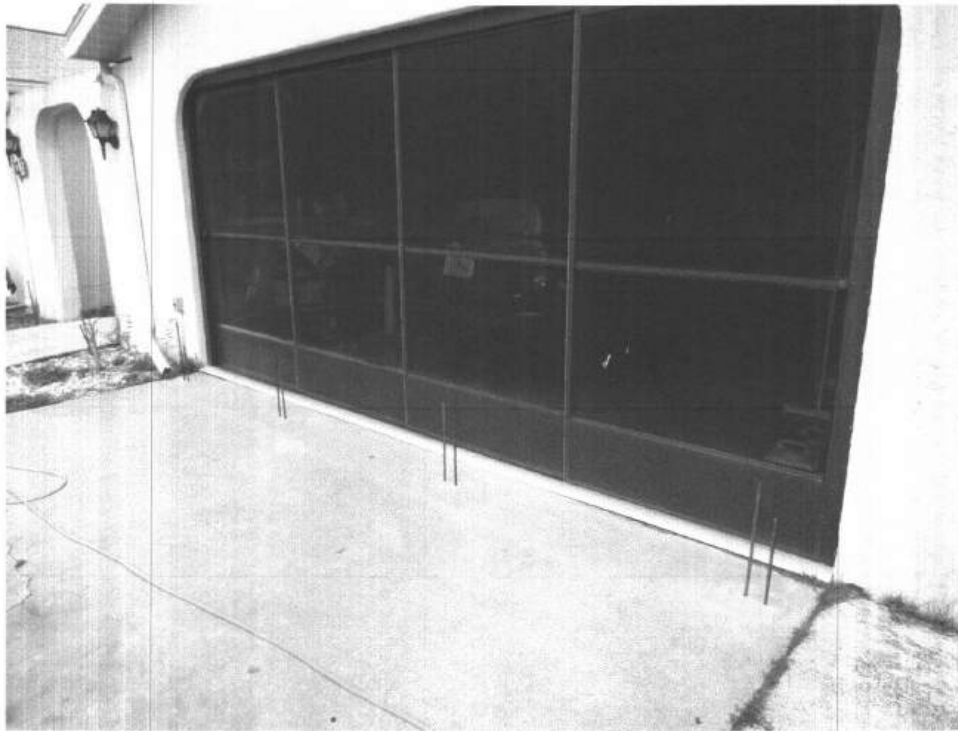
Picture 9: Holes drilled in driveway for chemical injections

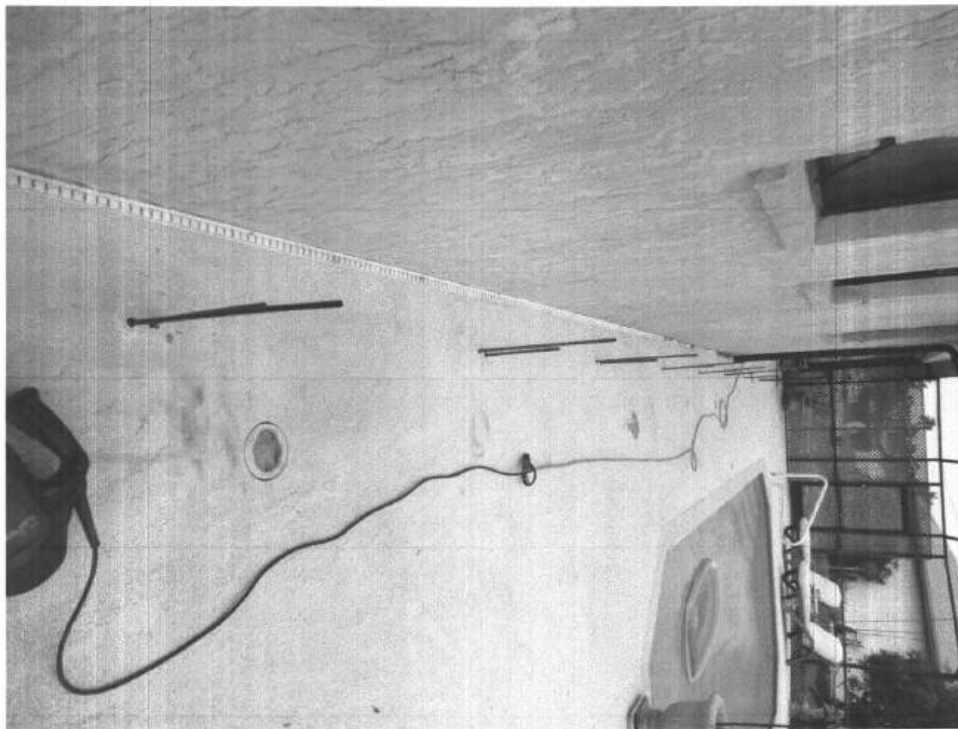
Picture 10: Holes drilled in pool deck for chemical injections

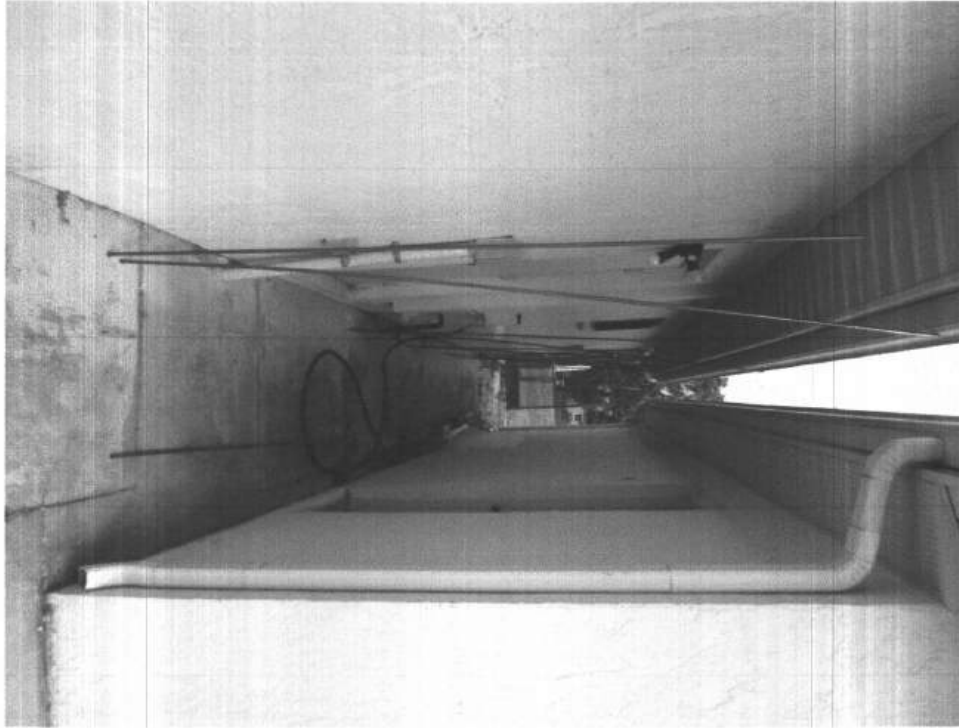
Picture 11: Installing chemical injections

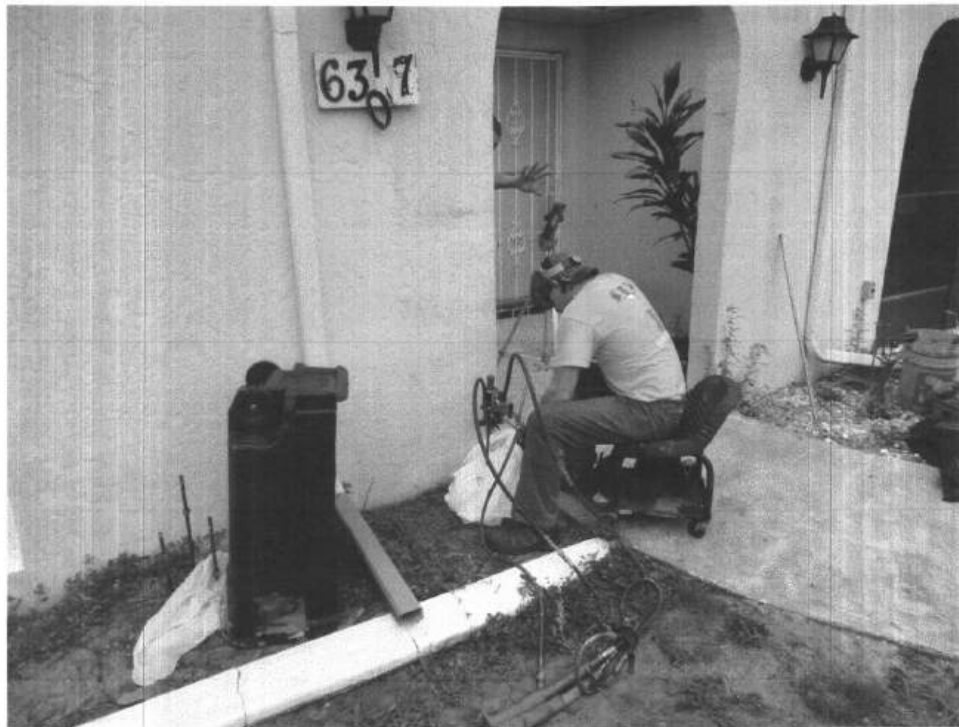
Picture 12: Pumping chemical injections
