**UNDERPINNING INSTALLATION MONITORING REPORT**

**The "Florida Eagle Investments LLC" Property  
2392 Fairview Road  
Spring Hill, Florida 34609**

**RE: Limited/Partial Underpinning Installation Monitoring Report**

**ADDRESS:** 2392 Fairview Road  
Spring Hill, FL 34609  
GEI Project # GEO-9501-08-16

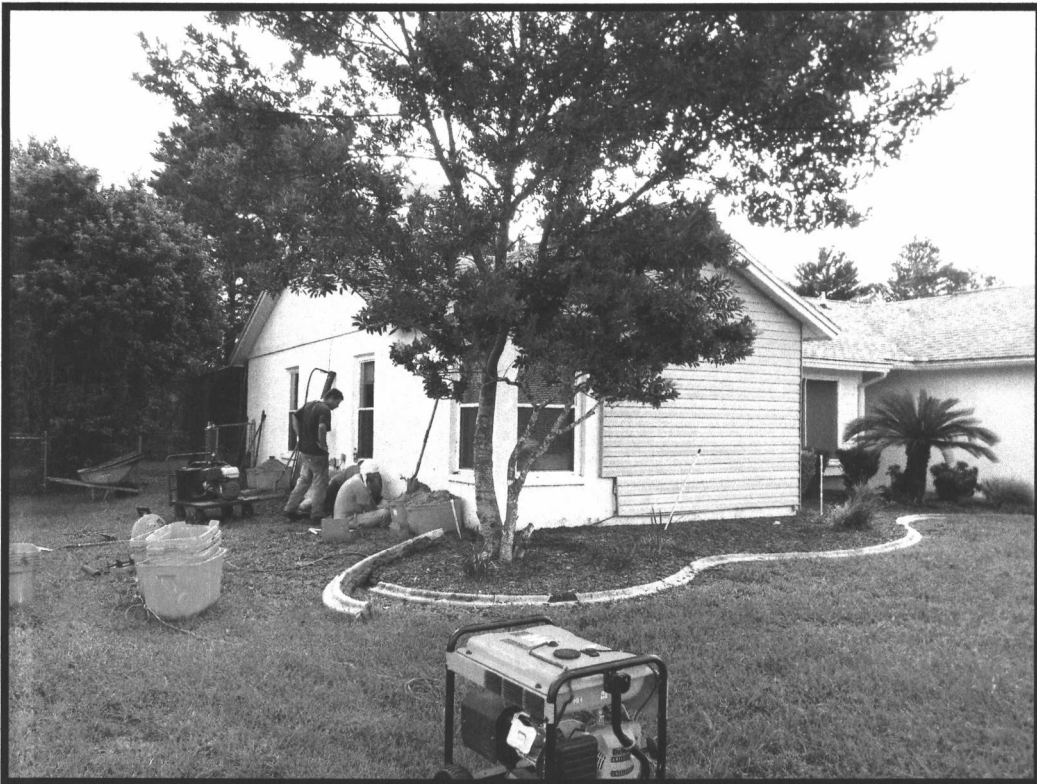
Photo 2: View of Pin installation along the targeted repaired area of the house.

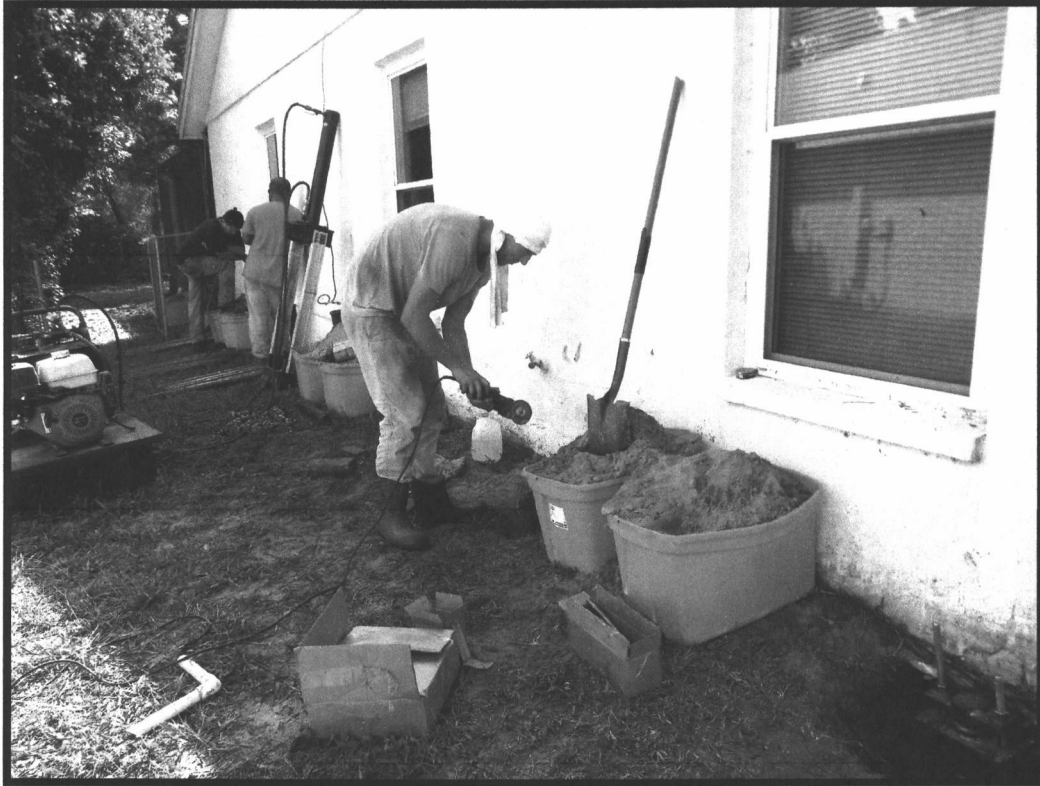
Photo 3: View of Pin installation along the targeted repaired area of the house

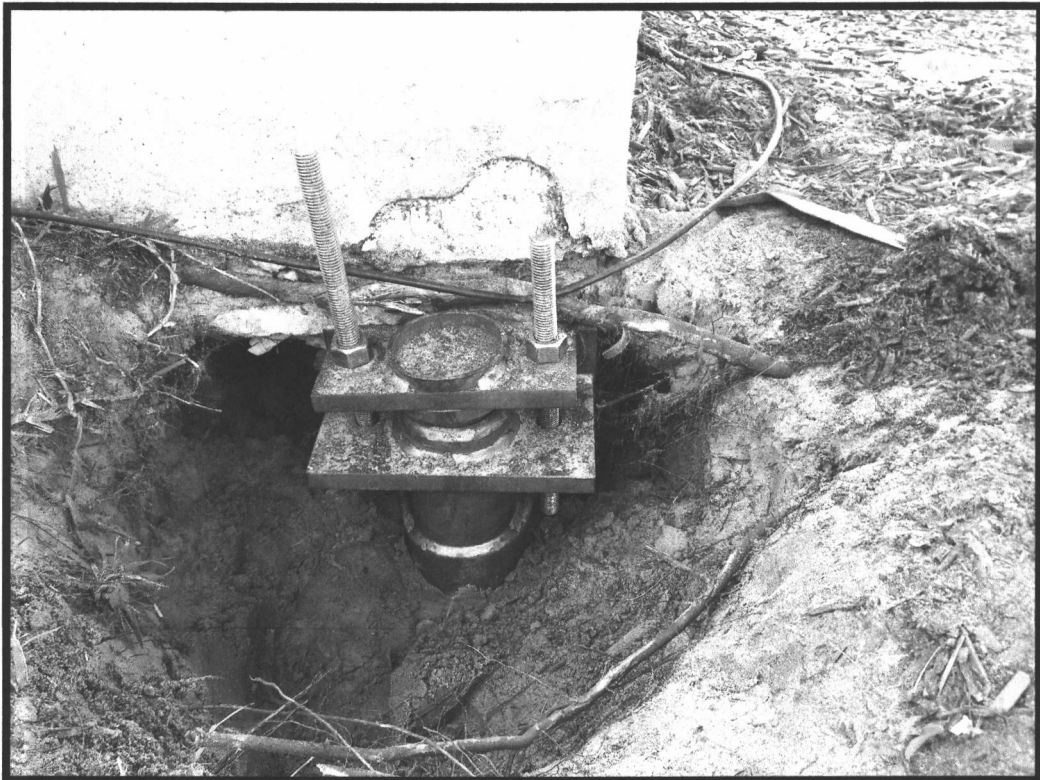
Photo 4: View of a typical completed pin and bracket.
