**FORENSIC GEOTECHNICAL EXPLORATION**

**HILPERT RESIDENCE**  
10464 Cranston Street  
Spring Hill, Florida 34608

Universal Project No. 0830.1000350.0000  
Citizens Property Insurance Corporation Claim No. 351934

October 22, 2010

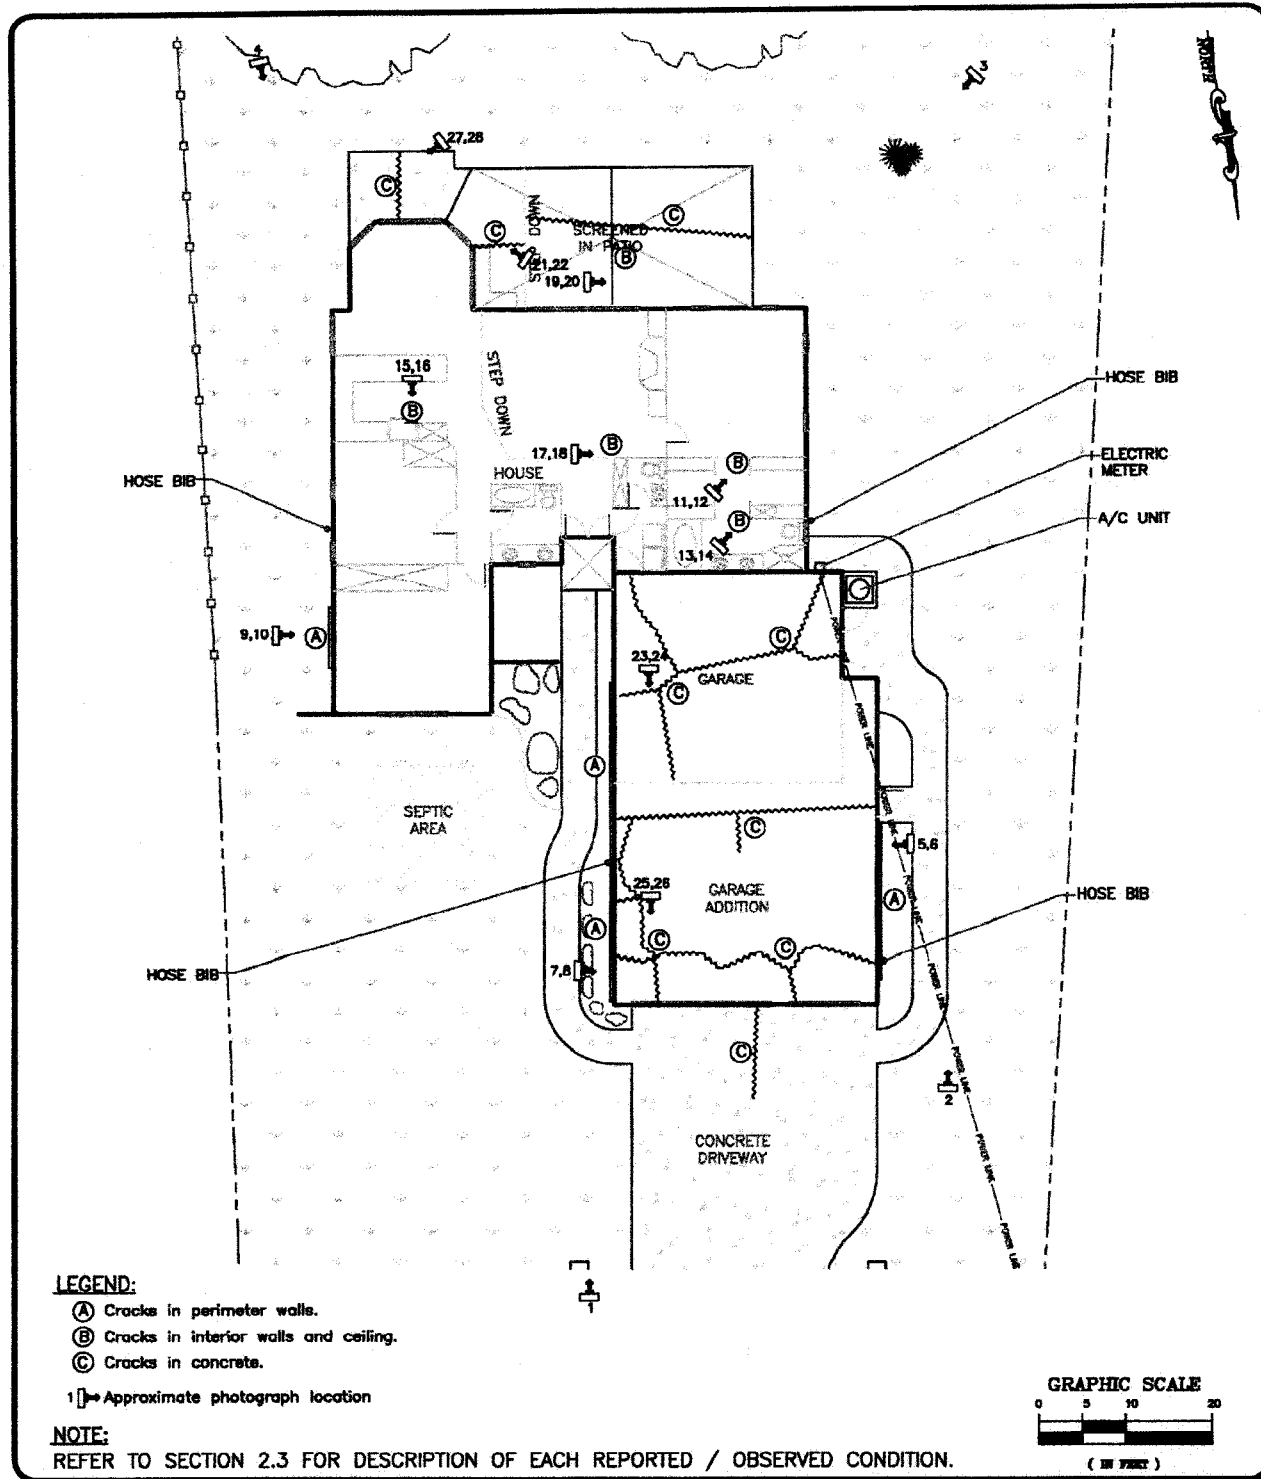
- A. Hairline cracks in the stucco were noted on the exterior masonry walls (Photographs 5 through 10).
- B. Joint cracks/separations were noted in the drywall and ceiling of the house (Photographs 11 through 20).
- C. Cracks were noted in concrete flatwork (Photographs 21 through 28).

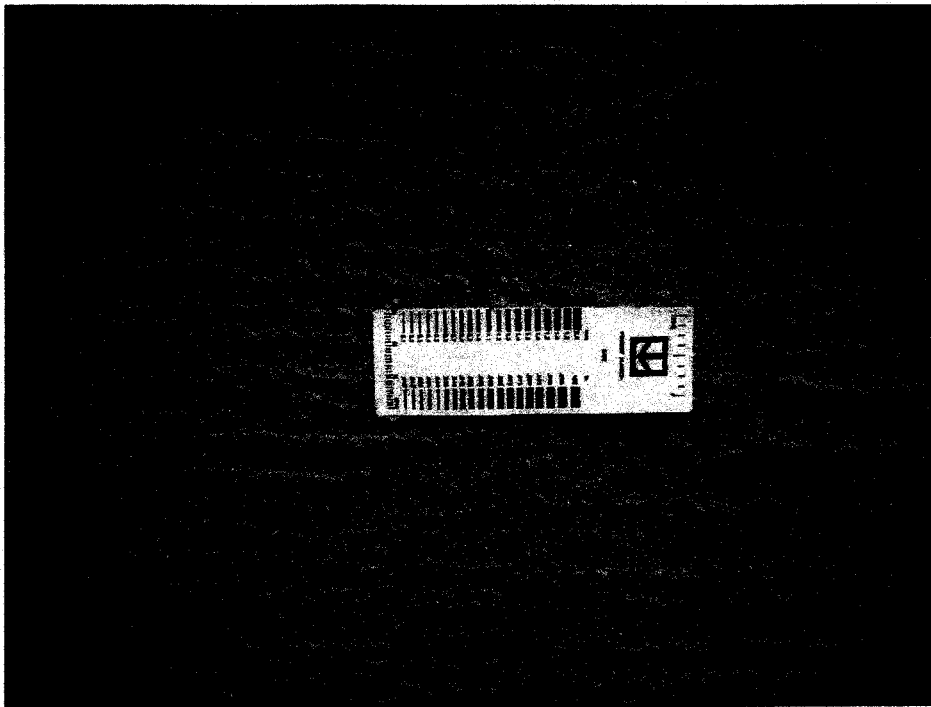
Photograph 6: A close-up view of Photograph 5. (A)

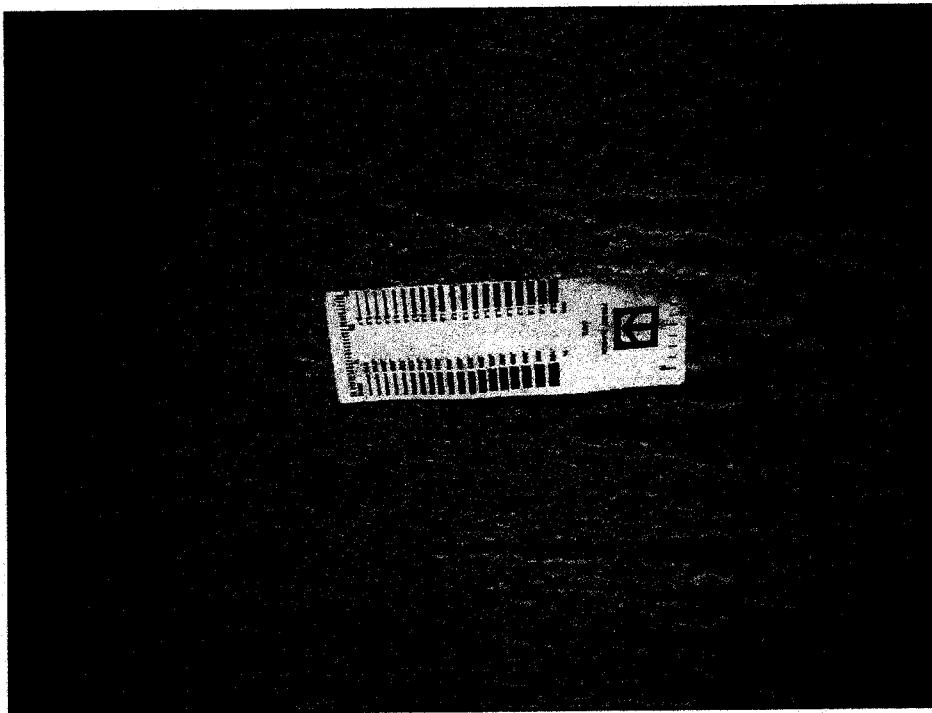
Photograph 8: A close-up view of Photograph 7. (A)

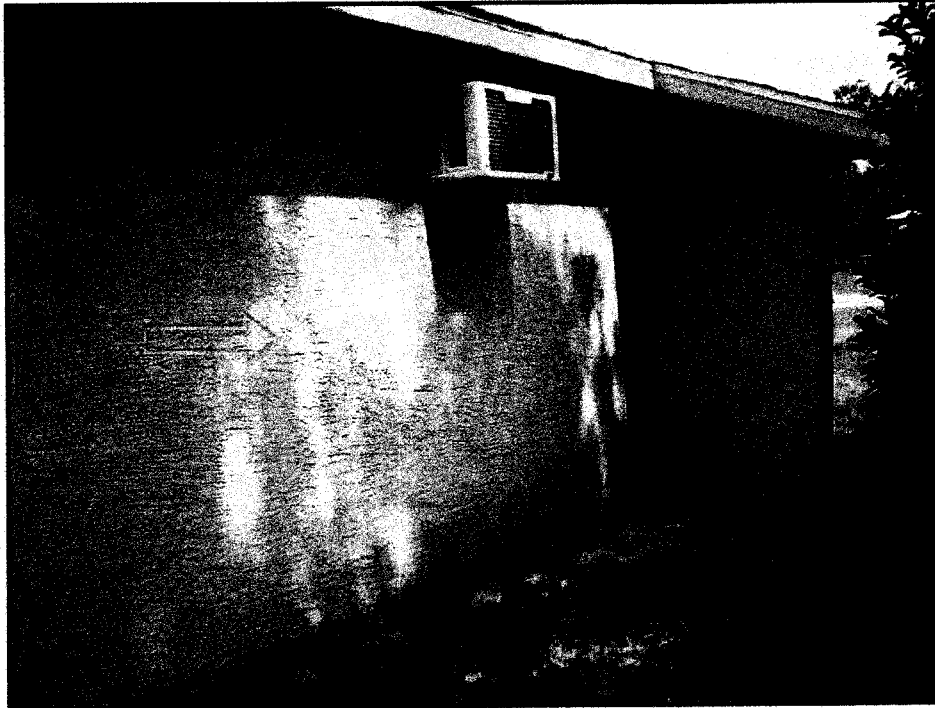
*Cracks will generally form in masonry due to very small differential settlements of the foundation system which can be exacerbated by inadequate embedment. Thermal and material expansion/contraction from normal temperature changes and dissimilar materials, and workmanship issues may cause typical cracks in masonry. Typical foundation settlement will occur and result in minor cracks of the masonry walls. The standard construction industry generally allows 1 inch of total settlement and ½ of an inch differential settlement. This can result in cracks less than ¼ of an inch in width in masonry structures.*

*As indicators of sinkhole activity were encountered within the borings advanced at the site; sinkhole activity cannot be ruled out as a potential contributory factor in the observed settlement related distresses.*

Photograph 9: Additional hairline crack in perimeter wall. (A)

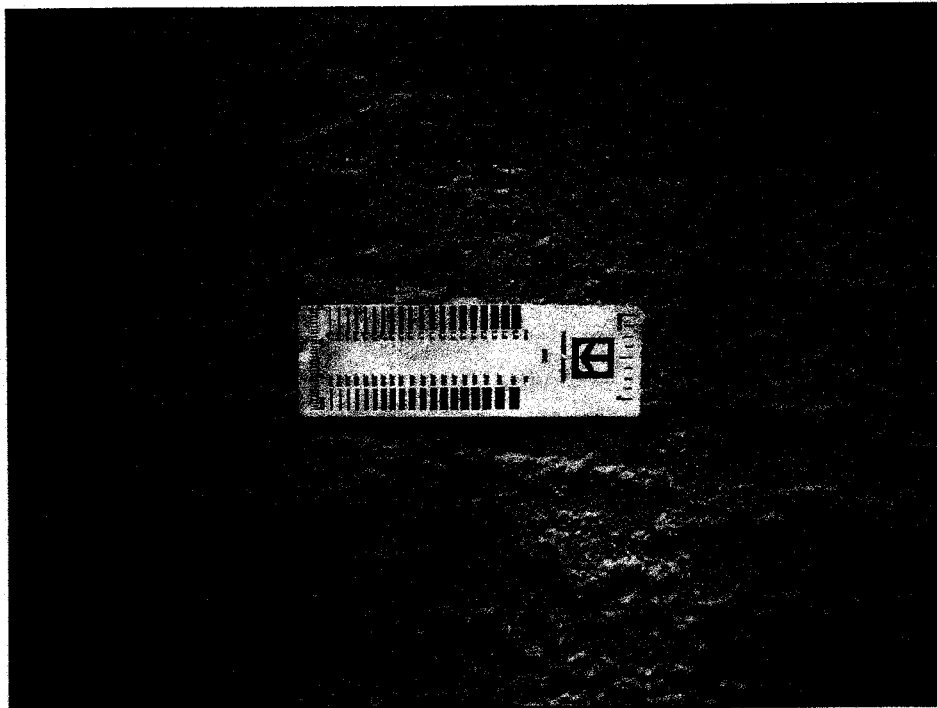
Photograph 10: A close-up view of Photograph 9. (A)

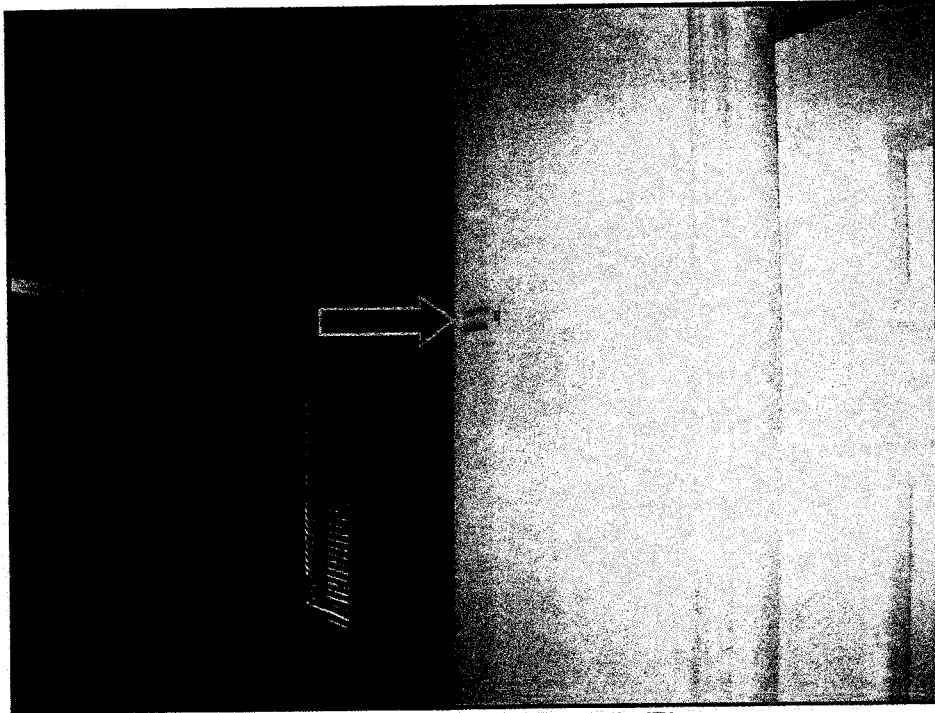
*Cracks will form in drywall due to very small differential movements. These differential movements may be a result of temperature or humidity related shrinking and swelling of the gypsum board or wood framing components, differential movement of dissimilar abutting materials, differential movement of connections at adjoining framing materials, or minor differential settlement of the building's foundation or roof truss system.*

*As settlement-related movement of the building structure may be a contributing cause of the observed distresses and indicators of sinkhole activity were encountered within the borings advanced at the site; sinkhole activity cannot be ruled out as a potential contributory factor in the observed distresses*

Photograph 11: A tapeline crack. (B)

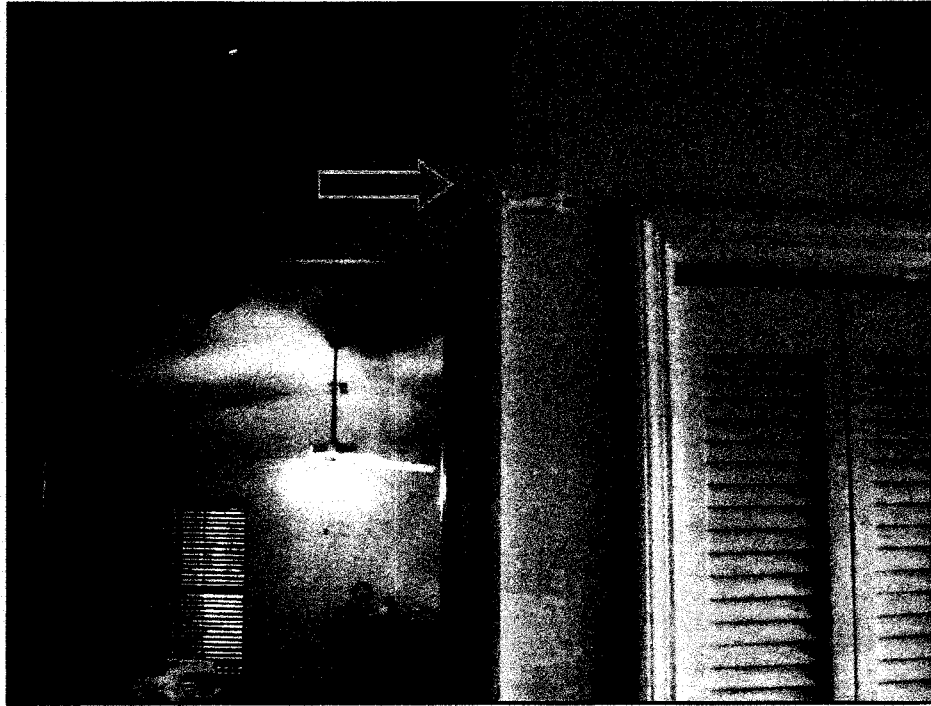
Photograph 13: Construction joint crack above a doorway. (B)

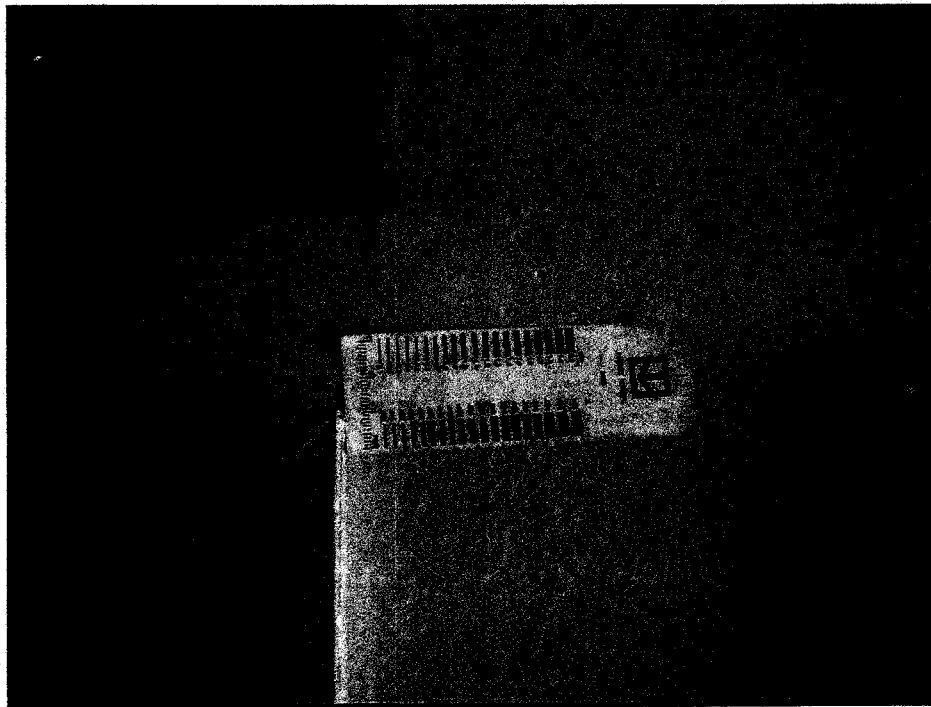
Photograph 14: A close-up view of Photograph 13. (B)

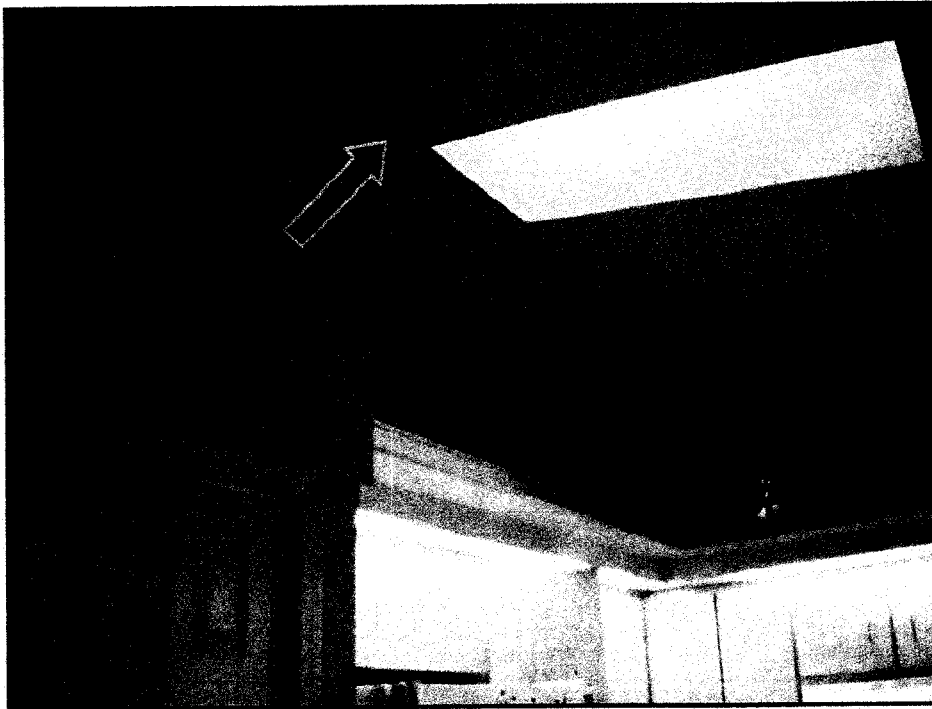
Photograph 15: Ceiling crack in skylight. (B)

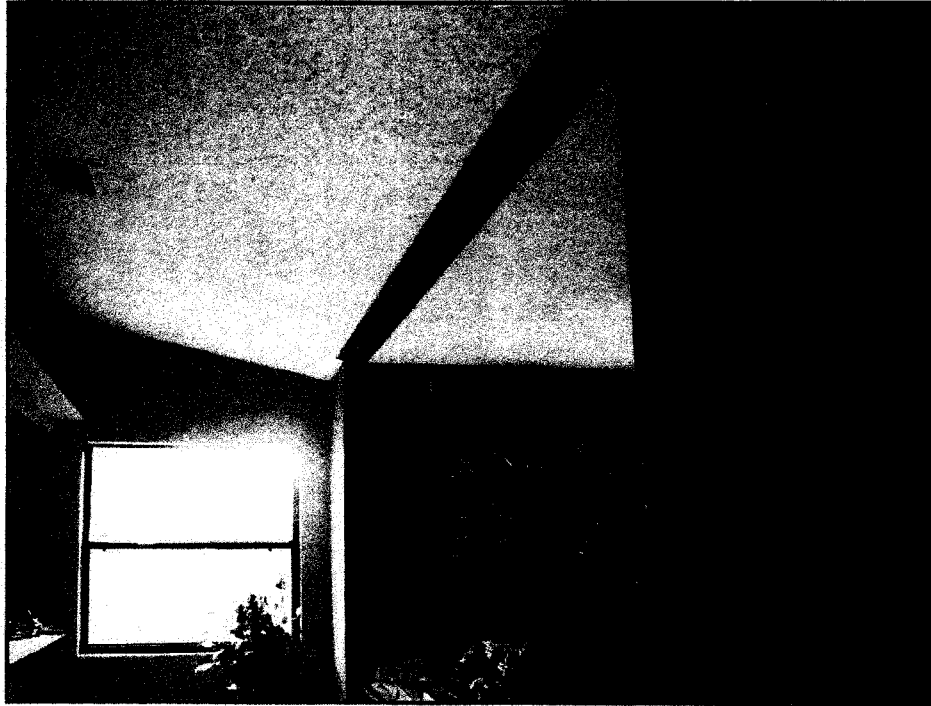
Photograph 17: Wood separation of ceiling joint. (B)

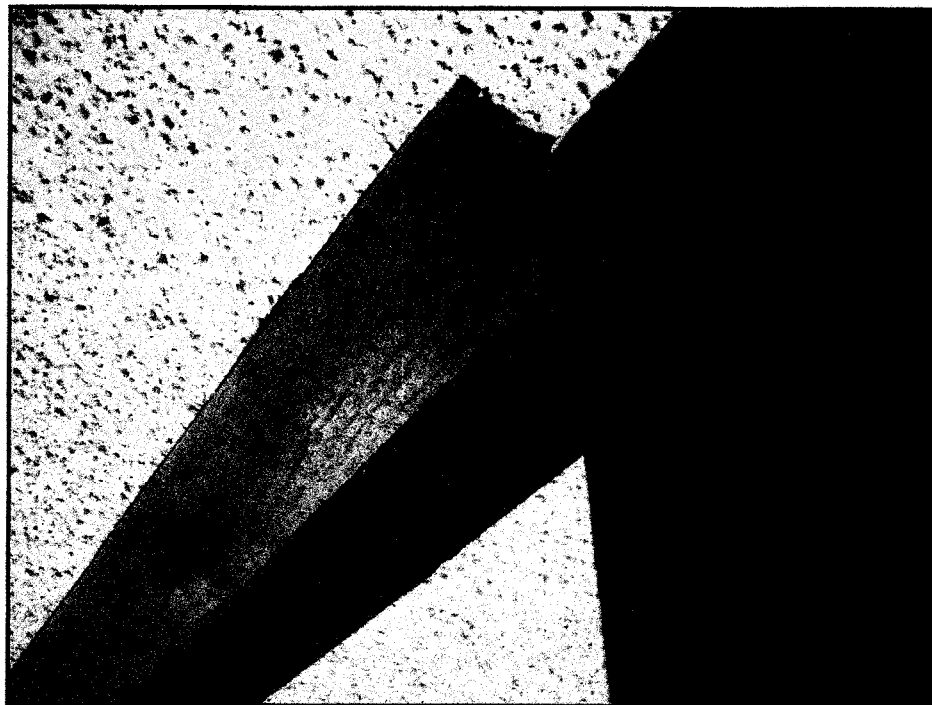
Photograph 18: A close-up view of Photograph 17. (B)

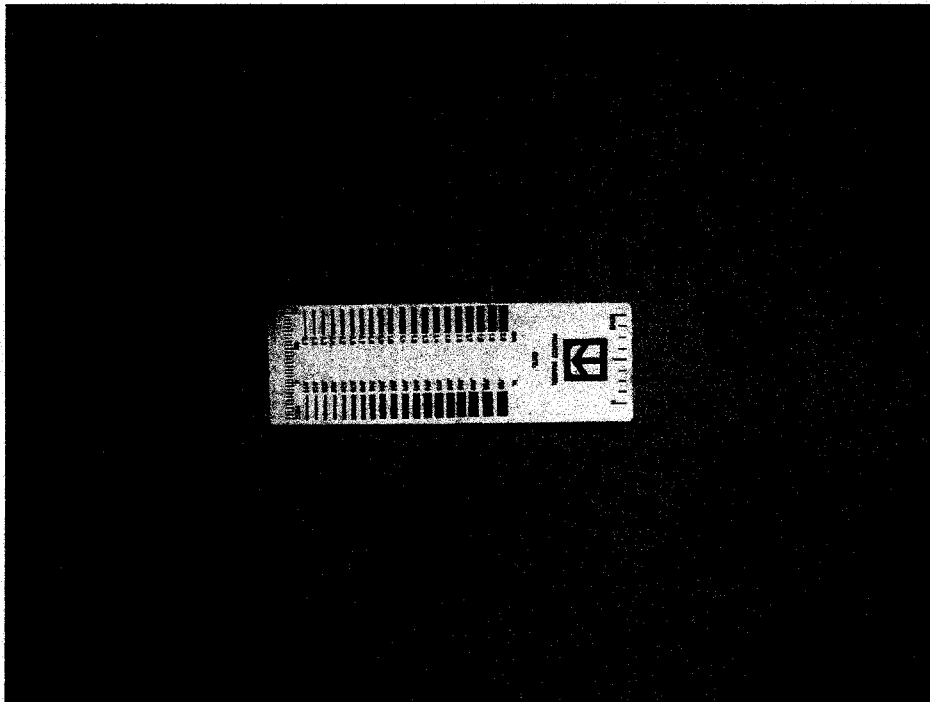
Photograph 22: A close-up view of Photograph 21. (D)

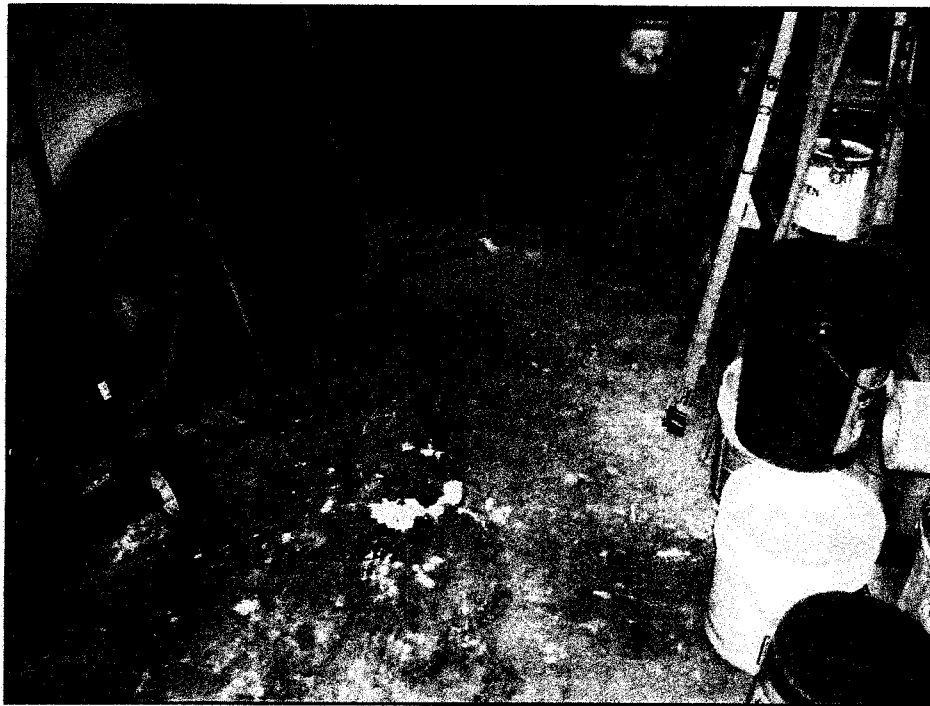
Photograph 24: A close-up view of Photograph 23. (C)

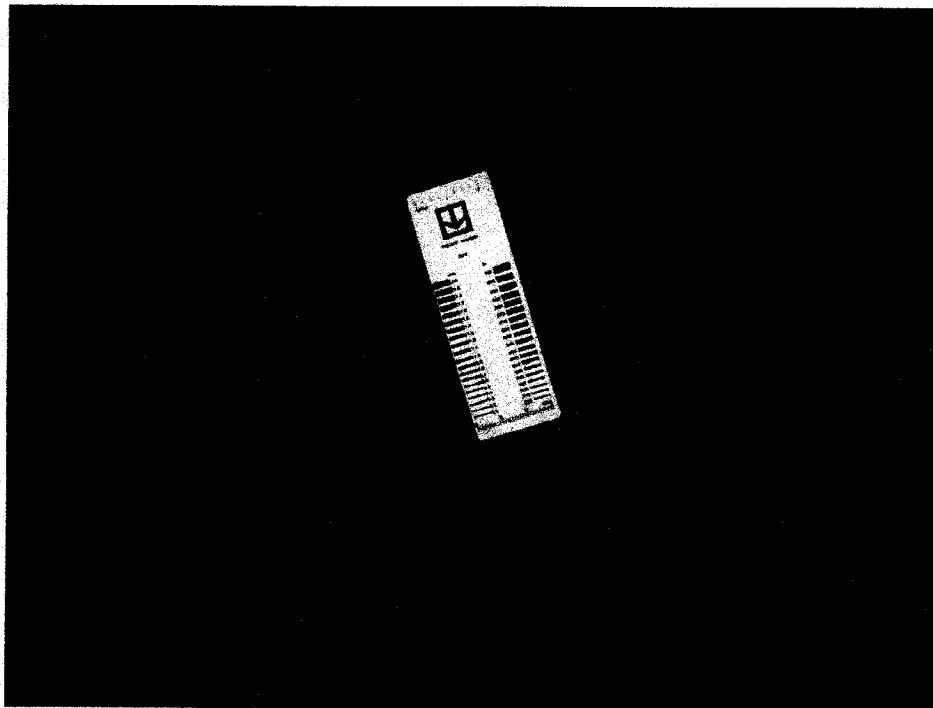
Photograph 26: A close-up view of Photograph 25. (C)

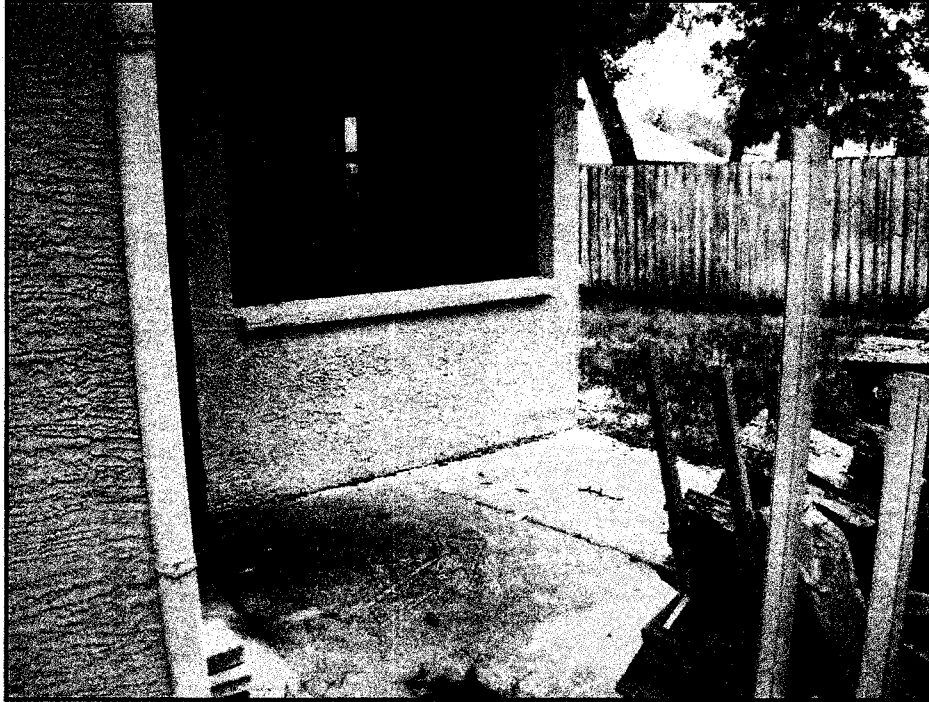
*The cracks in the slabs are generally associated with normal concrete shrinkage, a material property of poured or cast-in-place concrete flatwork. The cracks originate from tensile stress generated from the shrinkage of the concrete materials with evaporation of mix water, curing, and age. The cracks do not appear to show vertical offset and therefore are not considered settlement related.*

Photograph 27: A crack in concrete patio slab. (C)
