Home Inspection Report

9 Church St, Ellenburg Center, NY 12934

Thursday, May 28, 2026

Hawkeye Home Inspections, LLC

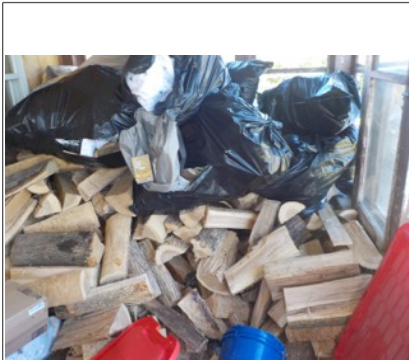
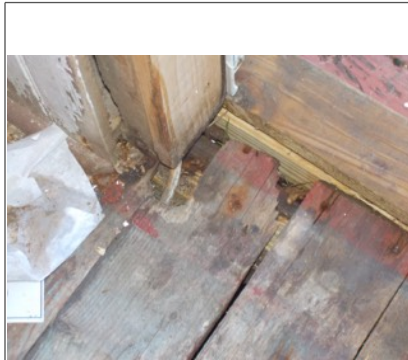
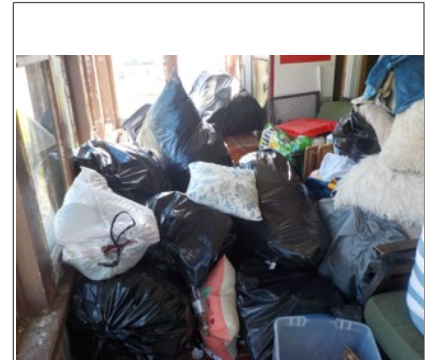
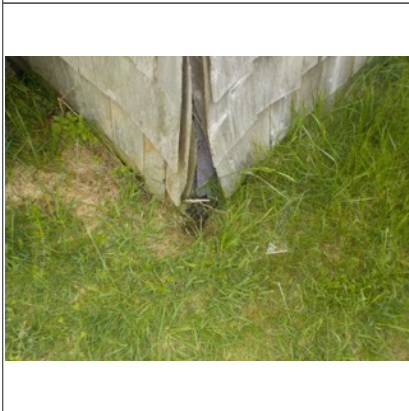
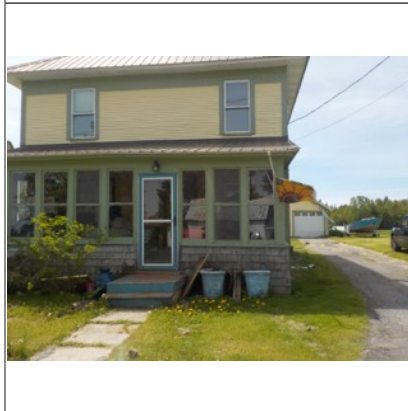
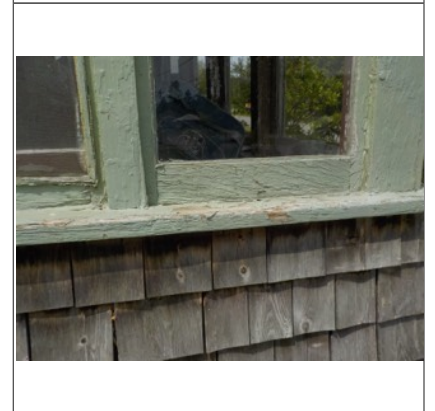
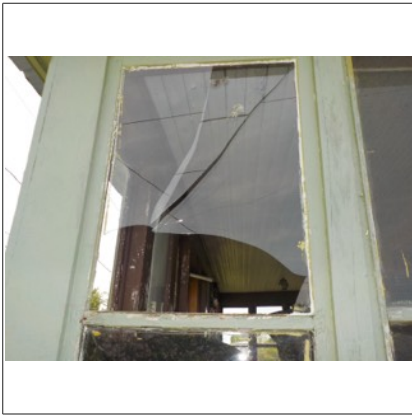
None Not Visible
Condition Satisfactory Marginal Poor Railing/Balusters recommended
Support Pier Concrete Wood Other: not visible
Floor Satisfactory Marginal Poor Safety Hazard
Comments Porch shows large amount of settling, rotted wood present on floor by door other ares not visible
 recommend contractor evaluate and repair as needed.
 Wood to earth contact on siding. Broken glass present

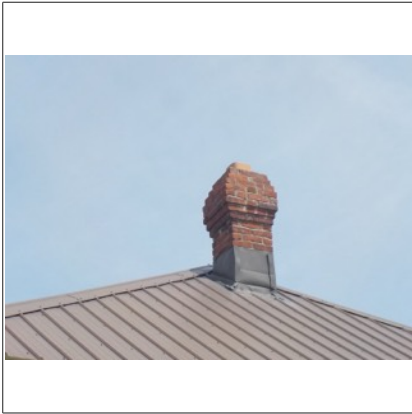
- Chimney(s)** None
- Location(s)** Middle of Roof
East
- Viewed From** Roof Ladder at eaves Ground (Inspection Limited) With Binoculars
- Rain Cap/Spark Arrestor** Yes No Recommended
- Chase** Brick Stone Metal Blocks Framed
- Evidence of** Holes in metal Cracked chimney cap Loose mortar joints Flaking Loose brick Rust
 No apparent defects
- Flue** Tile Metal Unlined Not Visible
- Evidence of** Scaling Cracks Creosote Not evaluated Have flue(s) cleaned and re-evaluated
 Recommend Cricket/Saddle/Flashing No apparent defects
- Condition** Satisfactory Marginal Poor Recommend Repair
- Comments** Recommend installing rain cap/spark arrestor
- Photos**

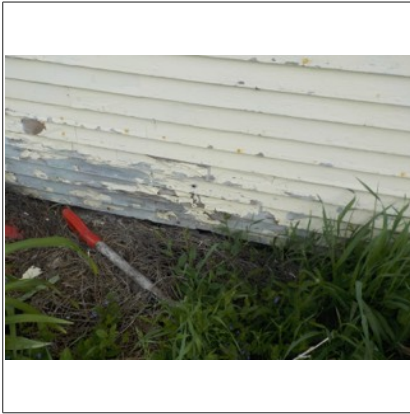
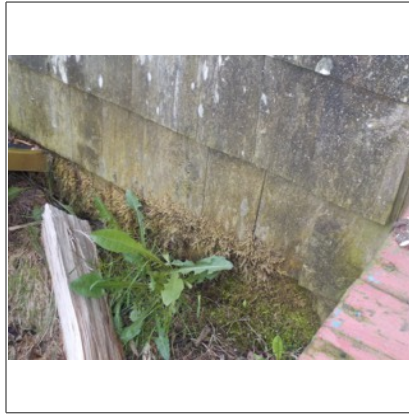
- Material** Stone Slate Block/Brick Fiberboard Fiber-cement Stucco EIFS* Not Inspected
 Asphalt Wood Metal/Vinyl Other: Typical cracks Peeling paint Monitor Wood rot
 Loose/Missing/Holes
- Condition** Satisfactory Marginal Poor Recommend repair/painting
- Comments** Siding had some damage, recommend repairing/replacing damaged sections
Siding was in need of normal painting / staining maintenance, recommend painting/staining

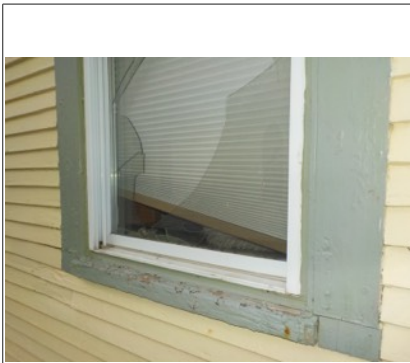
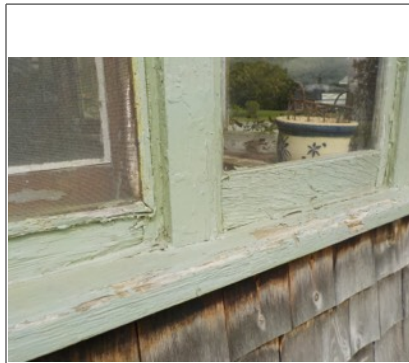
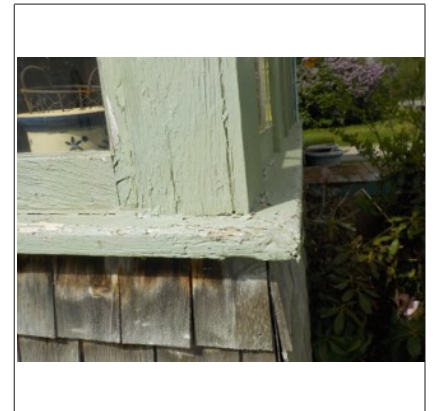
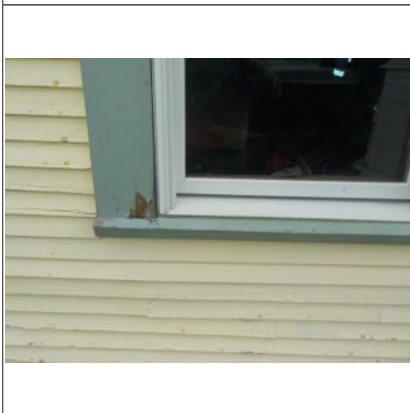
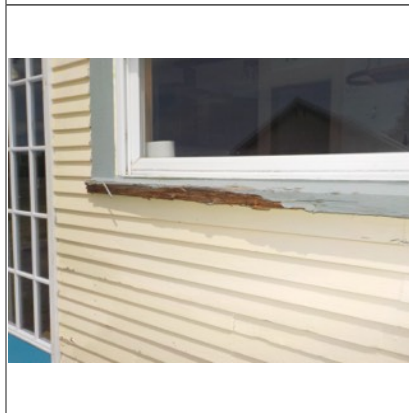
Comments Some loose and missing trim recommend repair
 Some rotted trim boards recommend repair/replacing damaged sections
 Recommend repair of damaged trim by a qualified contractor

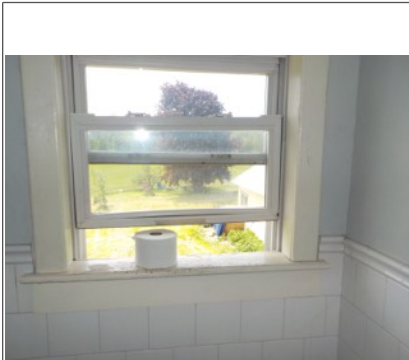
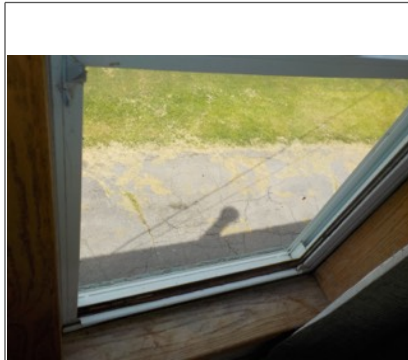
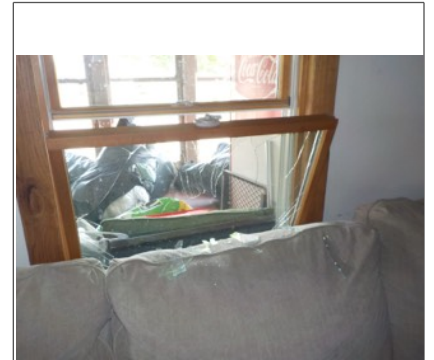
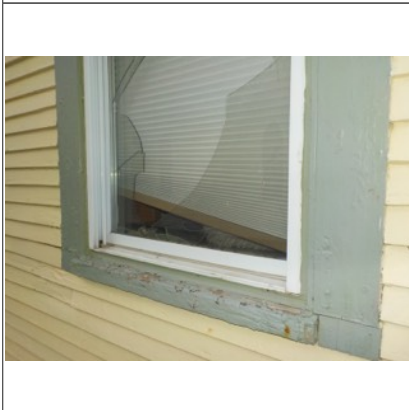
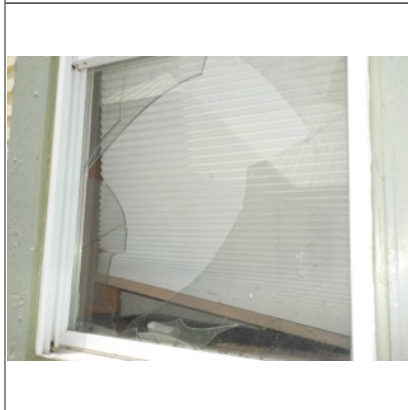
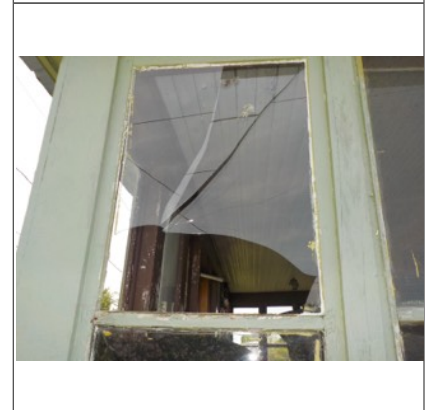
- Condition** Satisfactory Marginal Poor Wood rot Recommend repair/painting
 Recommend repair/replace damaged screens Failed/fogged insulated glass
Material Wood Metal Vinyl Aluminum/Vinyl clad
Screens Torn Bent Not installed Satisfactory
Comments There are many broken window throughout home. Window will need replacement
Photos

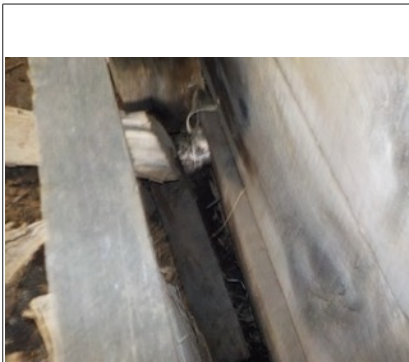
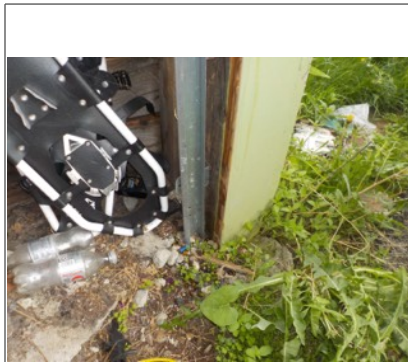
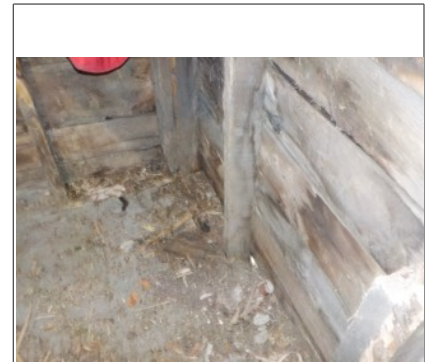
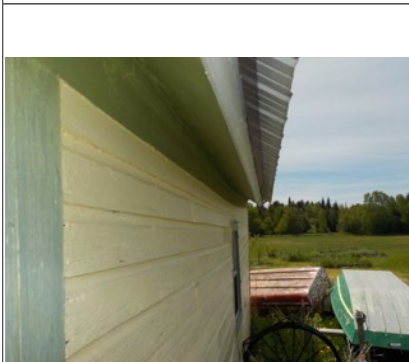
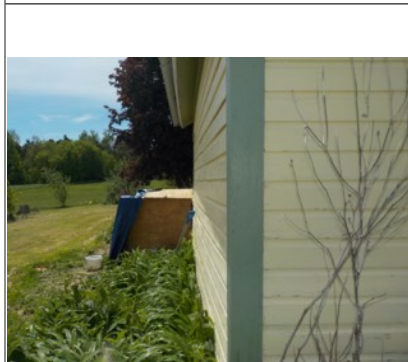
None Not Visible
 Floor level Elevated
 Rotted/Damaged Recommend repair
Comments Sill plates rotted recommend repair/replacement by qualified contractor
 Walls have moved recommend contractor evaluate all of the garage to see if it is even safe to be in

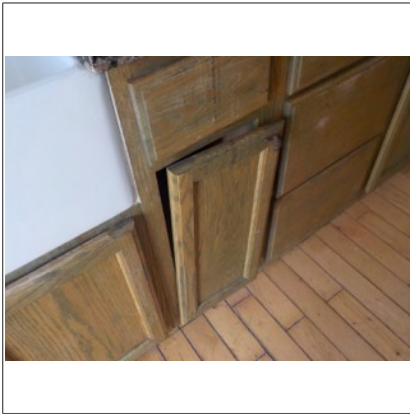
Condition Satisfactory Marginal Recommend repair/adjustment
Comments Damaged cabinets in need of repair

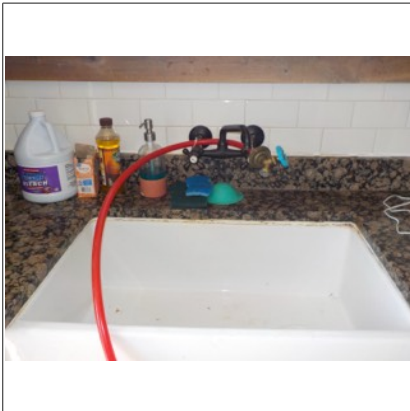
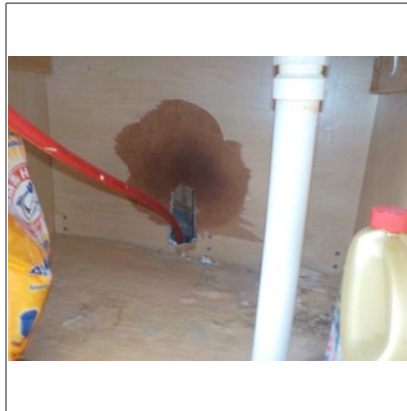
Comments There is a makeshift pip that is run to the sink there is no real plumbing fir sink and no proper drain

Recommend plumber evaluate all plumbing and install proper plumbing to kitchen sink.

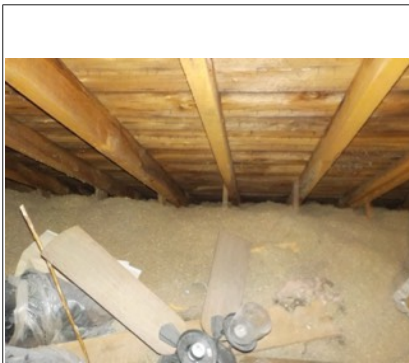
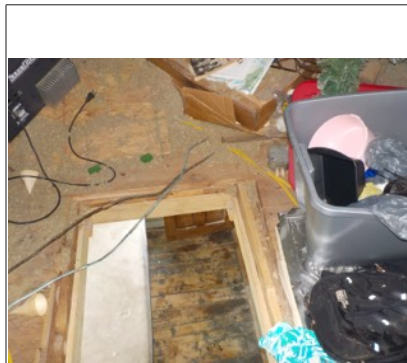
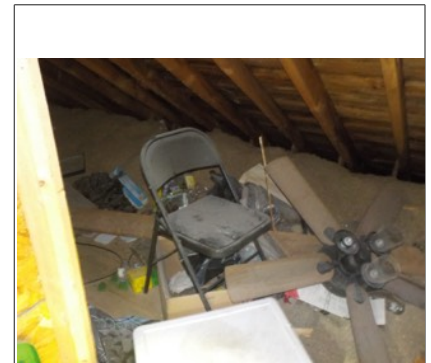
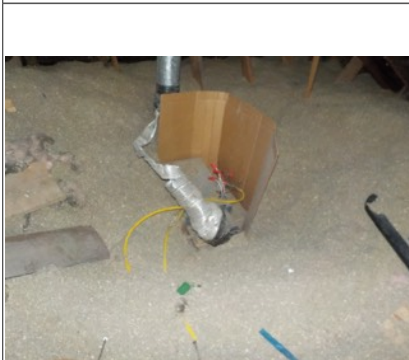
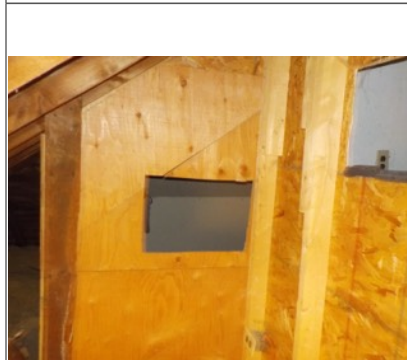
Comments Exhaust fan in need of repair. Wires lying on floor in need of repair. Disturbed insulation in need of repair

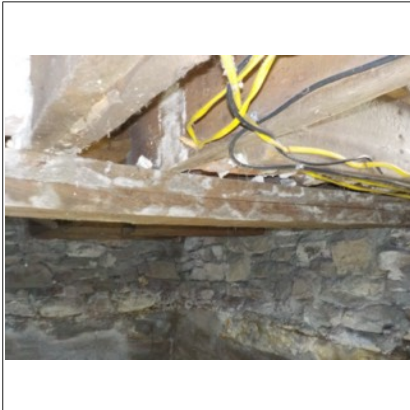
Some beams in basement were not installed properly

- Not Visible
- Satisfactory Marginal Poor Stained/Rusted
- Steel Wood Concrete LVL Not Visible
- Comments** Some beams are not installed properly
- Photos**

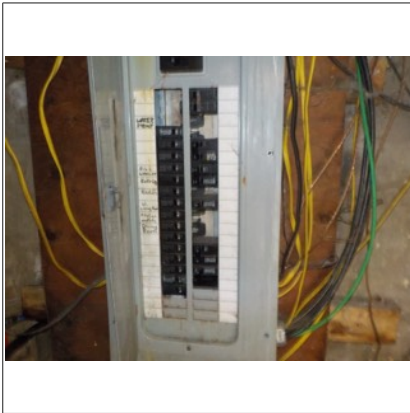
Location Basement
Condition Satisfactory Poor
Amperage/Voltage Unknown 60a 100a 150a 200a 400a 120v/240v
Adequate Clearance to Panel Yes No
Breakers/Fuses Breakers Fuses
Appears grounded Yes No Not Visible
GFCI breaker Yes No Operable: Yes No
AFCI breaker Yes No Operable: Yes No Not Tested
Main wire Copper Aluminum Not Visible Double tapping of the main wire Condition: Satisfactory
 Marginal Poor
Branch wire condition Satisfactory Poor Recommend electrician evaluate/repair Romex BX cable
 Conduit Knob/Tube Double tapping Wires undersized/oversized breaker/fuse
 Panel not accessible Not evaluated
 Reason:
Branch wire Copper Aluminum Solid Branch Aluminum Wiring Not Visible Safety Hazard
Comments Missing knockouts and rust present
Photos

Recommend evaluation of main panel and wiring in attic
