Prepared for Exclusive Use by:

301 Canyon Dr
Grants Pass OR 97527

11/17/2025

Kelley Property Inspections dba HouseMaster
1241 NW Lawnridge Ave
Grants Pass OR 97526
541-295-5802

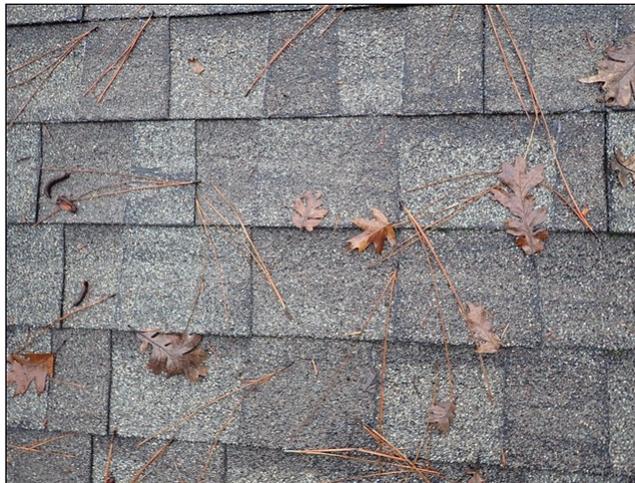
1.0 (Picture 1)

Roof covering is rated in fair condition based on age and wear. Granular loss observed on most fields. Additionally, excess debris and moss build-up noted. Recommend having roof checked and serviced as needed by a qualified roofing contractor. Look to replace covering in the next 5 to 7 years.

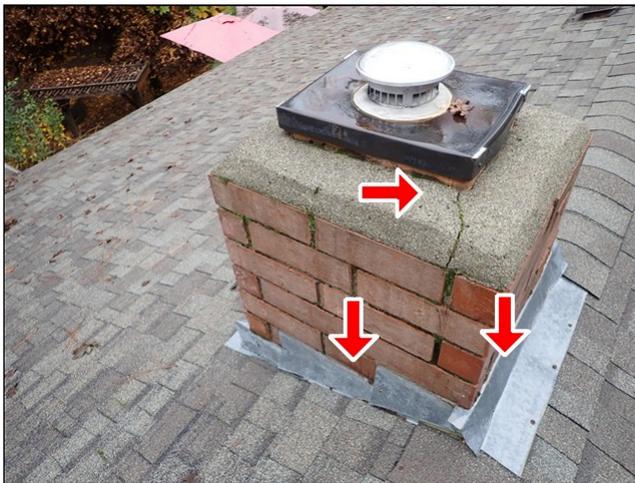
1.1 (Picture 1)

Cracking observed on chimney cap at multiple locations. Recommend having concrete cap checked and sealed as needed by a qualified contractor. Additionally, moisture stains noted on roof sheathing around chimney in attic area. Check and repair flashing as needed.

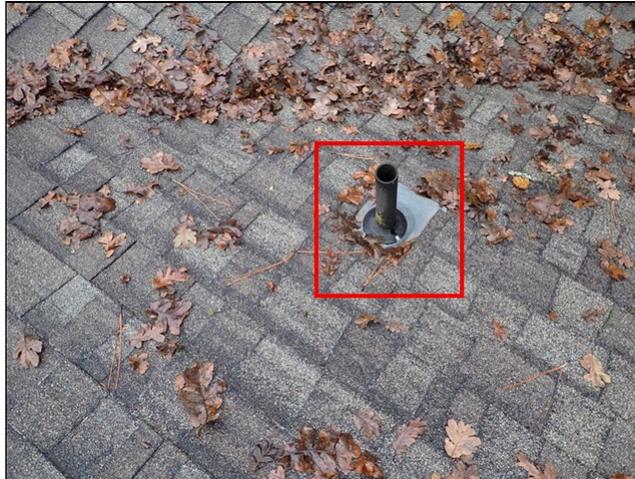
1.3 (Picture 1)

Some deterioration noted at vent pipe/flashings junctures. All vent pipe flashings should be checked periodically and should be repaired and/or sealed as needed.

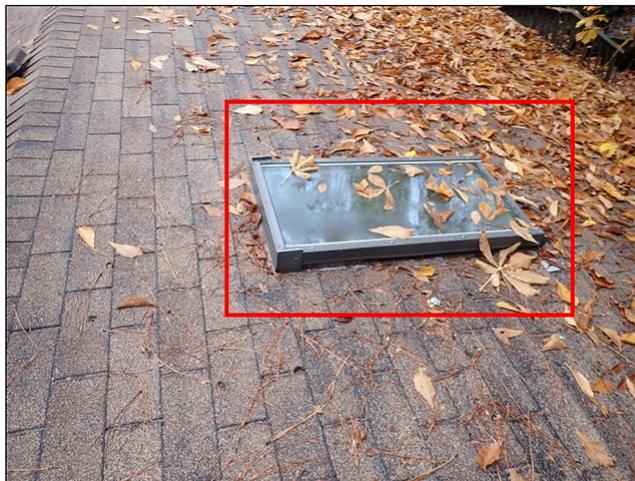
1.5 (Picture 1)

Recommend clearing debris from on and around skylights to preclude moisture absorption issues.

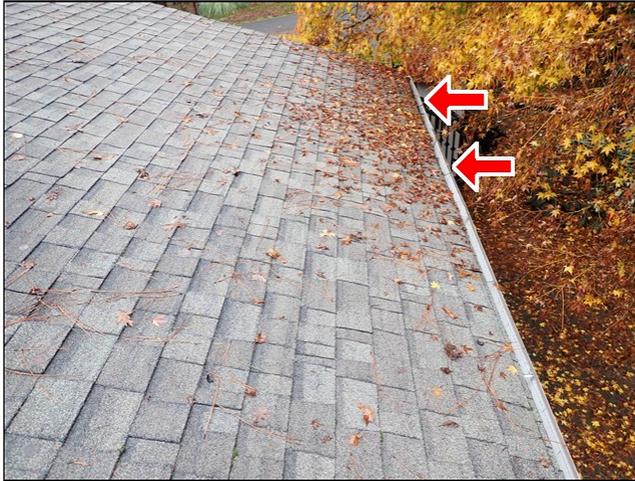
1.6 (Picture 1)

Build up of leaves/debris in gutters. Recommend cleaning now and on a routine basis for proper function.

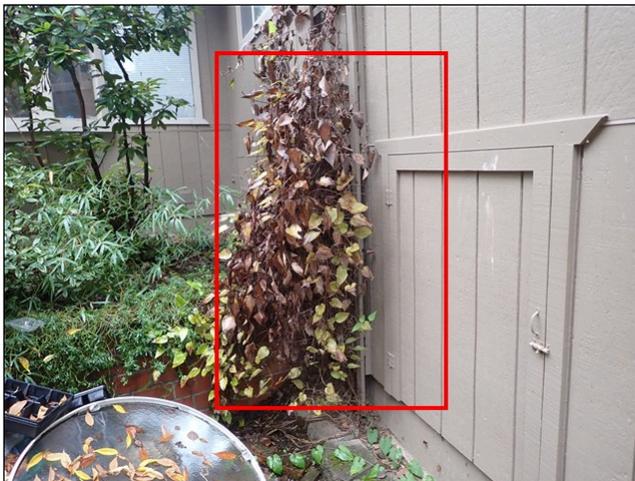
2.0 (Picture 1)

Vegetation noted growing up side of house. Recommend trimming/maintaining at least 6 inches away from home as they can contribute to moisture infiltration and insect infestation.

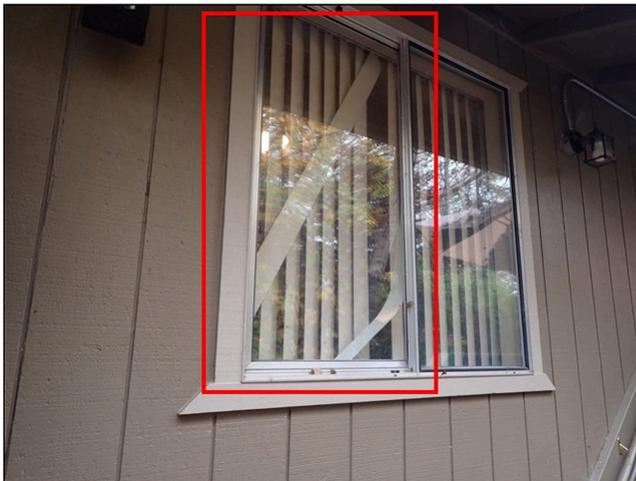
2.1 (Picture 1)

Recommend replacing missing screens as needed or desired.

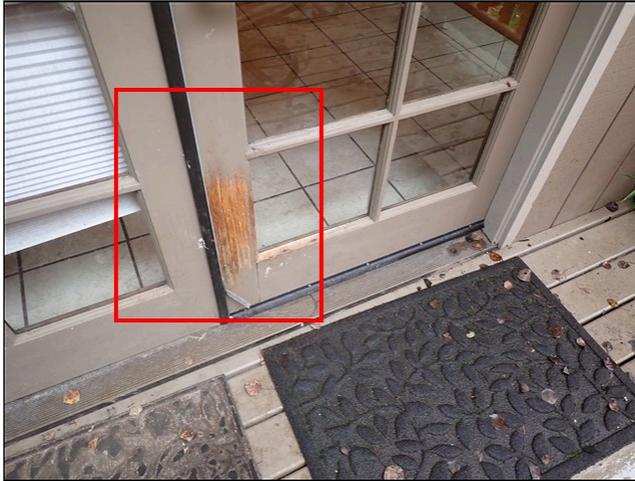
2.2 (Picture 1)

General wear noted on multiple entry doors. Recommend repair or refinish as needed or desired.

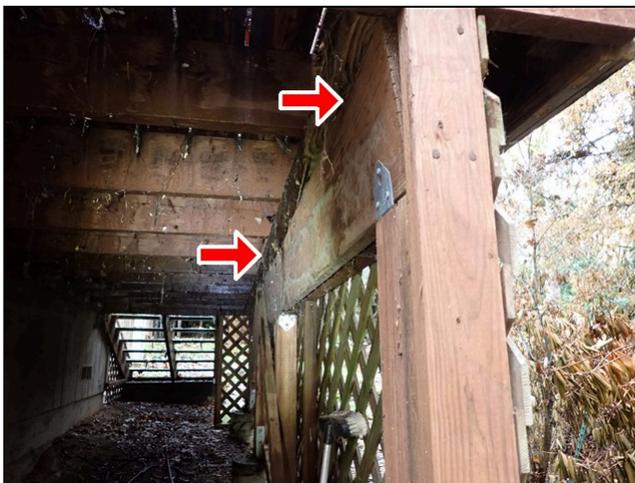
2.4 (Picture 1)

Deck structures around home are rated in fair condition based on age and general wear. It appears that some repairs have recently been made. However, several areas of damage are still present. Support beam under back left structure is warped or twisted. Moisture damages and peeling paint noted on multiple areas of decking. Wood rot observed on support at back right of garage. Due to current conditions, recommend having all decks and related framing further evaluated and repaired as needed by a qualified contractor. Prep and paint as needed to ensure proper protection.

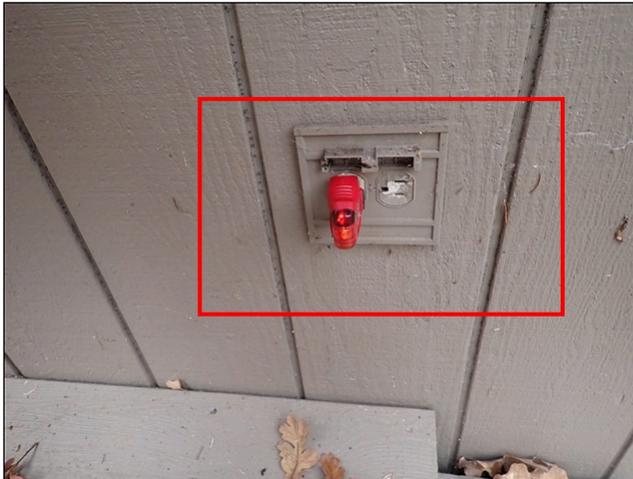
2.5 (Picture 1)

Outlet at back of home tested in reversed polarity at time of inspection. Additionally, cover is damaged. Recommend further evaluation and repair as needed by a qualified electrician.

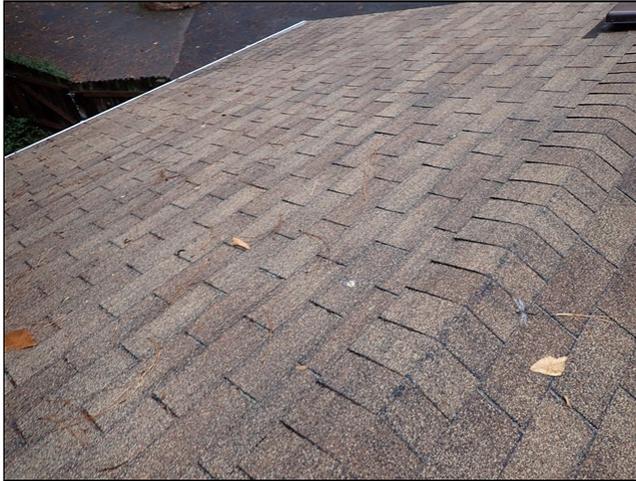
4.0 (Picture 1)

Roofing material over garage is at or near the end of its useful service life. Excess granular loss observed. Moisture stains noted on soffit sheathing. Additionally, debris buildup observed. Recommend having material checked by a qualified roofing contractor to determine repair or replacement needs and associated cost.

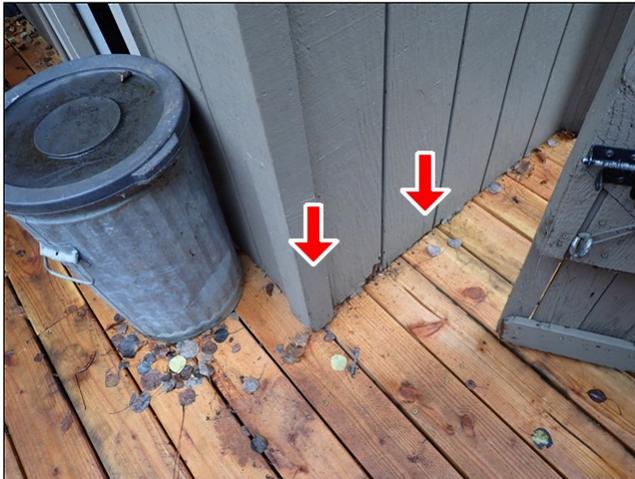
4.1 (Picture 1)

Area of deterioration noted at front left of garage. Recommend further evaluation and repair as needed by a qualified contractor.

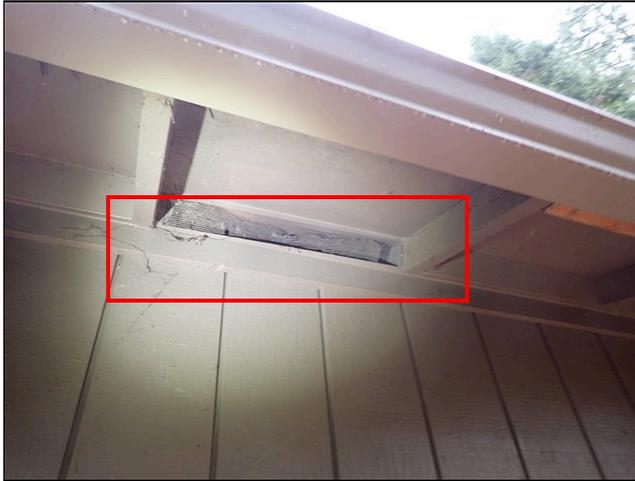
4.4 (Picture 1)

Several vent screens are damaged. Recommend replacement to ensure proper operation.

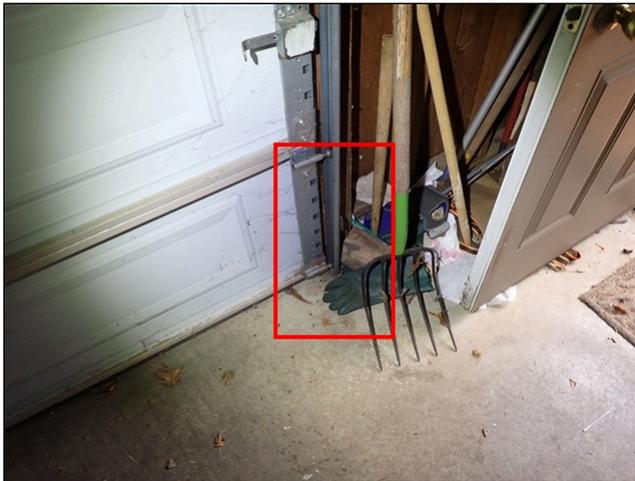
4.7 (Picture 1)

The door operator did not reverse when met with resistance. Some older units do not have this safety feature; correct as required. Additionally, recommend adding electronic eye system at bottom of door opening as a safety upgrade.

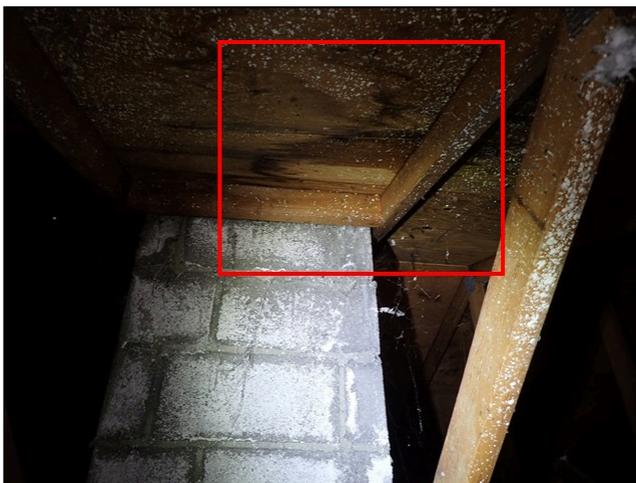
5.1 (Picture 1)

Moisture stains noted on roof sheathing at multiple locations from attic entrance point. See related comments in roofing section. Recommend having areas checked and repaired as needed by a qualified contractor.

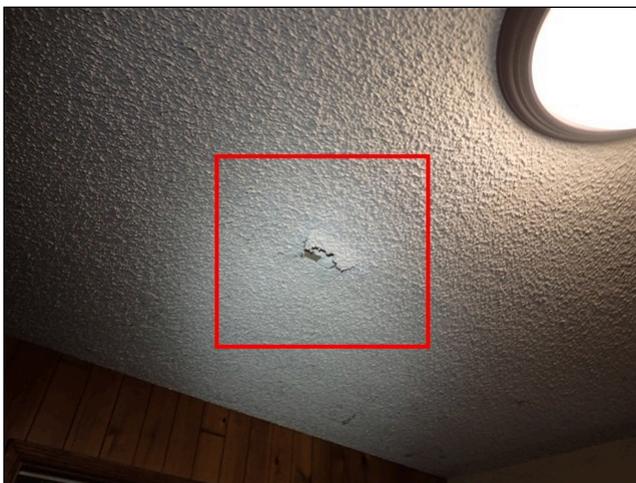
6.0 (Picture 1)

Damages noted on ceiling in laundry room area of home. Recommend repair as needed by a qualified contractor.

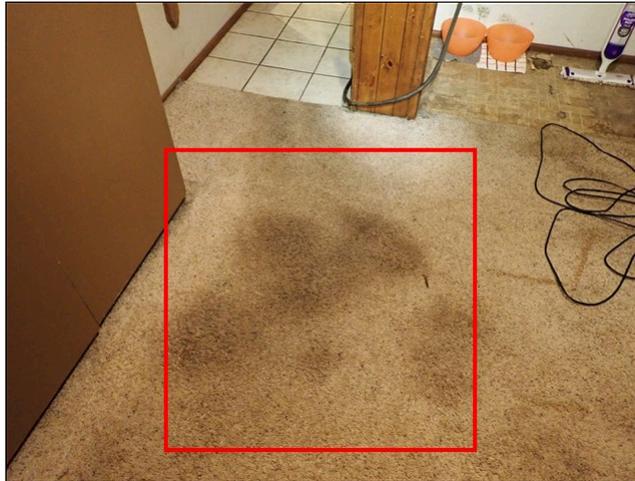
6.2 (1) Carpets are stained and worn at multiple location in home. Recommend cleaning or replacing as needed by a qualified contractor.

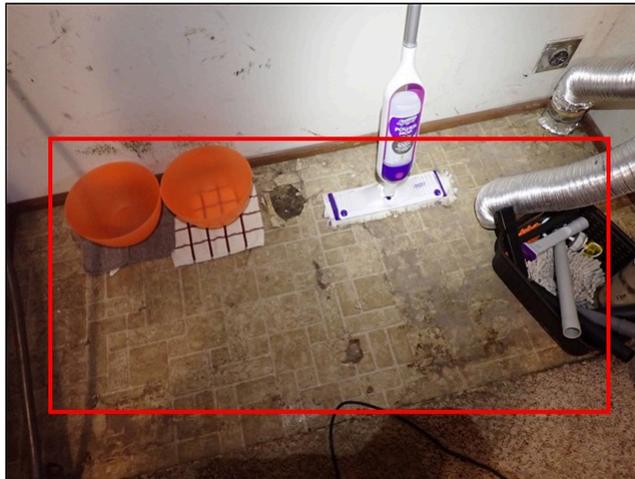
6.2 (2) Linoleum floor coverings in laundry room area are damaged. Recommend repair or replacement as needed by a qualified contractor.

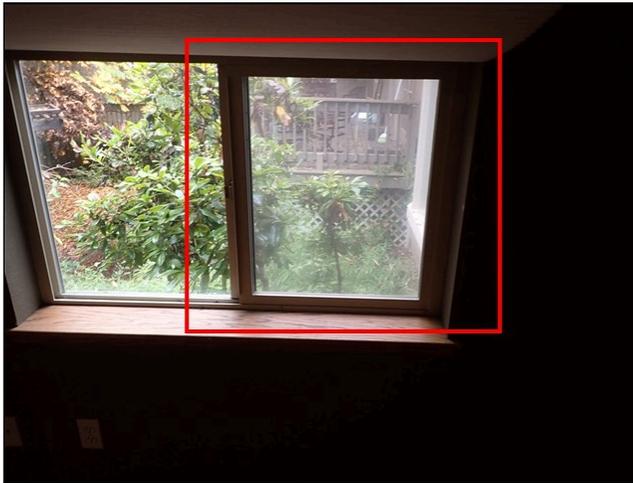
6.3 (Picture 1)

Evidence of the failure of the seal on insulated window in master bedroom. While not readily apparent at the time of inspection, other insulated-glass units may have also failed. Recommend a check of all units to determine extent of repair/replacement work required.

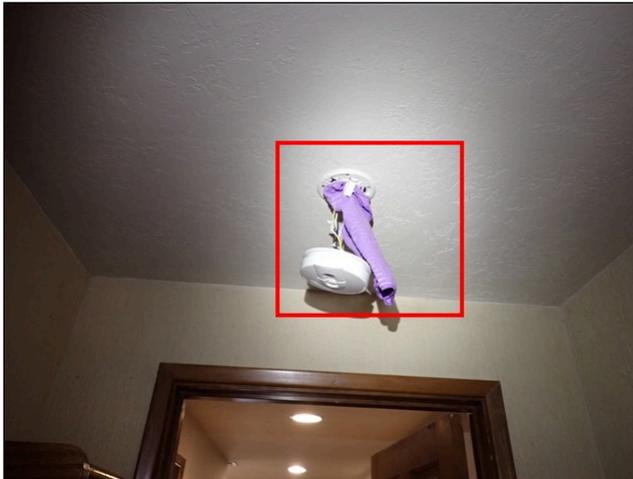
6.6 (Picture 1)

Recommend adding and reattaching smoke detectors in home at sleeping areas and hallways. Additionally, add carbon monoxide detectors to bring home up to current safety standards.

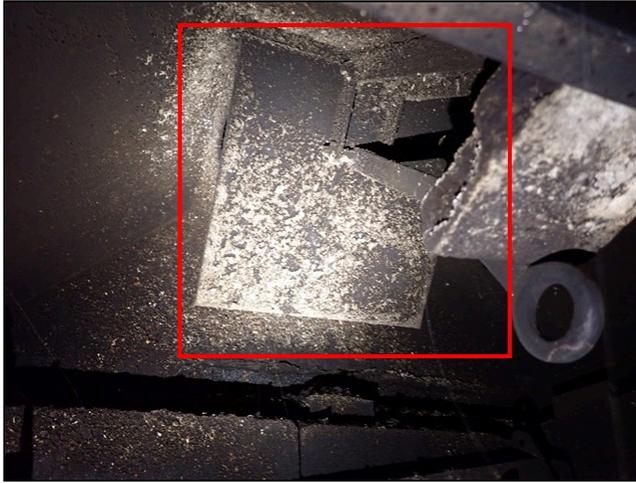
6.7 (Picture 1)

Heavy buildup noted inside of wood burning fireplace. Recommend having fireplace checked and serviced as needed by a qualified chimney contractor.

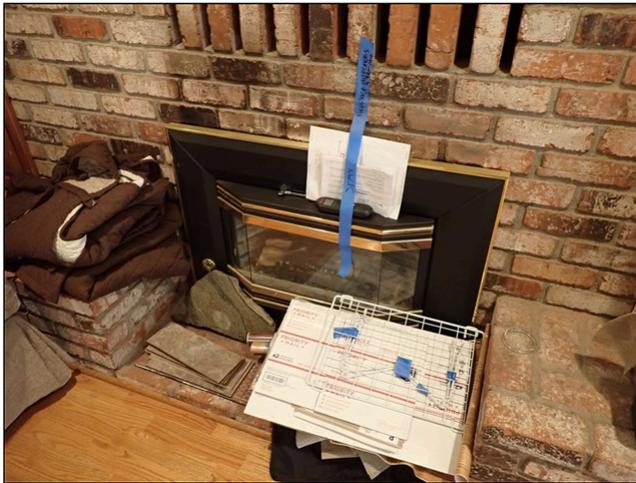
6.8 (Picture 1)

Gas burning fireplaces were not tested at time of inspection due to pilot lights not being lit. Glass is cloudy at master bedroom unit. Recommend having units checked and tested or repaired as needed by a qualified contractor.

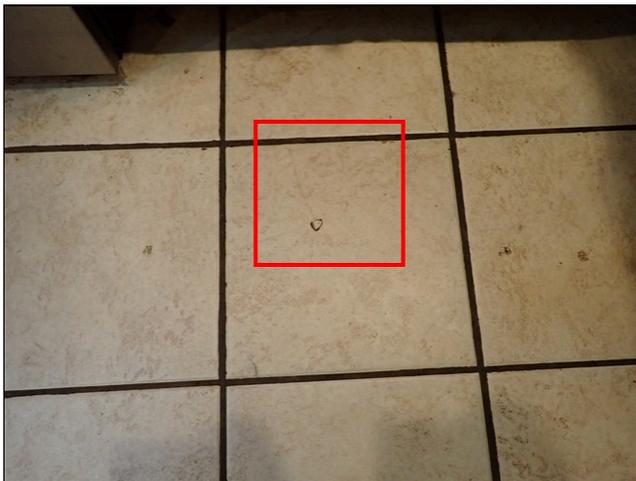
7.1 (Picture 1)

Several tiles in kitchen area are cracked or damaged. Recommend repair or replacement as needed by a qualified contractor.

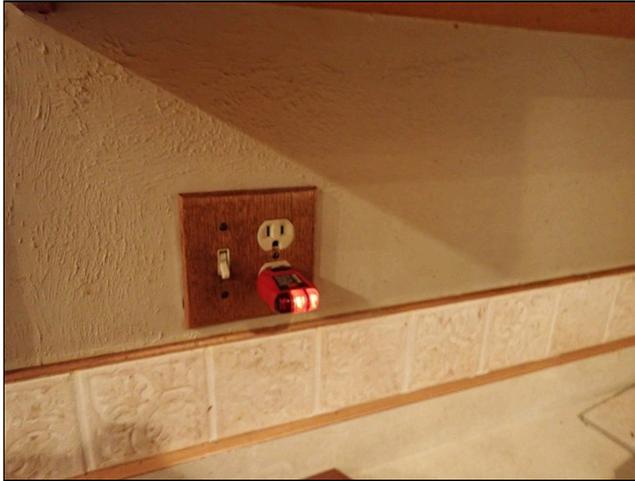
7.2 (Picture 1)

Kitchen outlets are not GFCI protected. Recommend replacing as a safety upgrade.

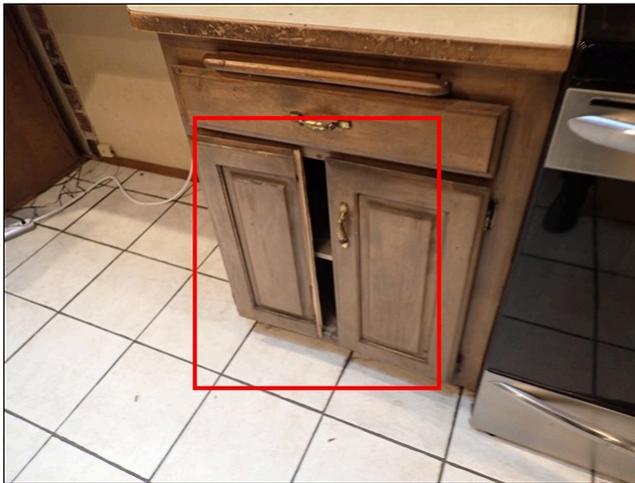
7.6 (Picture 1)

Damaged cabinetry observed. Recommend repair or replacement as needed by a qualified contractor.

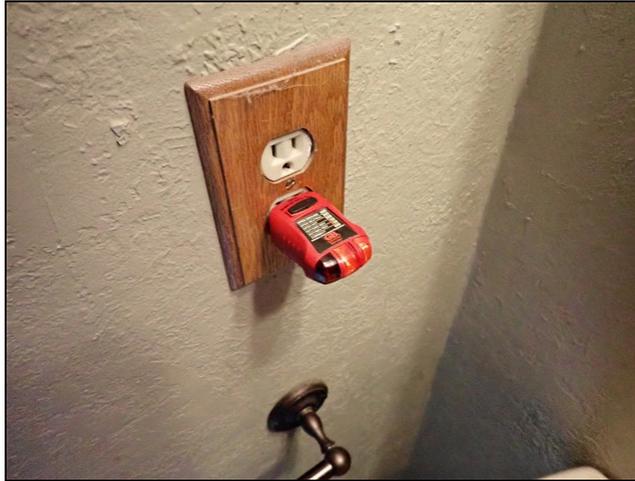
8.5.A (Picture 1)

Bathroom outlets are not GFCI protected. Recommend consulting with qualified electrician for proper placement of GFCI outlets as a safety upgrade.

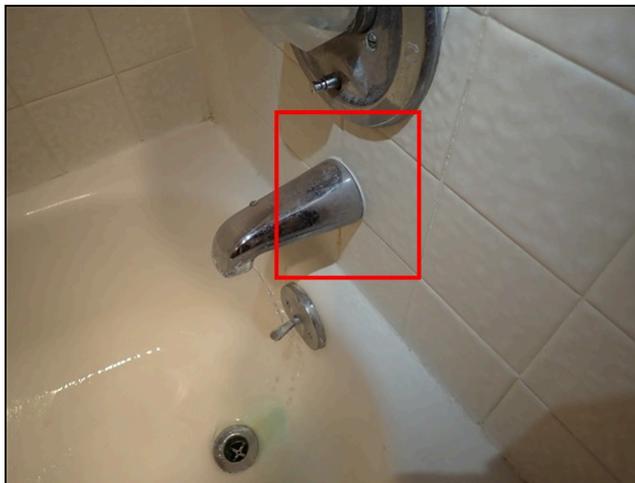
8.0.B (Picture 1)

Moderate surface wear or damage is generally cosmetic; if the base material has not been exposed or materially affected, the need for replacement is discretionary. Gap between nozzle and shower enclosure; recommend caulking to prevent water intrusion into wall cavity.

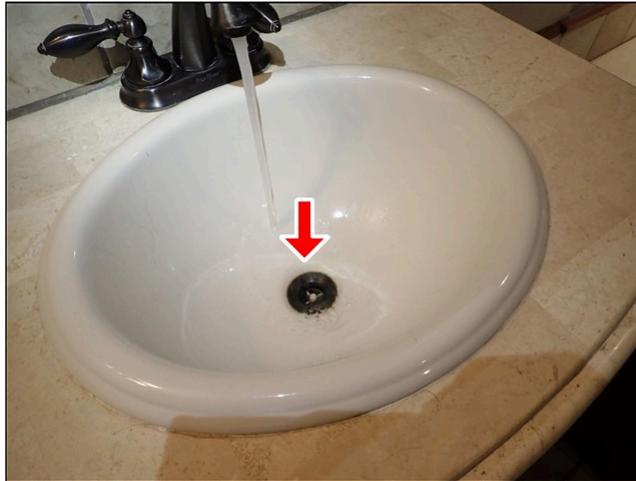
8.1.C (Picture 1)

Recommend adding sink stopper mechanisms to ensure proper operation.

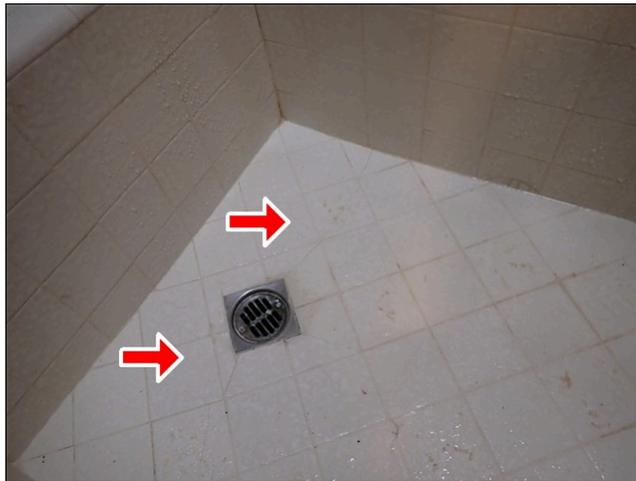
8.4.C (Picture 1)

Several cracked tiles observed that base of shower pan. Recommend repair as needed by a qualified contractor to ensure surface is properly sealed.

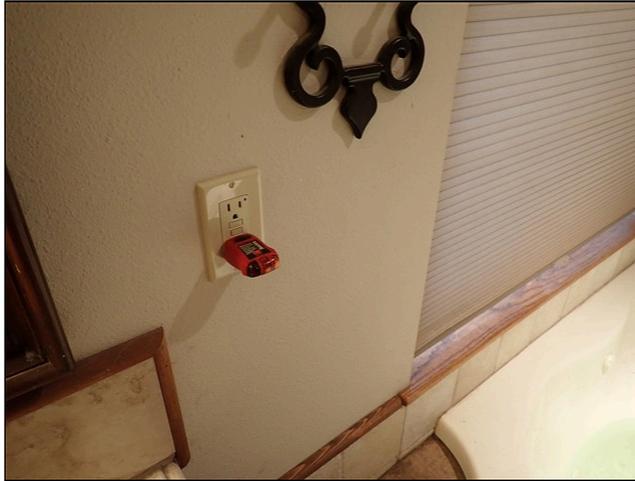
8.8.C (Picture 1)

Outlets were not operational at time of inspection. Recommend conditions be checked and repaired as needed by a qualified electrician.

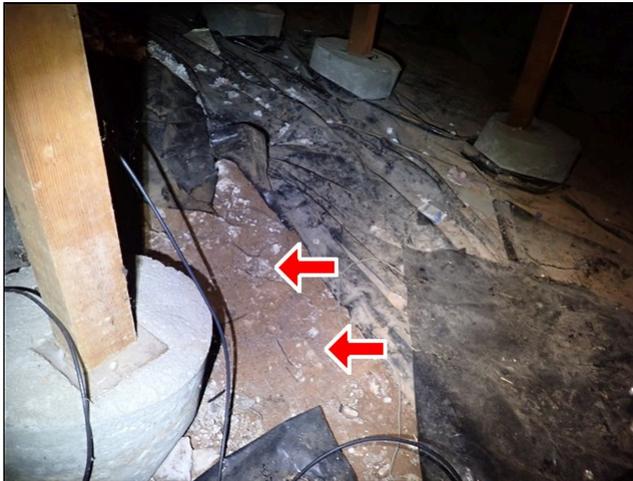
9.4 (Picture 1)

Recommend redistributing vapor barrier to help control moisture levels in living space.

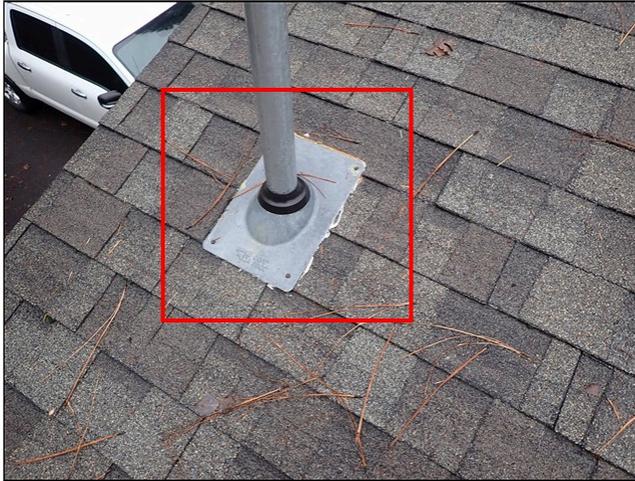
11.0 (Picture 1)

Roof flashing boot connection to roof is improper. Exposed edges noted. Typically roofing should cover upper 2/3 of all flashing. Recommended further evaluation and repair as needed by a qualified roofing contractor.

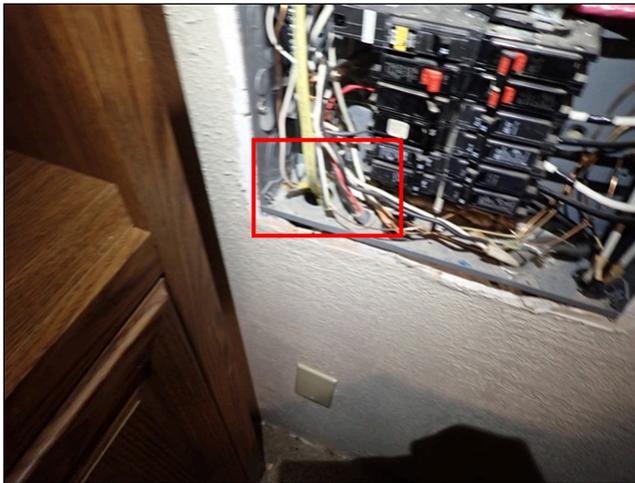
11.3 (Picture 1)

Wire grommet is missing at base of panel. Recommend adding to protect wire sheathing from damages.

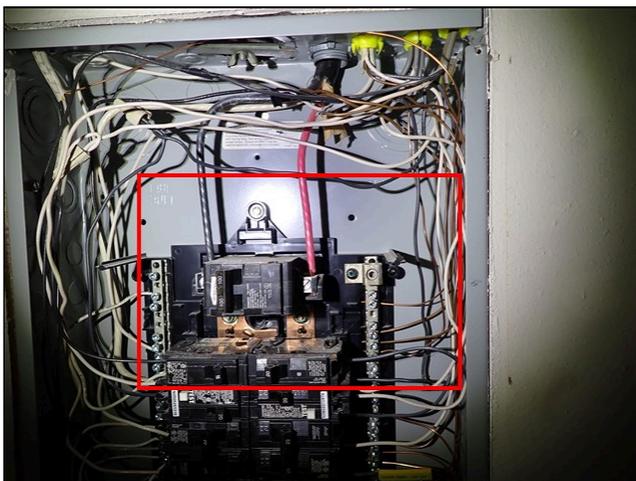
11.4 (Picture 1)

Main disconnect in panel is oversized for current wiring. This is a potential safety hazard. Recommend conditions be further evaluated and repaired as needed by a qualified electrical contractor.

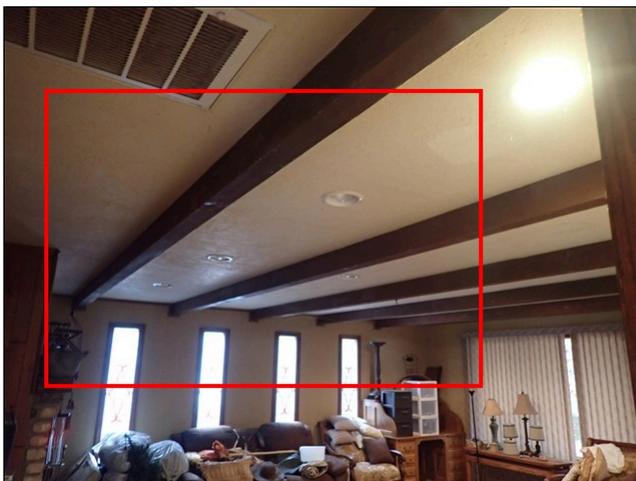
11.6 (Picture 1)

Several lights were not operable. Any inoperative unit may be due to a defective fixture or bulb. Replace bulbs as first action; contact qualified electrician if issue persists.

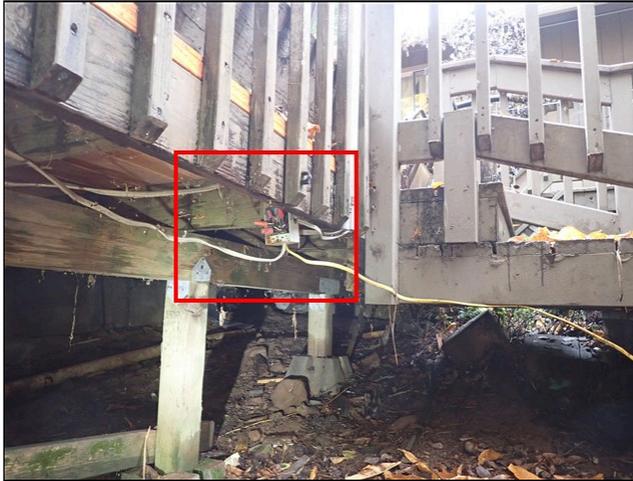
11.7 (Picture 1)

Open junction box and exposed wires observed under deck area at back of home. Recommend having area checked and sealed or repaired as needed by a qualified electrician.

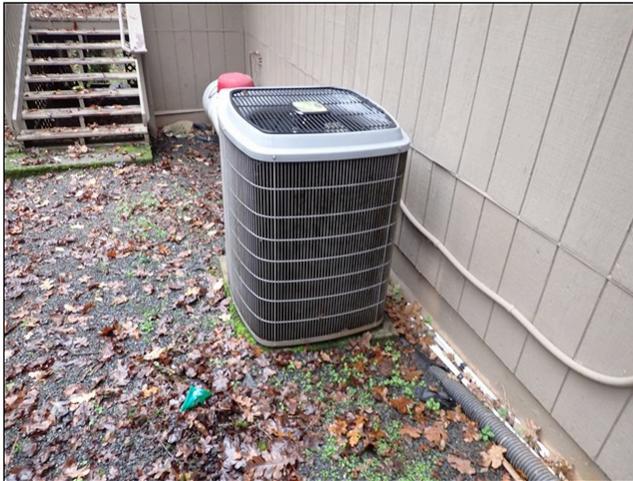
12.1 (Picture 1)

Outdoor unit was operational, but is old; future service life is indeterminate. Monitor for signs of failure, repair or replace as needed.

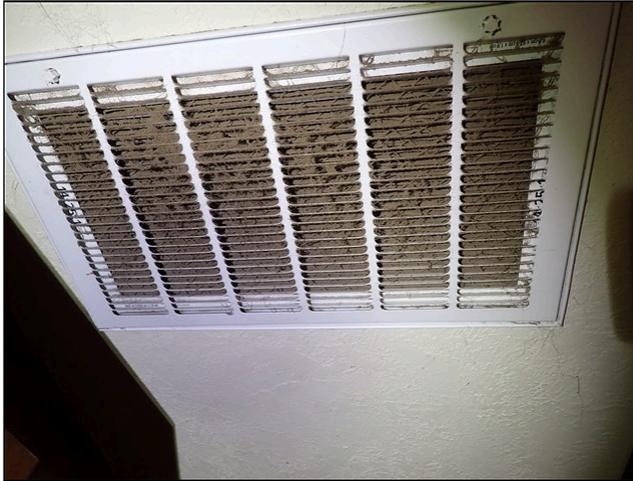
12.2 (Picture 1)

Indoor filters are dirty, recommend having system checked and serviced as needed by a qualified HVAC contractor.

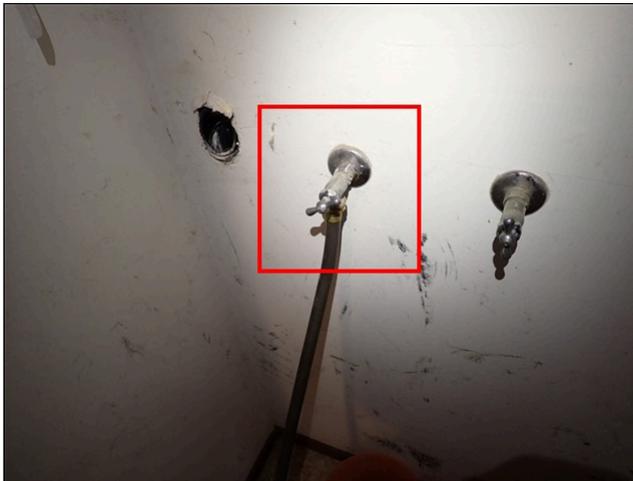
13.1 (Picture 1)

Washer supply connection does not fully shut off. Recommend further evaluation and repair as needed by a qualified contractor.
