RESIDENTIAL INSPECTION REPORT BY PORCH LIGHT

3209 NW Fairway Heights Dr
Bend, OR 97703

Bart Volz
08/07/2024

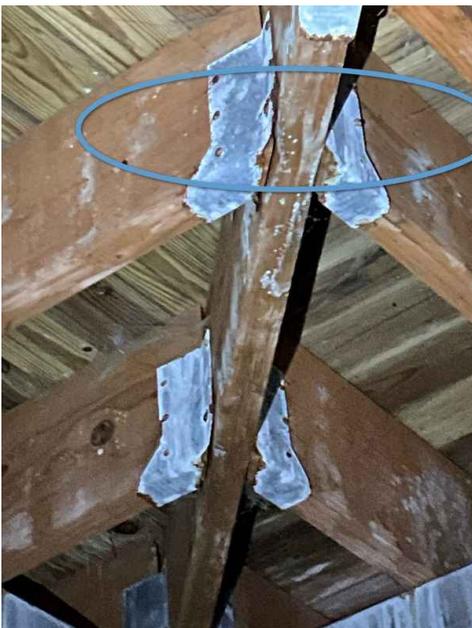
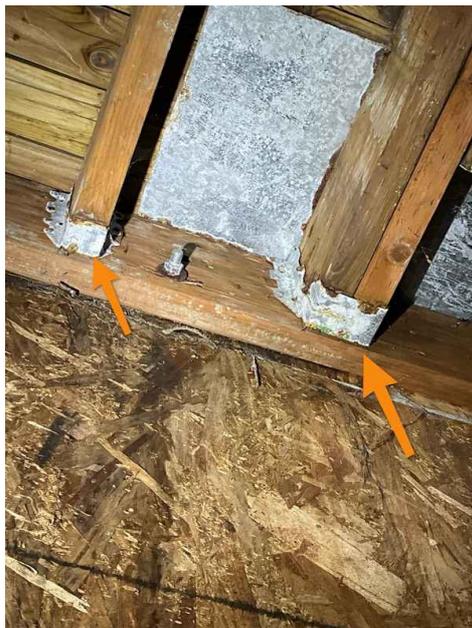
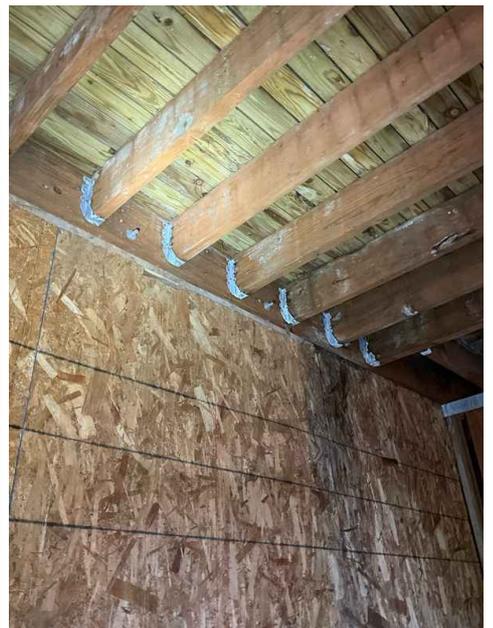
2.4.1 Decks, Balconies, Stairs/ Railings, Porches, Covered Overhangs

CORROSION ON GALVANIZED FRAMING HANGERS

Galvanized framing hangers beneath the deck showed signs of corrosion at multiple locations. These hangers support the structure, and continued corrosion could lead to instability.

Recommendation: Conduct a thorough evaluation to determine the extent of the corrosion and assess whether replacement of the hangers is necessary to ensure the stability and extend the life expectancy of the deck structure. It is advisable to consult a qualified professional or contractor to perform the assessment and recommend appropriate corrective actions.

Contact a qualified professional.

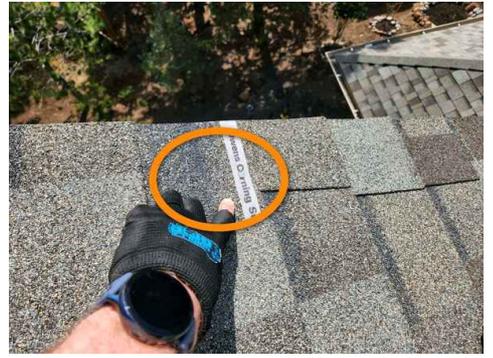
3.1.1 Roof Coverings

Exposed fasteners pose a risk of moisture intrusion, which can compromise the integrity of the roof covering and flashings.

Recommendation: Seal all exposed fasteners to prevent water penetration and maintain the durability of the roofing system.

Contact a qualified roofing professional.

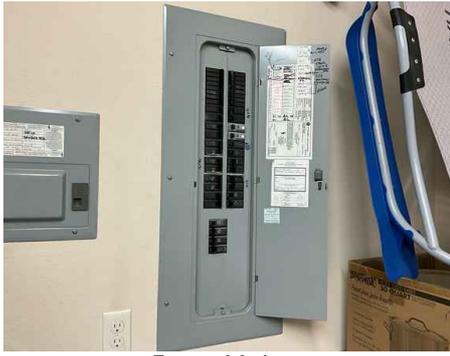
Front Main

Main and Distribution Panels: No Defects Observed: Inspection of Electrical Panel(s)

The electrical panel(s) were thoroughly inspected.

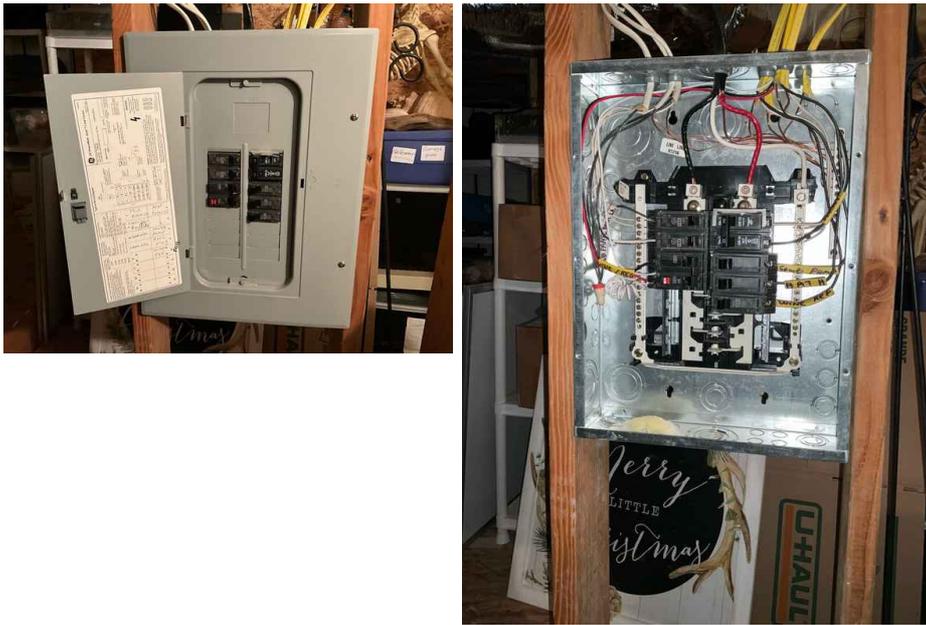
Crawlspace

Main and Distribution Panels: No Defects Observed: Inspection of Electrical Panel(s) 2

The electrical panel(s) were thoroughly inspected.

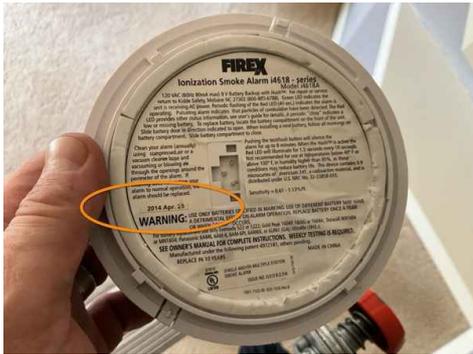
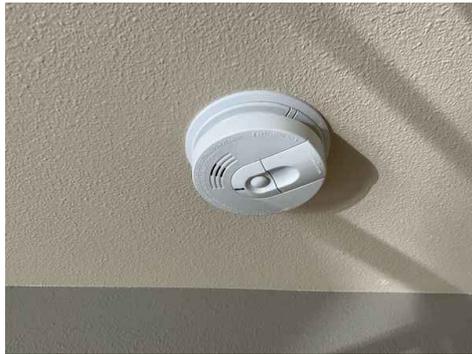
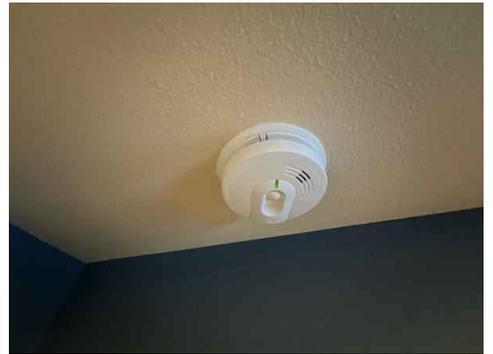
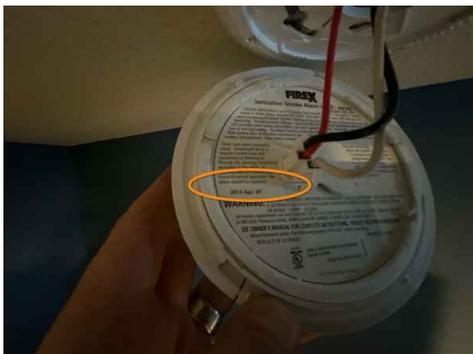
EXPIRED SMOKE ALARMS: URGENT REPLACEMENT NEEDED

According to Oregon law, smoke alarms older than 10 years must be replaced at the time of house transfer to ensure building occupant safety. Additionally, smoke alarms must be replaced with like-for-like units, ensuring compatibility and effectiveness. All hardwired compartments must be replaced with hardwired smoke alarms.

Replace all expired smoke alarms promptly to comply with Oregon state safety requirements and maintain the safety of occupants.

Replacement smoke alarms should be installed by minimum installation and location standards, as outlined by state building codes. Correction should be completed before the close of escrow to ensure compliance and safety.

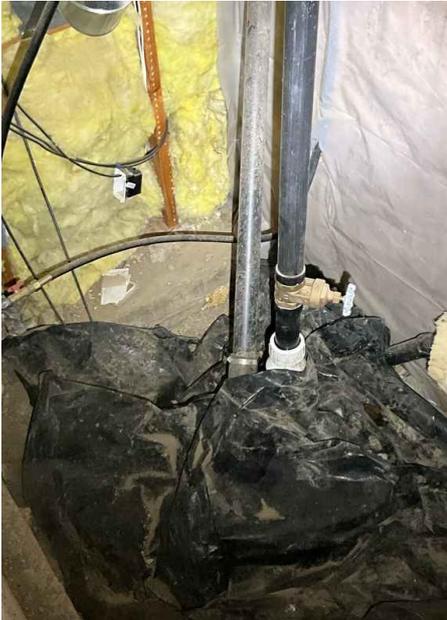
Plumbing Drainage Systems: Sewage pump was observed

Sewage Pump was present in the building. Evaluation of function and installation is not part of this inspection, although no defects observed.

Typical life expectancy of a sump pump is 10 + years. Actual age of this sump pump is unknown and determination if there was a grinder pump was not part of the inspection.

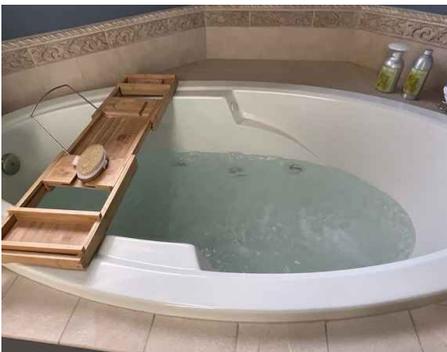
Water Supply Plumbing, Distribution System, and Fixtures: Jetted Tub Was Functional

The jetted tub was functional at the time of inspection. Motor access was present and a GFCI outlet protected the circuit.

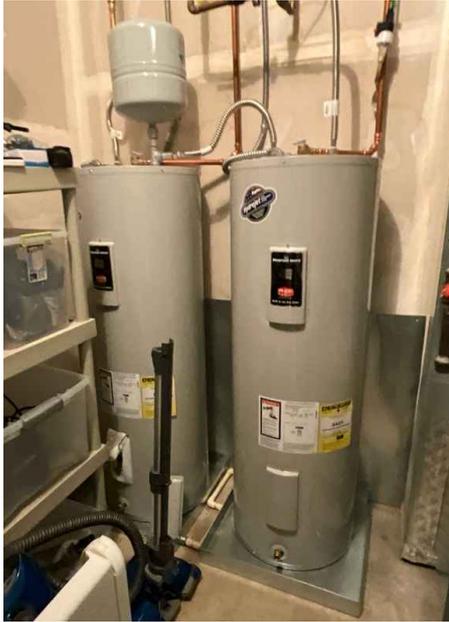
Water Heating Systems, Flues and Vents: Water Heater was Functional

The water heater was operational during testing, indicating it was functional.

While the water heater was found to be working properly, regular maintenance is recommended to ensure continued optimal performance.

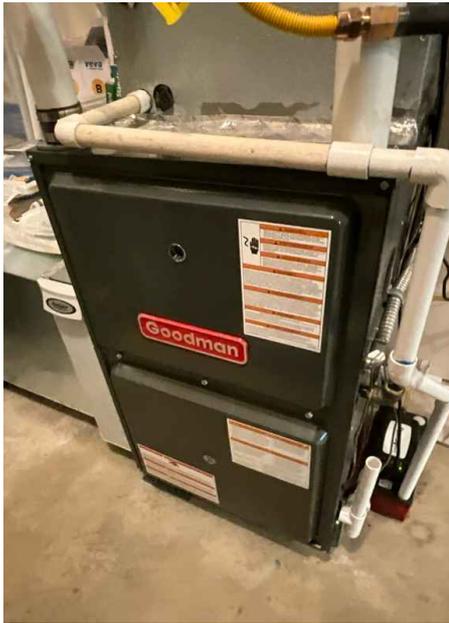
Downstairs Mechanical Room

The Heating equipment was functional during testing. Further evaluation may be necessary by a qualified HVAC technician to determine if service is required to extend life expectancy and maintain performance.

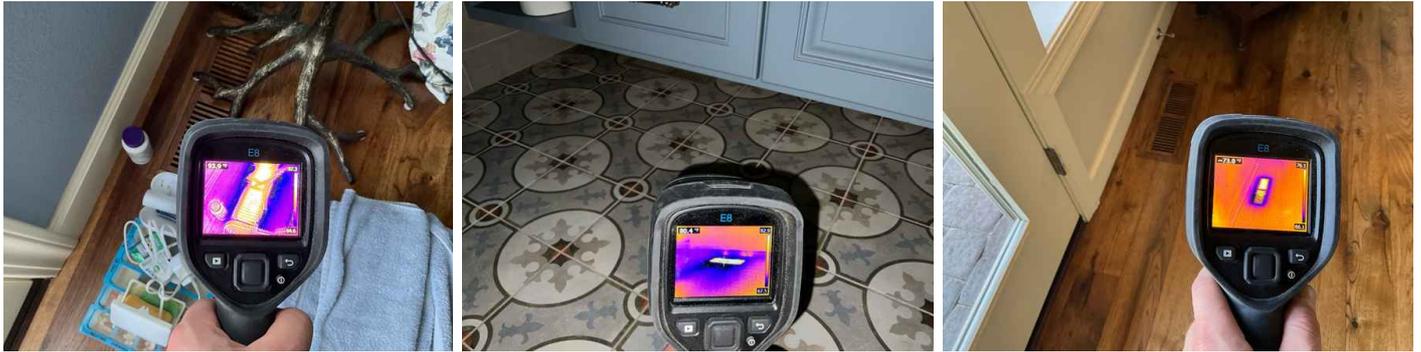
Distribution Systems (including fans, pumps, ducts and piping, with supports, insulation, air filters, registers, radiators, fan coil units and convectors): Thermal Validation of HVAC supply vents

Heating and cooling air ducts were inspected with thermal imaging and confirmed proper heating and cooling distribution to vents in the house.

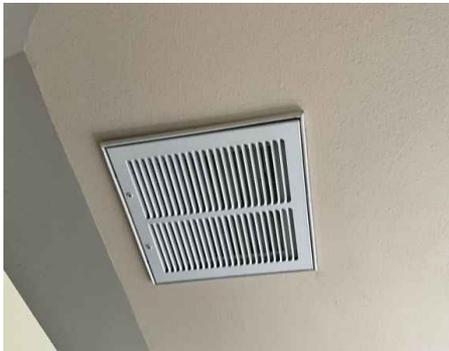
Distribution Systems (including fans, pumps, ducts and piping, with supports, insulation, air filters, registers, radiators, fan coil units and convectors): Air filter location

Bedrooms and Hallway ceilings

The air filter was either located at the furnace filter cabinet or the air return register. This is for your information.

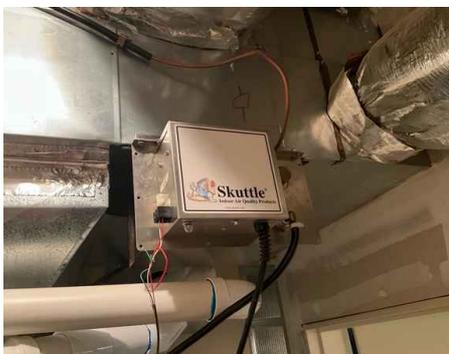
Distribution Systems (including fans, pumps, ducts and piping, with supports, insulation, air filters, registers, radiators, fan coil units and convectors): Central Air Humidifier present

A central air humidifier was connected to the house's central air system. These devices humidify the air to enhance comfort for the occupants. Central humidifiers are integrated into the house's plumbing and forced-air heating systems. No defects were observed, and it appeared to be operational.

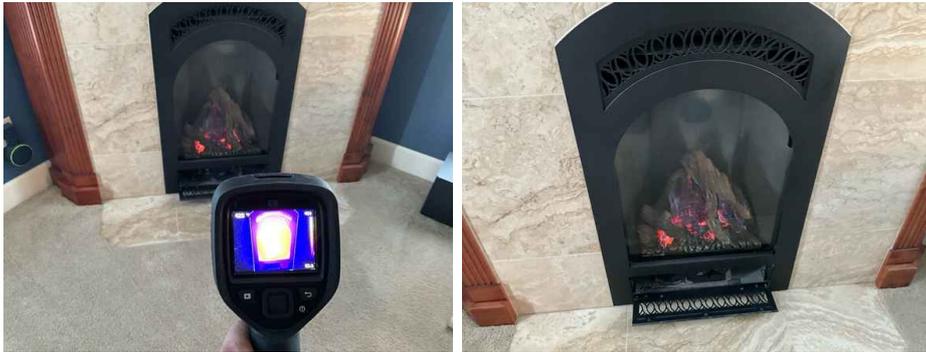
Thermal image validation of fireplace

Fireplaces (Gas, Wood Burning, Pellet): Gas fireplace WAS functional

Master Bedroom

The gas-burning fireplace was functional during testing.

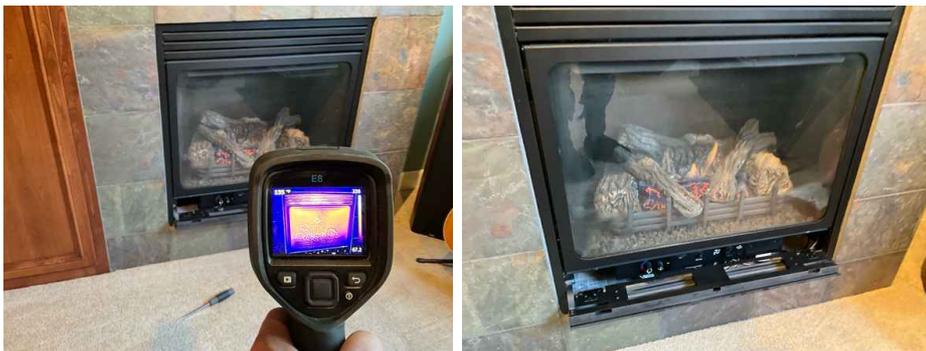
Thermal image validation of fireplace

Fireplaces (Gas, Wood Burning, Pellet): Gas fireplace WAS functional 2

Downstairs Living Room

The gas-burning fireplace was functional during testing.

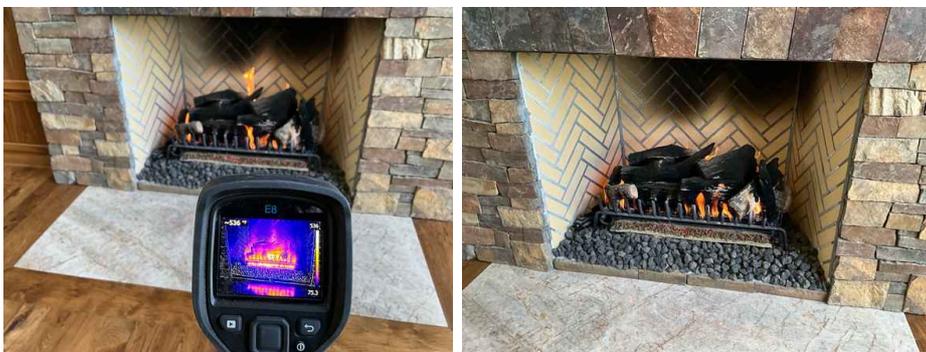
Thermal image validation of fireplace

Fireplaces (Gas, Wood Burning, Pellet): Gas fireplace WAS functional 3

Main Living Room

The gas-burning fireplace was functional during testing.

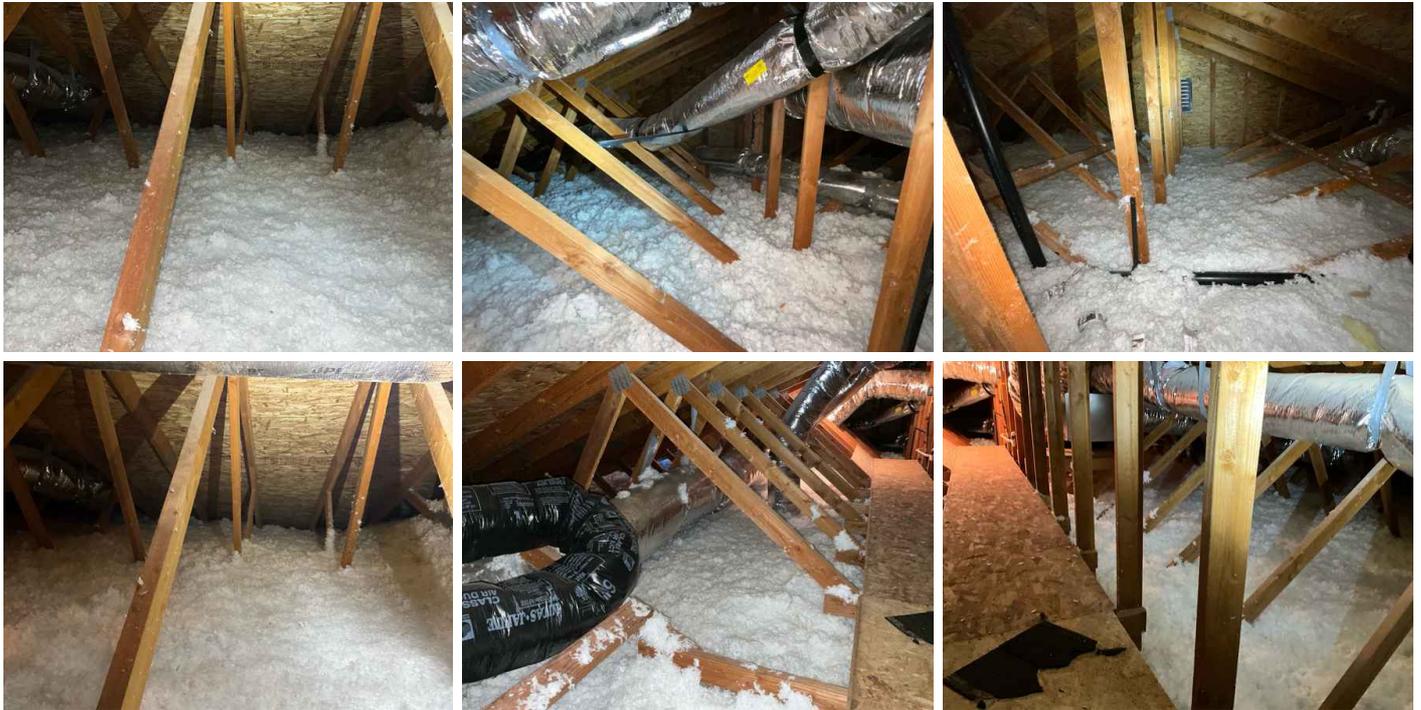
Attic Insulation: The insulation in the attic was found to be adequate based on observations from accessible locations. *The attic was inspected solely from the entry hatch and was not walked through to prevent any potential injury or disruption to the recently installed insulation's thermal efficiency.*

Accessibility Limitation: *It's important to note that not all attic areas were visible from the entry hatch or access point.*

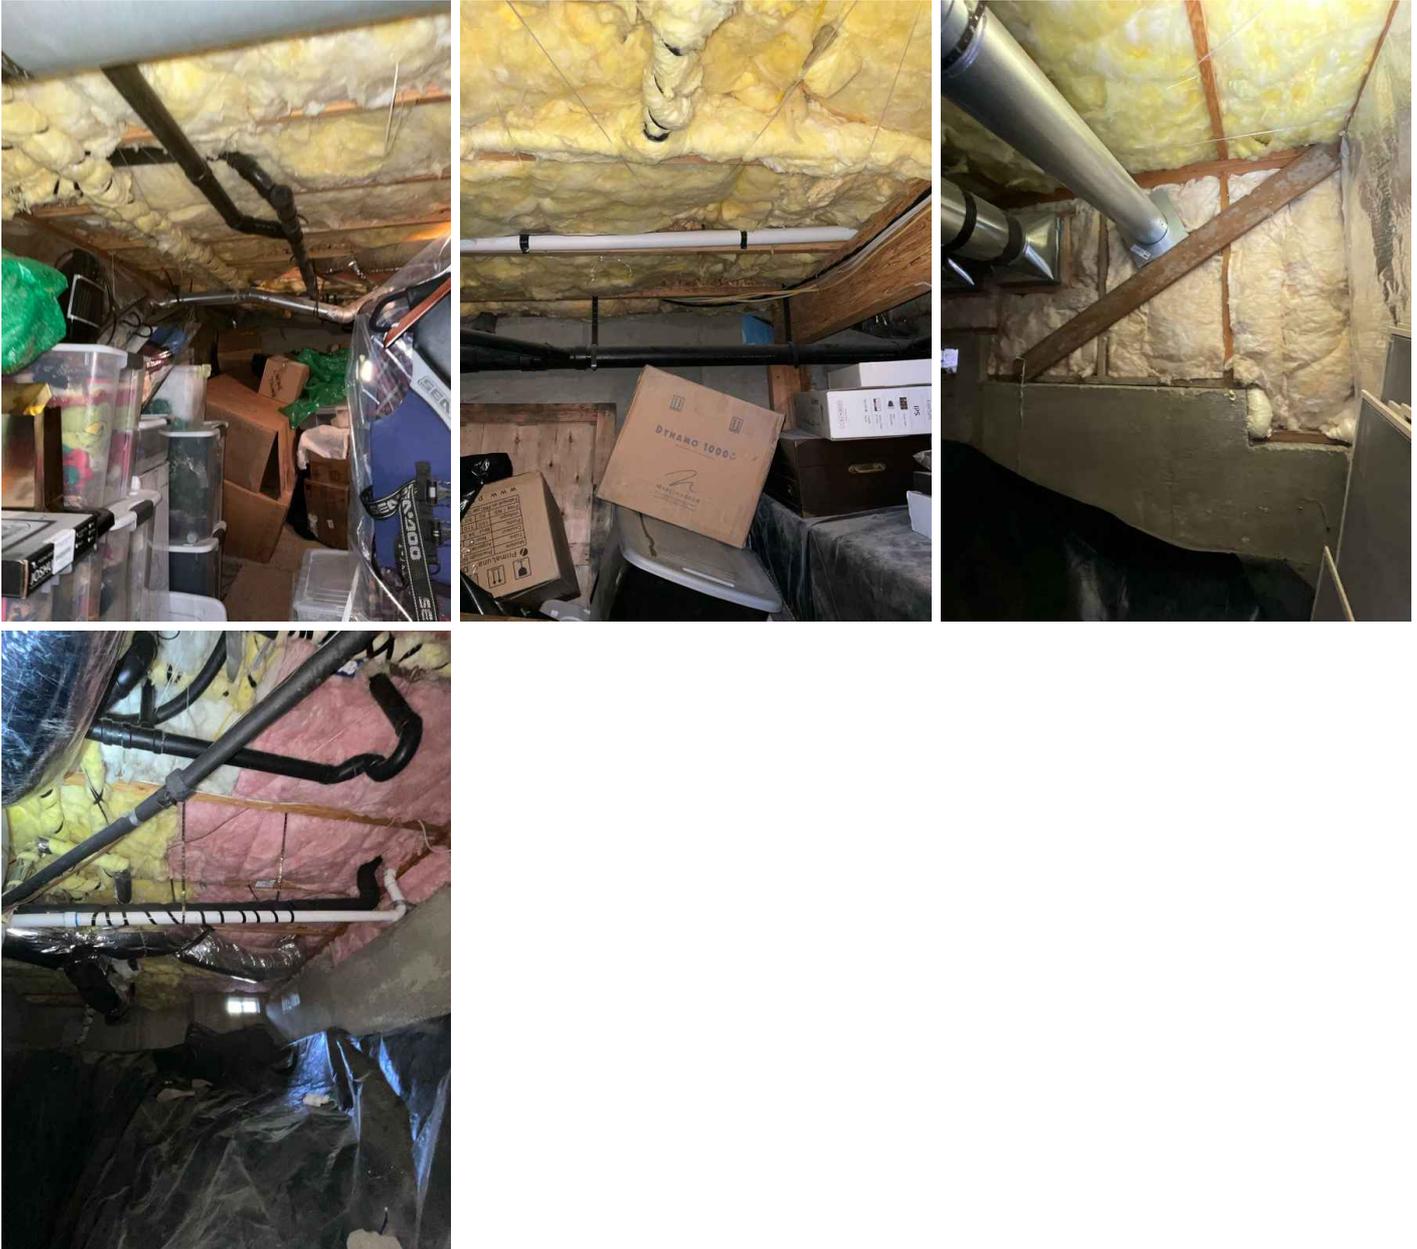
Insulation Under Floor System: Adequate and Consistent Floor Insulation

The underfloor insulation system appeared consistent and demonstrated adequate support, with an estimated R-value in line with expectations.

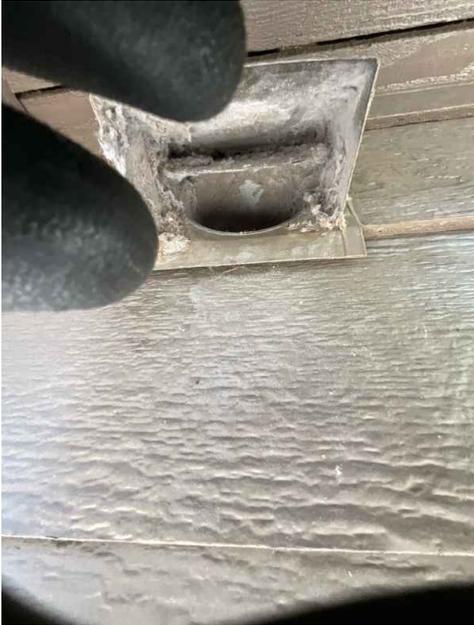
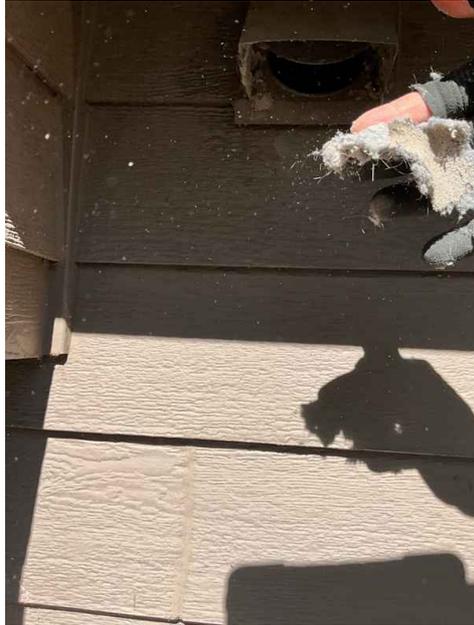
10.5.1 Venting Systems (Kitchens, Baths and Laundry)

Debris buildup was observed in the laundry duct vent, potentially reducing drying capacity and posing a fire hazard due to flammable lint accumulation.

The collection of lint debris caused the flap damper to be in the open position . Recommend cleaning of dryer duct. Excessive dryer lint was pulled from the interior of the duct opening

Recommendation: Have professional cleaning and maintenance performed on the dryer duct to remove all flammable debris and improve drying capacity.

Contact a qualified professional.

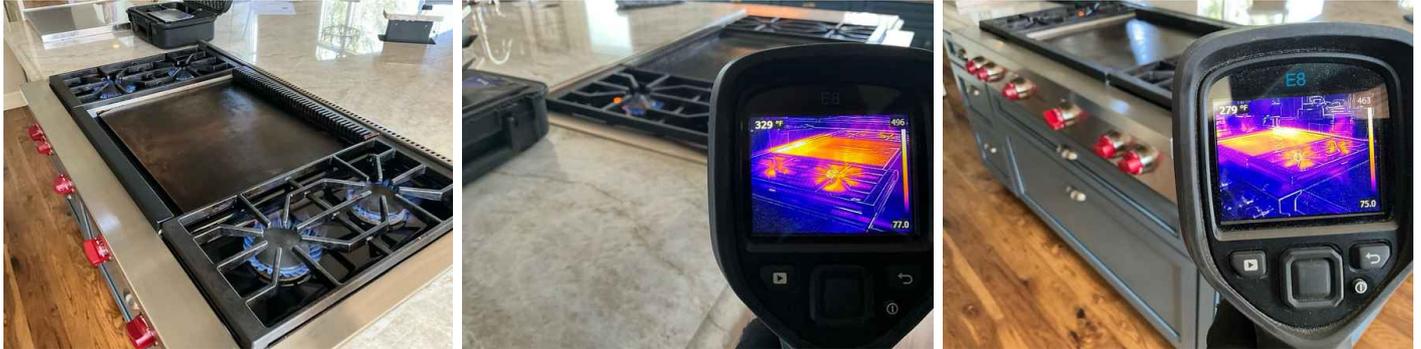
Ranges/Ovens/Cooktops: Cook Top Functional - No Defects

The cooktop was tested and found to be functional. No issues were observed during the inspection.

Recommendation: Although the cooktop was operating properly, regular maintenance and periodic checks are recommended to ensure continued safe and efficient performance.

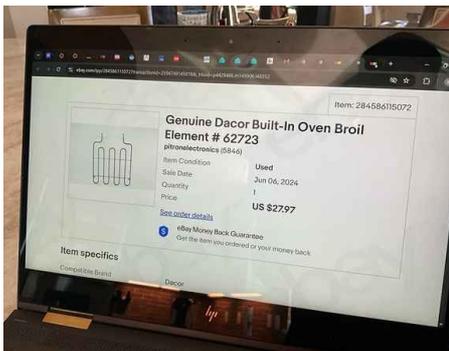
Ranges/Ovens/Cooktops: Wall Oven Restoration and Functionality

The homeowner reports that recent restoration has been performed on the wall oven, including updates to the electronics and replacement of the heating element in the top broiler. Documentation of these repairs was provided for reference. Upon evaluation during the inspection, the wall oven was confirmed to be functional.

Recommendation: Continue to monitor the wall oven to ensure it maintains proper functionality. Keep the provided documentation for future reference and warranty purposes, if applicable. No further action is required at this time unless issues arise.

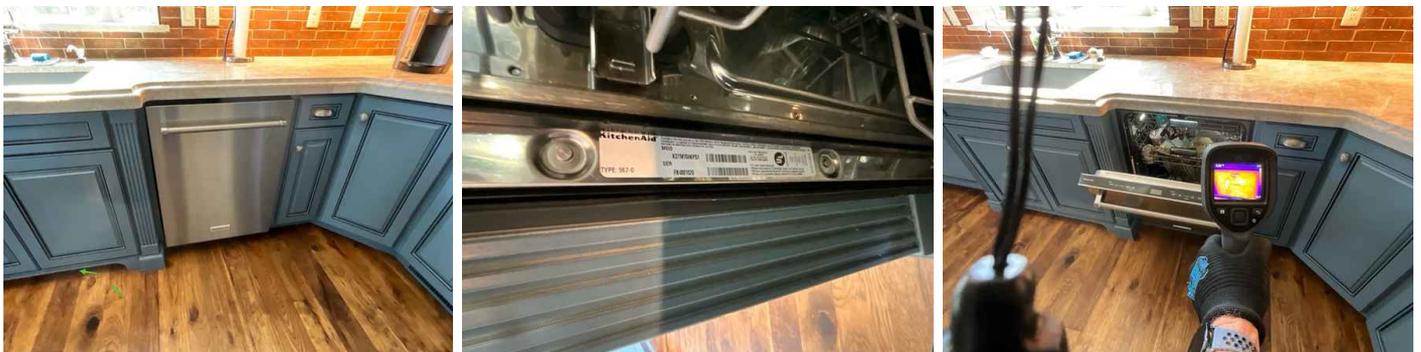
Dishwasher: Functional Dishwasher

The dishwasher was operational during testing, indicating its current functionality.

Recommendation: While the dishwasher was found to be working properly, regular maintenance and cleaning are recommended to ensure continued optimal performance.

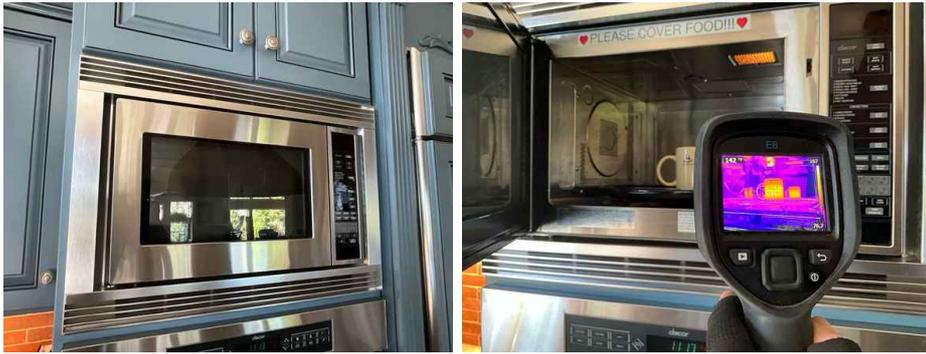
Functional Microwave Observation

The microwave was found to be operational, with no operational defects detected during the assessment.

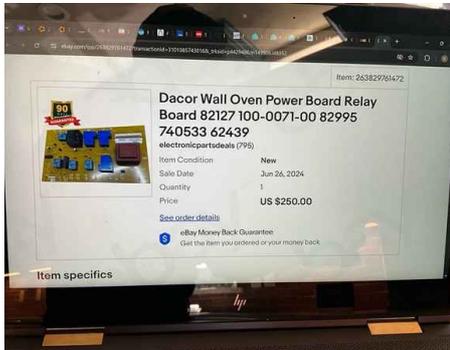
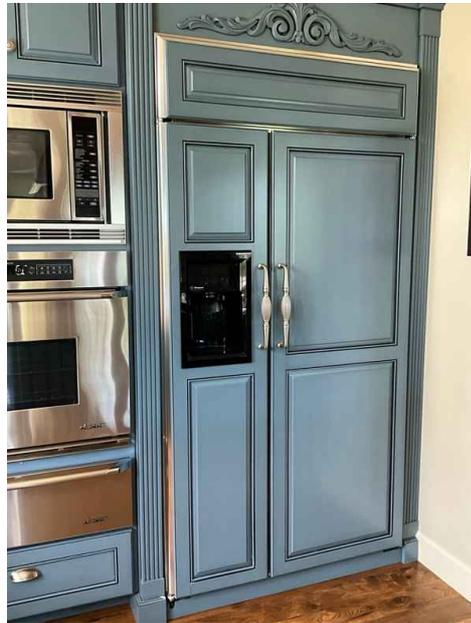
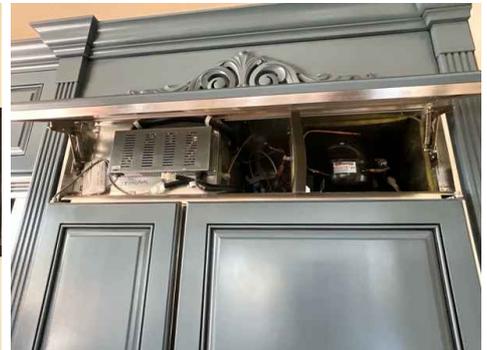
Refrigeration: Refrigerator Restoration and Functionality

The homeowner reports that recent restoration has been performed on the refrigerator, including updates to the electronics, replacement of seals, and maintenance of the compressor. Documentation of these repairs was provided for reference. Upon evaluation during the inspection, the refrigerator was confirmed to be functional.

Recommendation: Continue to monitor the refrigerator to ensure it maintains proper functionality. Keep the provided documentation for future reference and warranty purposes, if applicable. No further action is required at this time unless issues arise.
