# Confidential Inspection Report

4th St  
Glennallen, AK 99588

DATE:  
Monday, April 13, 2026

Inspected By: Benjamin Crowley  
License #135839  
Ridgeline Inspections LLC  
(907) 795-6212  
office@ridgelinealaska.com

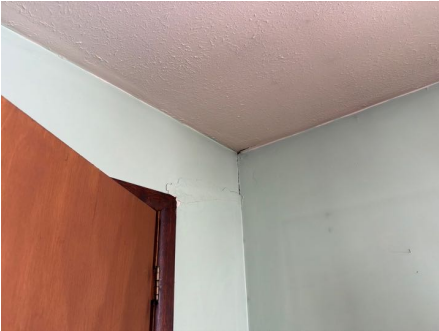
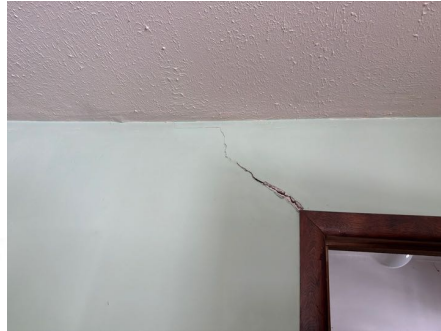
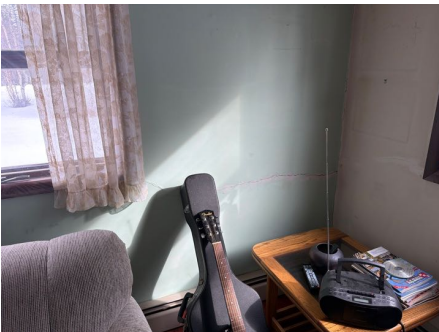
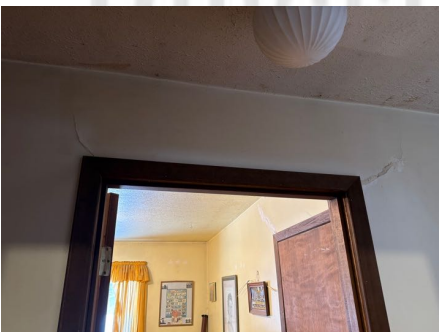
**PRM 31:** There were signs of possible structural movement in interior walls/floors. It was not evident whether this is ongoing or past damage only. This is common for this area of Alaska that is affected by permafrost. This should be further evaluated by a structural engineer to determine structural integrity and the likelihood of continuing damage.

**PRM** There were signs of possible structural movement in interior walls/floors. It was not evident whether this is ongoing or past damage only. This is common for this area of Alaska that is affected by permafrost. This should be further evaluated by a structural engineer to determine structural integrity and the likelihood of continuing damage.

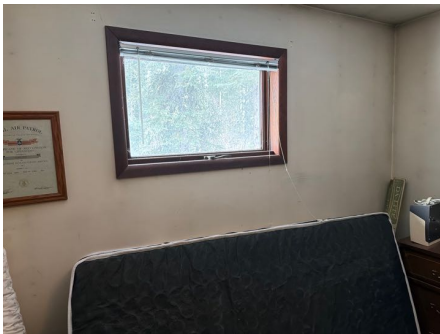
**2:** Egress windows pictured below had multiple safety violations.

Back bedroom - over 48" from the floor

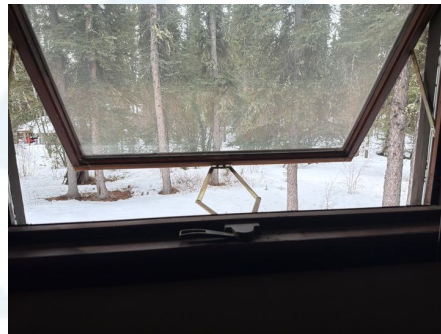
Back bedroom - wrong hardware/too small

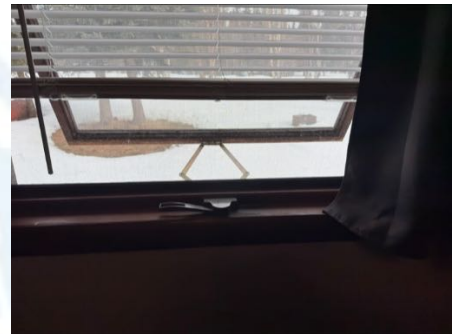
Second front bedroom - wrong hardware

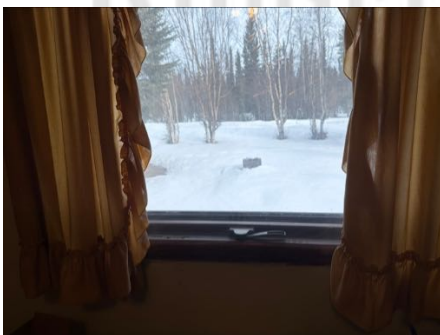
First front bedroom - wrong hardware

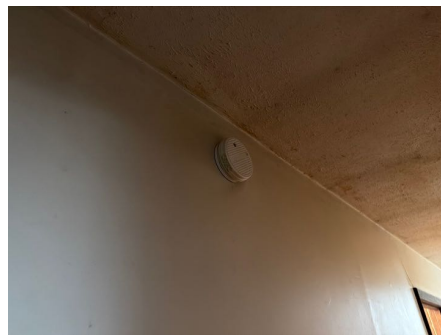
Hall

**H&S** CO detectors were not placed properly to protect the bedrooms. A CO detector or combination detector should be installed on each level and within 15 ft of each bedroom to protect home occupants.

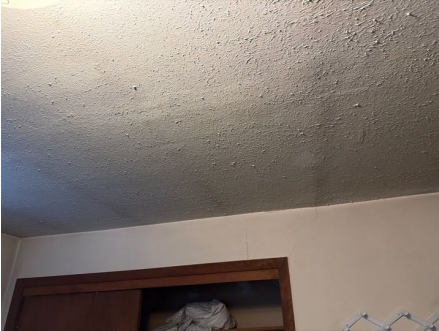
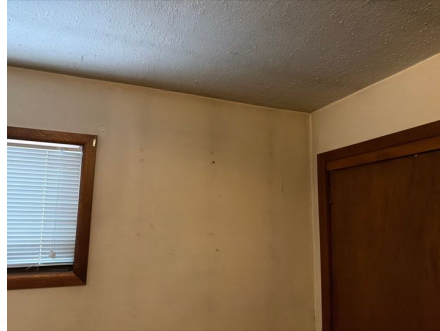
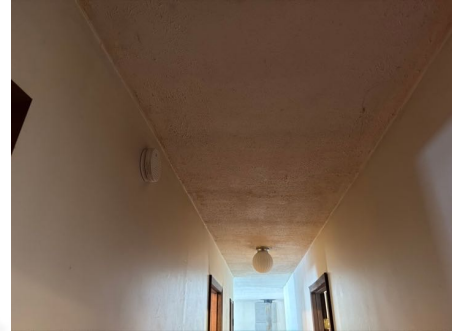
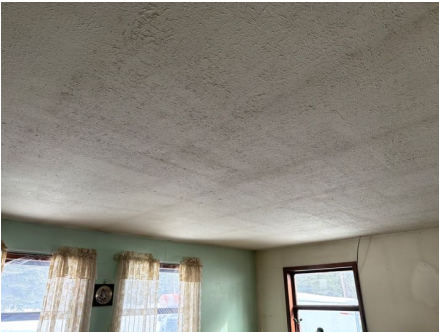
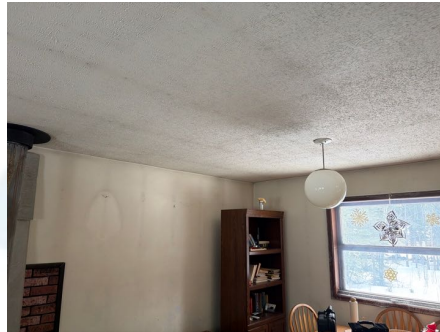
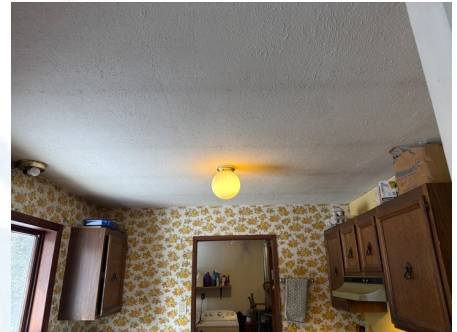
**MTN** Ceilings in the home showed signs of "ghosting".

Ghosting is fine dust collected on the ceiling/wall that sticks in a pattern outlining the studs and rafters opposite in the attic. This is because the rafters are colder than the insulation surrounding them, and small amounts of condensation form on the inside of the ceiling, where dust sticks. This is not a major concern, but can sometimes be remedied by adding additional insulation.

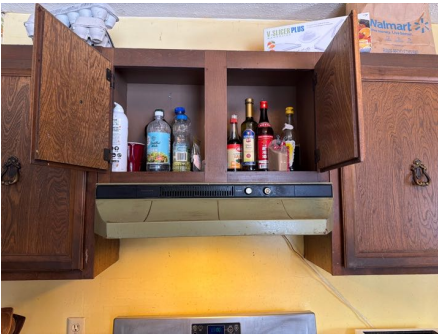
**MTN** The range hood did not exhaust to the exterior.

There were cleanable filters to re-circulate air, but these "filtration systems" are not actually ventilation, and exhaust fumes are best vented outside rather than within the living space.

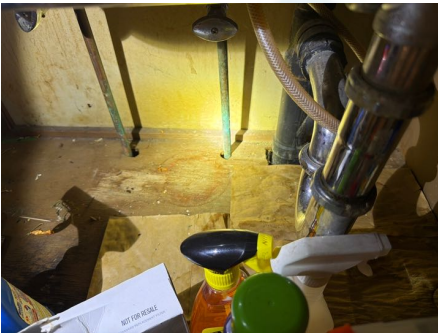
**MTN** Kitchen sink cabinet floors had damage from past moisture. Monitoring or repair recommended to ensure no further leaks.

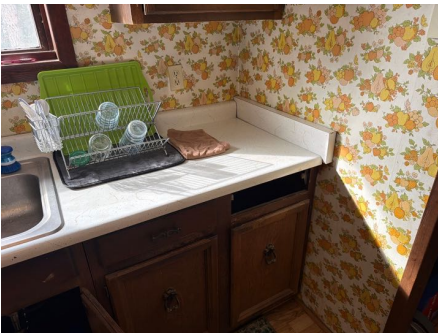
**MTN** Kitchen counters/cabinets had moderate damage visible. Repair/replacement recommended.

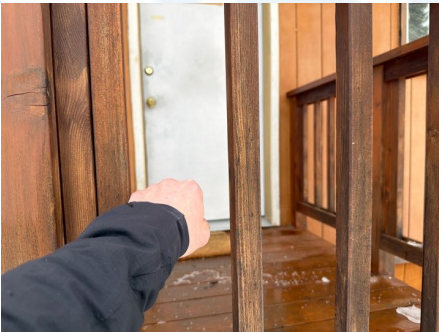
**H&S 13:** Spaces between porch guardrail balusters were too wide. Safe building practices dictate that a 4 inch sphere may not pass through the guardrail at any point. This condition may be hazardous to small children. All corrections should be made by a qualified contractor.

**H&S** Spaces between porch guardrail balusters were too wide. Safe building practices dictate that a 4 inch sphere may not pass through the guardrail at any point. This condition may be hazardous to small children. All corrections should be made by a qualified contractor.

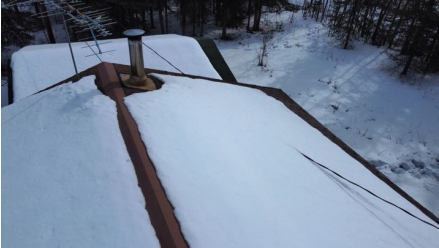
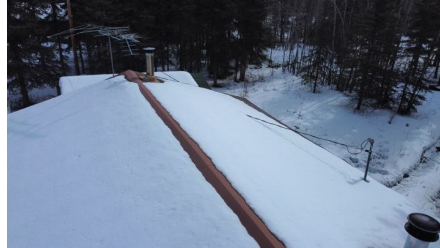
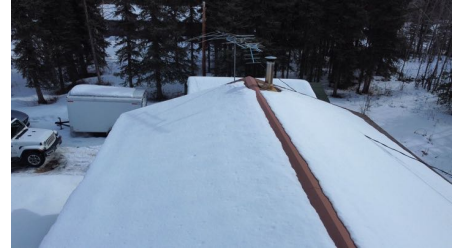
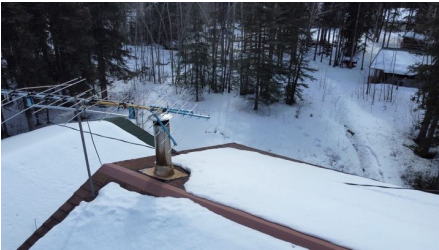
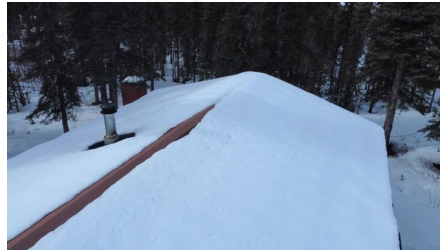
✓ The roof was inspected with a drone. Snow cover limited the visibility of the inspection, and evaluation after snow removal is recommended.

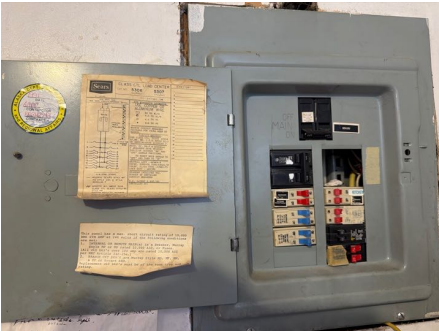
**H&S** The Circuit Directory label at the service panel was incomplete. The service panel should contain a clearly-marked label identifying individual circuits so that in an emergency, individual circuits can be quickly shut off.

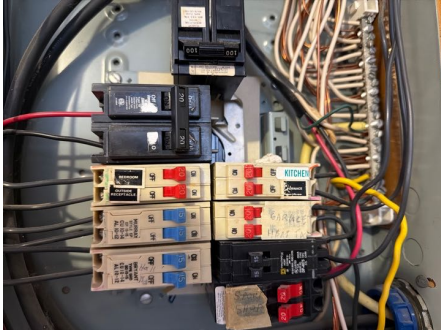
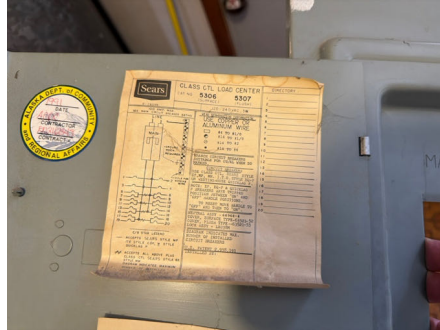
**H&S** A circuit breaker(s) in the panel was a different brand from the panel. Breakers from one manufacturer used in the panel of another manufacturer may result in poor connections, if the brands are not compatible. This can create a potential fire or shock hazard. Evaluation and correction (if necessary) by an electrical contractor is recommended.

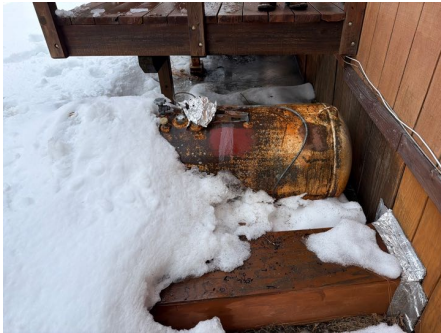
The propane tank appeared to be in good visible condition. However, evaluation of propane tanks lies beyond the scope of the general Home Inspection. The propane tanks can be evaluated by the contractor supplying the home with propane.

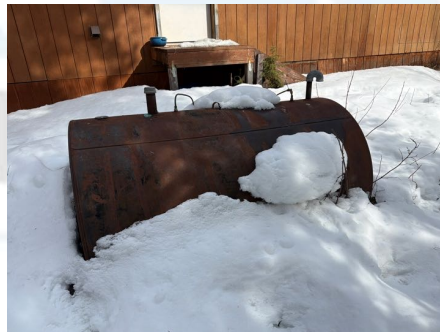
Main house

The heating oil tank was not resting on a proper stand. Tanks should rest on a proper, stable stand on a level surface to prevent them from damage, falling, or rolling.

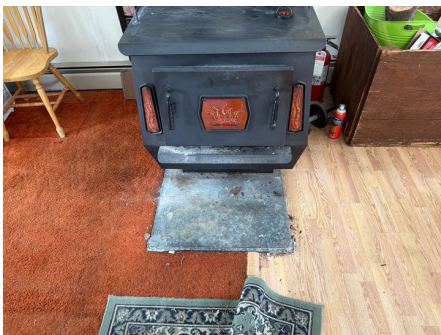
**H&S** The hearth of the wood stove did not extend far enough past the firebox. For wood stoves with a firebox opening of less than 6 square feet, modern safety practices require a non-combustible surface to extend a minimum of 16 inches from the front of the firebox and 8 inches to either side.

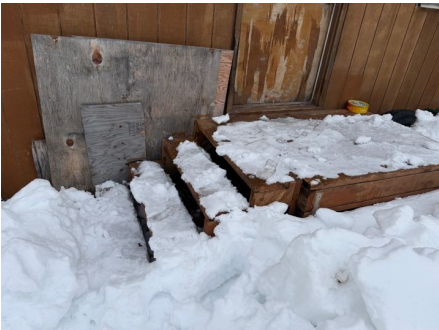
**H&S** The outbuilding porch staircase had no handrail. Generally-accepted current safety standards mandate that stairs with 4 or more risers should have a handrail.

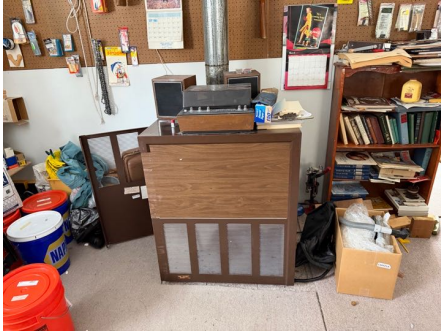
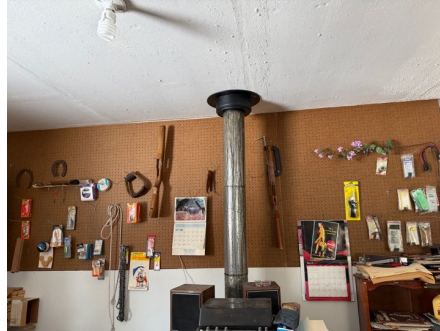
**H&S** There was an oil heater in the cabin that was not in operation.  
A full evaluation and any necessary repairs/maintenance are recommended before use.
