Professional Home Inspections

Home Inspection Report

8861 E.Kiva Way, Palmer, AK 99645

3290

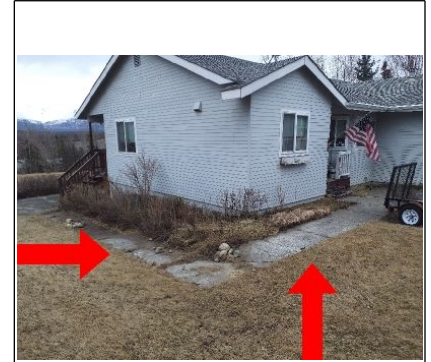
Recommend evaluation for repair of the deteriorating Concrete service walk leading from the garage to the porch located on the front of the home.

Photo of the concrete service walk located on the left-hand side home leading to the deck located on the back of the home.

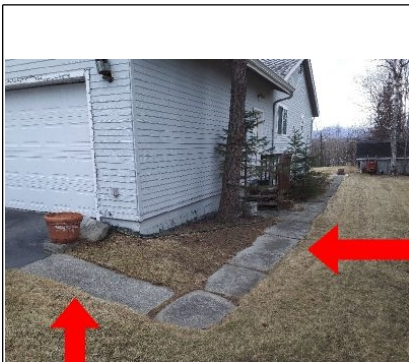
Photo of the concrete service walk located on the right hand side of the home leading to the service entry door for the garage and the back of the home.

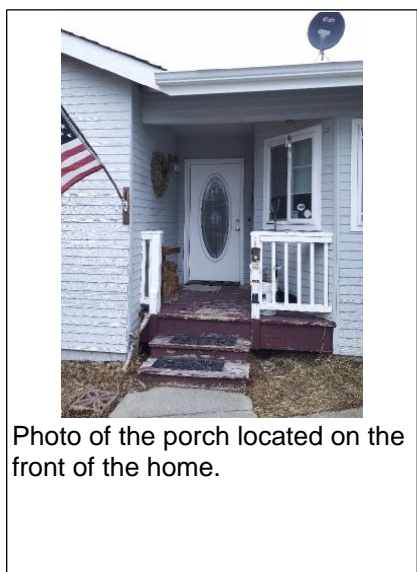
Comments Recommend repainting the porch and guardrail this would help along the life of the porch and guardrail located on the front of the home.

Photo of the porch located on the front of the home.

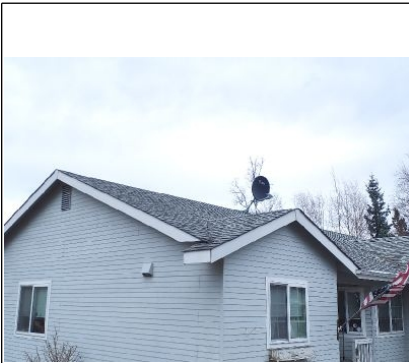
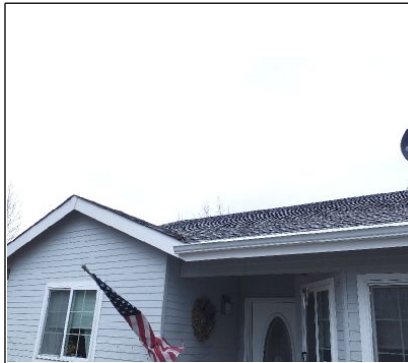
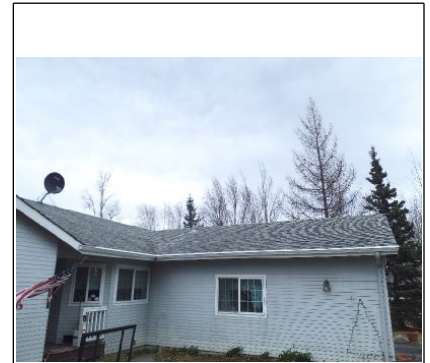
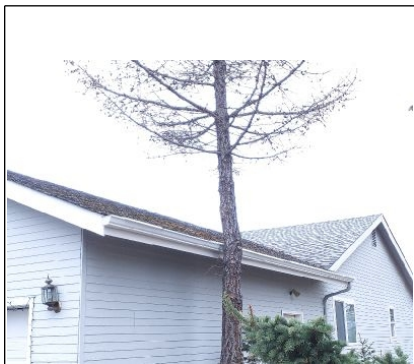
Recommend evaluation by a licensed roofing contractor for the removal of the moss growth occurring on the roof located on the right hand side of the garage and the backside of the roof.

Overview of the roof.

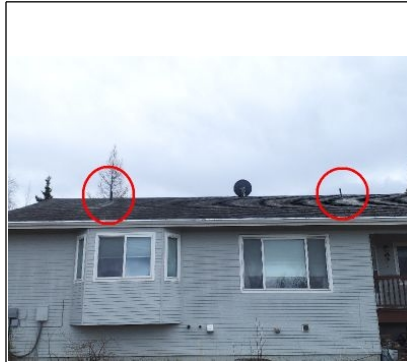
- 5.Recommend evaluation by licensed plumber for the repair of the plumbing vent located on the back side of the roof the right hand side of the satellite dish at the time the inspection you can see that the Plumbing vent is leaning to left hand side and it's no longer pointing straight up. You can refer to the photos in the roof section of this report for line items 4 and 5.

Photo of two Plumbing vents.

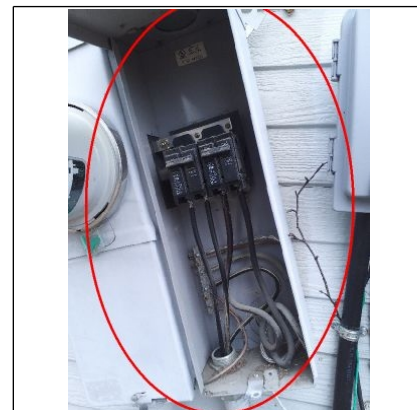
Recommend a licensed electrician remount the service entry and disconnect panel and electric meter properly to the home at the time of the inspection the service entry and disconnect panel and electric meter are detach from the home and leaning to the left hand side this could be a safety hazard.

Photo of the service entry and disconnect panel located on the back of the home.

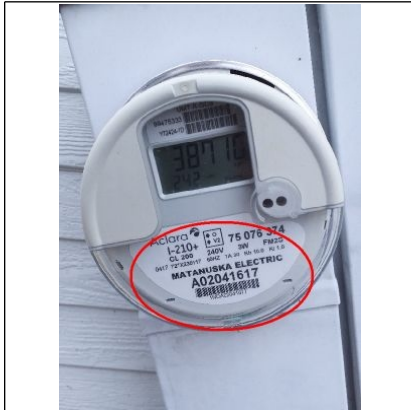
Photo of the electric meter located on the back of the home.

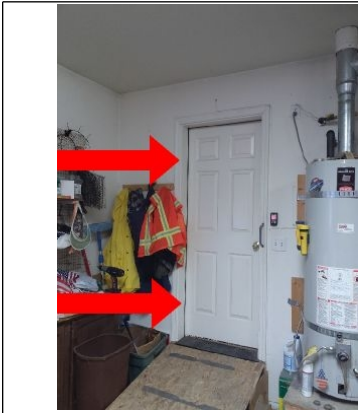
The self-closing hinges on the fire separation door going from the garage into the home need to be adjusted so that the door will close and latch on its own.

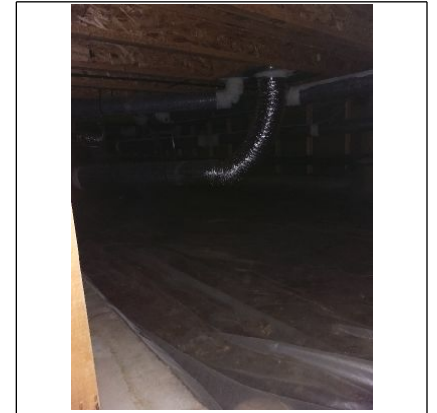
Recommend restretching and sealing the seams and the perimeter of the poly sheeting on the floor in the crawlspace around the well pressure tank there should be no exposed dirt.

Photo example of The Vapor Barrier located in the crawl space.

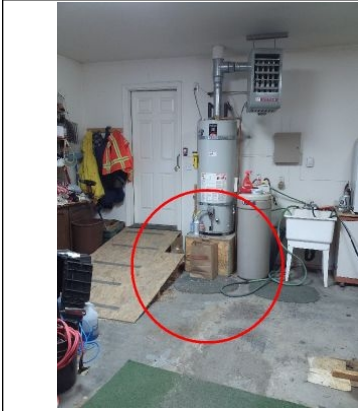
There should be a Bollard installed in front of the water heater in the garage for protection from possible vehicle impact.

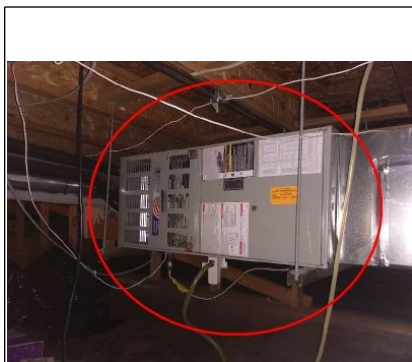
Comments Recommend having the furnace and HRV system located in the crawl space and the gas space heater for the garage all serviced by an HVAC technician before closing.

Photo of the Furnace located in the crawl space.

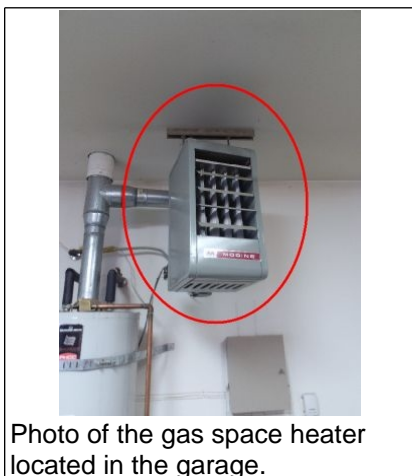
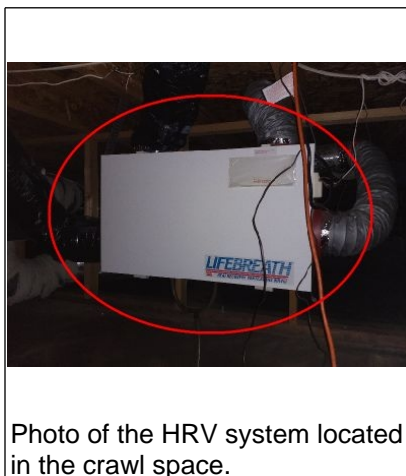
Comments Recommend having the gas space heater for the garage and the HRV system located in the crawl space serviced by an HVAC technician before closing.

Photo of the gas space heater located in the garage.

Photo of the HRV system located in the crawl space.

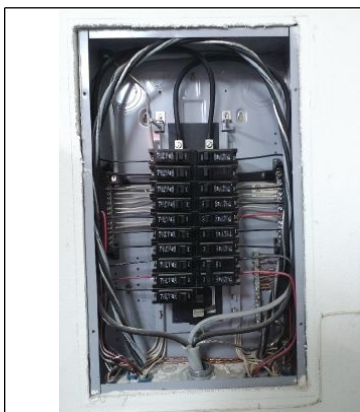
- 17.Two Handle ties are needed in the electrical panel, Whenever two breakers are sharing the same neutral they require a handle tie. You can refer to the photo in the electric section of this report. Recommend any work done in the electrical panel be done by licensed electrician.

Comments Two Handle ties are needed in the electrical panel, Whenever two breakers are sharing the same neutral they require a handle tie.

Photo of the electrical panel located in the garage.
