**FORENSIC GEOTECHNICAL EXPLORATION**

**HILPERT RESIDENCE**  
10464 Cranston Street  
Spring Hill, Florida 34608

Universal Project No. 0830.1000350.0000  
Citizens Property Insurance Corporation Claim No. 351934

October 22, 2010

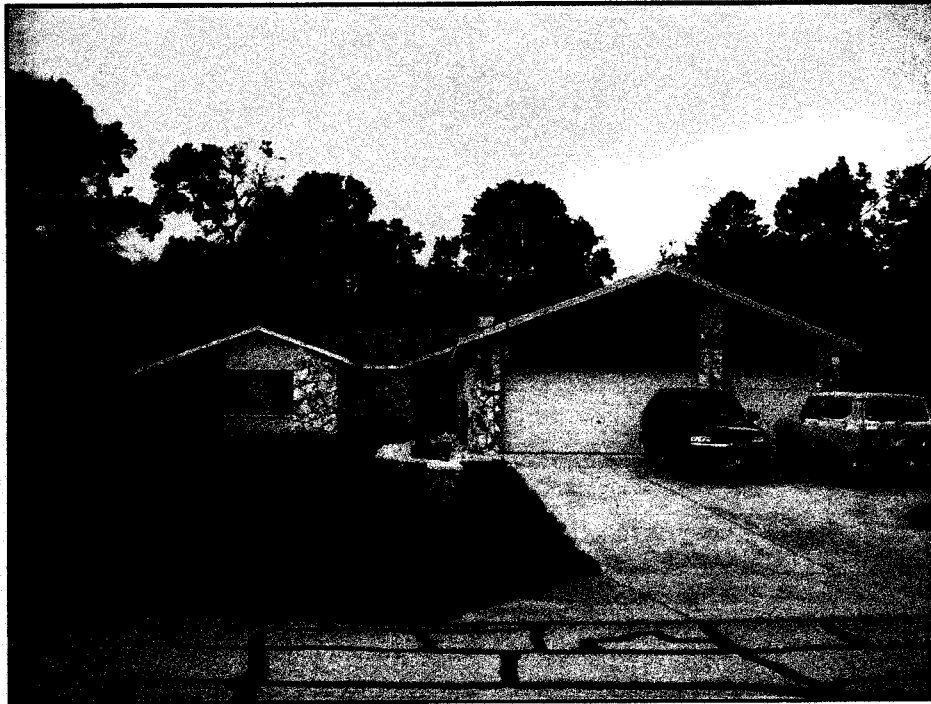
Photograph 1: The front of the house looking south.

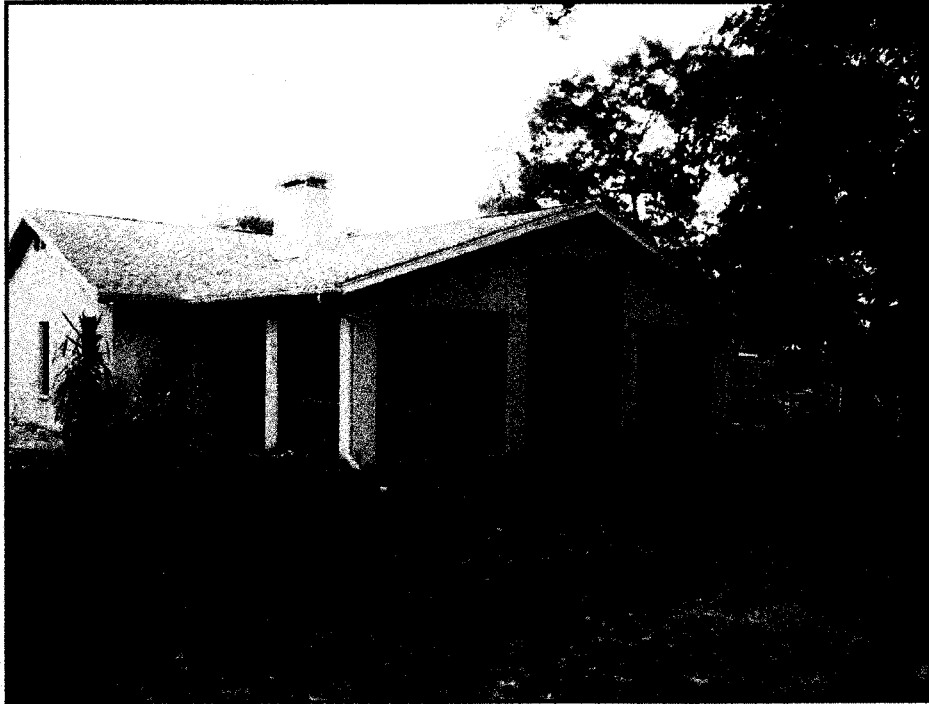
Photograph 3: The south side of the house looking northeast
