Home Inspection Report

9 Church St, Ellenburg Center, NY 12934

Thursday, May 28, 2026

Hawkeye Home Inspections, LLC

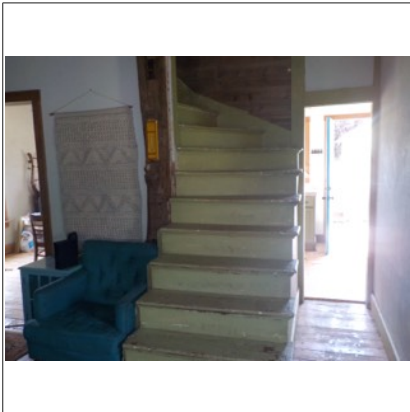
Stairs/Steps/Balconies

- None
- Condition** Satisfactory Marginal Poor Loose/Missing
- Handrail** Satisfactory Marginal Poor Safety hazard Hand Rail/Railing/Balusters recommended
- Risers/Treads** Satisfactory Marginal Poor Risers/Treads uneven Trip hazard
- Comments**
- Photos**
