Prepared for Exclusive Use by:

301 Canyon Dr
Grants Pass OR 97527

11/17/2025

Kelley Property Inspections dba HouseMaster
1241 NW Lawnridge Ave
Grants Pass OR 97526
541-295-5802

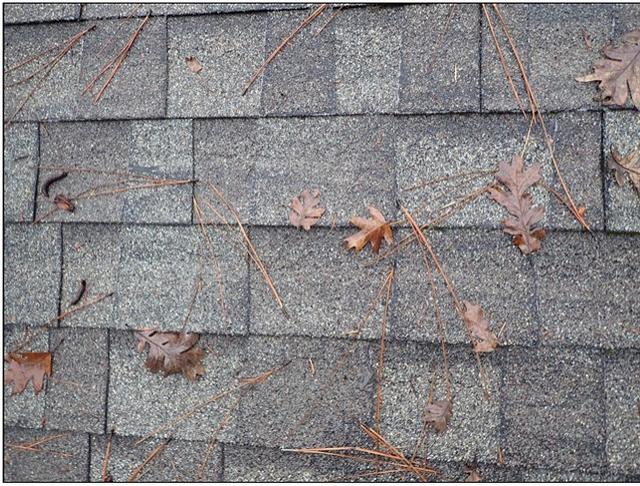
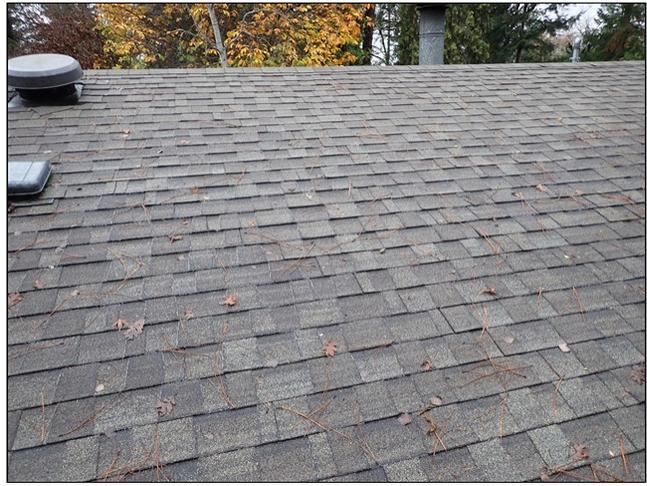
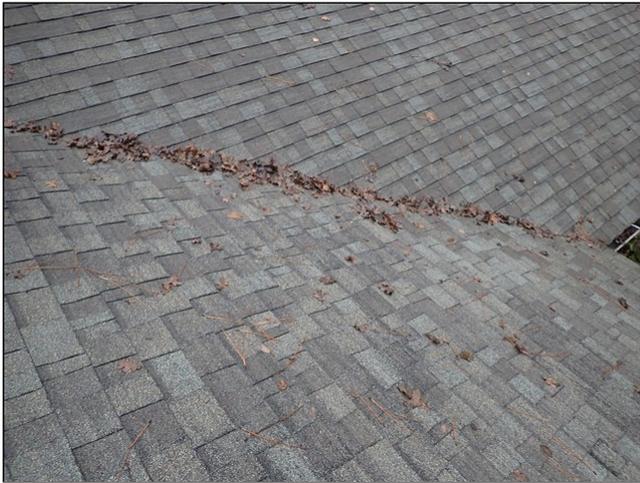
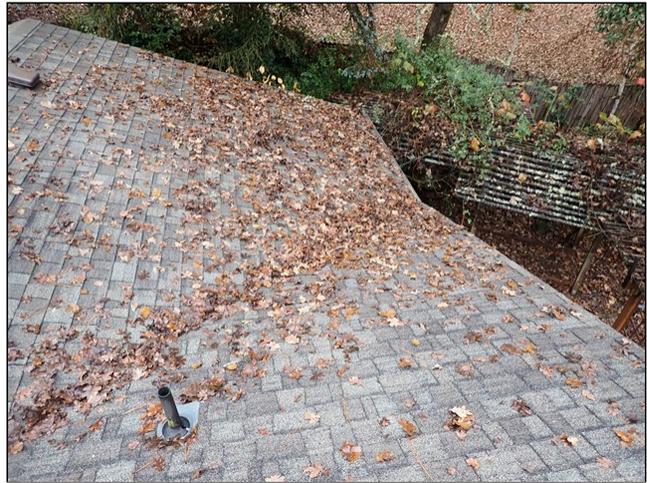
●					1.0 ROOF COVERING Roof covering is rated in fair condition based on age and wear. Granular loss observed on most fields. Additionally, excess debris and moss build-up noted. Recommend having roof checked and serviced as needed by a qualified roofing contractor. Look to replace covering in the next 5 to 7 years.
●					1.1 CHIMNEY Cracking observed on chimney cap at multiple locations. Recommend having concrete cap checked and sealed as needed by a qualified contractor. Additionally, moisture stains noted on roof sheeting around chimney in attic area. Check and repair flashing as needed.
●					1.2 CHIMNEY (2)
●					1.3 PLUMBING STACKS/VENT COVERS Some deterioration noted at vent pipe/flashing junctures. All vent pipe flashings should be checked periodically and should be repaired and/or sealed as needed.
●					1.4 VENTILATION COVERS
●					1.5 SKYLIGHT(S) Recommend clearing debris from on and around skylights to preclude moisture absorption issues.

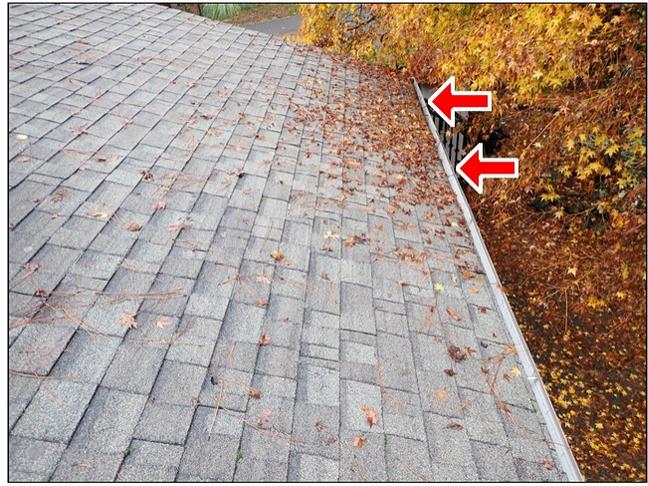
1.6 RAIN GUTTERS (Picture 1)

●					1.6 RAIN GUTTERS Build up of leaves/debris in gutters. Recommend cleaning now and on a routine basis for proper function.
●					1.7 DOWNSPOUTS / ROOF DRAINS
●					1.8 FASCIA / SOFFITS

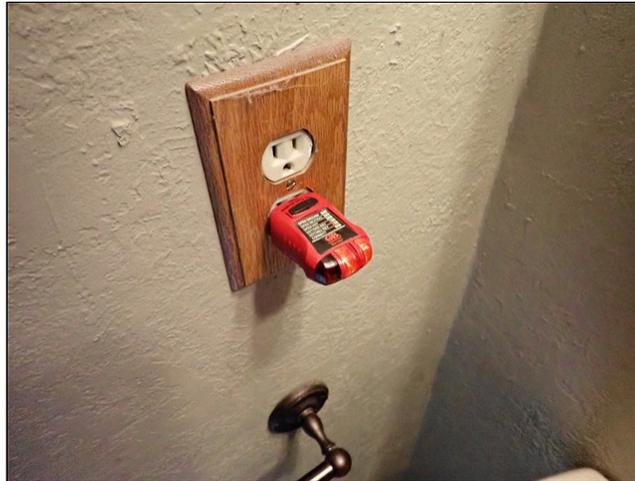
8.5.A ELECTRIC / GFCI (Picture 1)

●					8.0.A SINK(S)
●					8.1.A TOILET
●					8.2.A FLOOR(ING)
●					8.3.A WALLS / CEILING
			●		8.4.A VENTILATOR
	●				8.5.A ELECTRIC / GFCI Bathroom outlets are not GFCI protected. Recommend consulting with qualified electrician for proper placement of GFCI outlets as a safety upgrade.

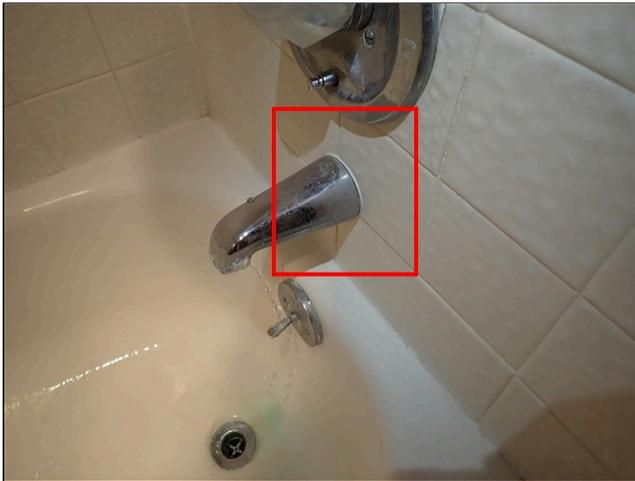
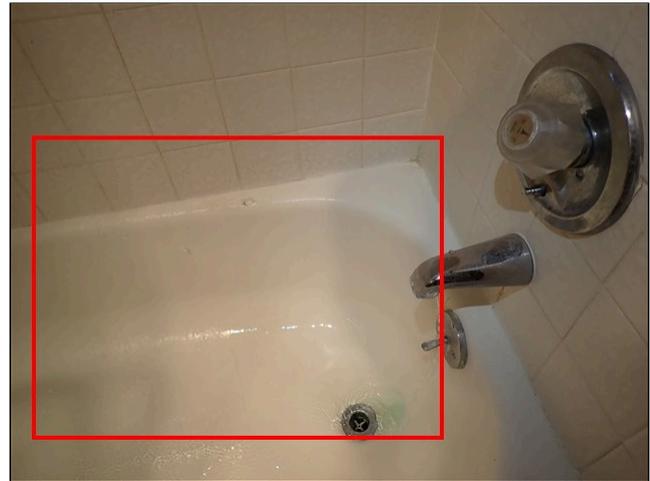
8.0.B BATHTUB (Picture 1)

●					8.0.B BATHTUB Moderate surface wear or damage is generally cosmetic; if the base material has not been exposed or materially affected, the need for replacement is discretionary. Gap between nozzle and shower enclosure; recommend caulking to prevent water intrusion into wall cavity.
●					8.1.B SINK(S)
●					8.2.B TOILET
●					8.3.B FLOOR(ING)
●					8.4.B WALLS / CEILING
●					8.5.B VENTILATOR
●					8.6.B ELECTRIC / GFCI

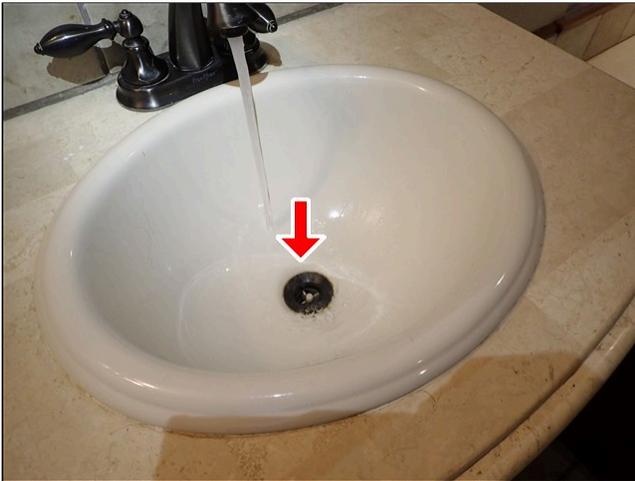
8.1.C SINK(S) (Picture 1)

●					8.0.C JETTED BATH
	●				8.1.C SINK(S) Recommend adding sink stopper mechanisms to ensure proper operation.
●					8.2.C TOILET
●					8.3.C STALL SHOWER
	●				8.4.C SURROUND / ENCLOSURE Several cracked tiles observed that base of shower pan. Recommend repair as needed by a qualified contractor to ensure surface is properly sealed.
●					8.5.C FLOOR(ING)
●					8.6.C WALLS / CEILING
●					8.7.C VENTILATOR
	●				8.8.C ELECTRIC / GFCI Outlets were not operational at time of inspection. Recommend conditions be checked and repaired as needed by a qualified electrician.

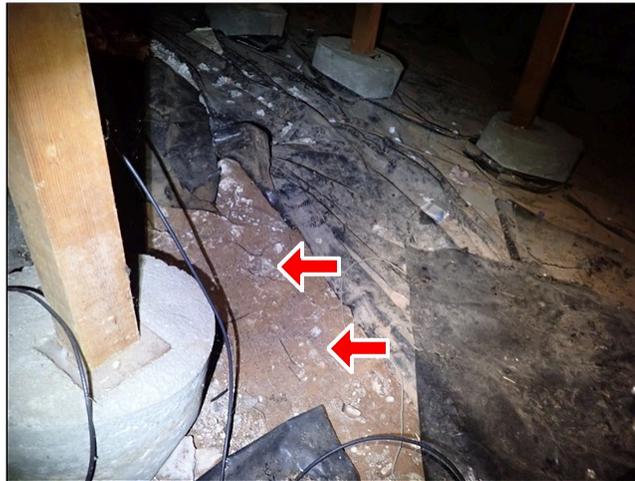
9.4 CRAWLSPACE FLOOR (Picture 1)

●				9.0 FOUNDATION/ FRAMING
●				9.1 PIERS / POST
●				9.2 FLOOR FRAMING
●				9.3 MAIN BEAM(S)
	●			9.4 CRAWLSPACE FLOOR Recommend redistributing vapor barrier to help control moisture levels in living space.
●				9.5 CRAWLSPACE VENTILATION PROVISIONS

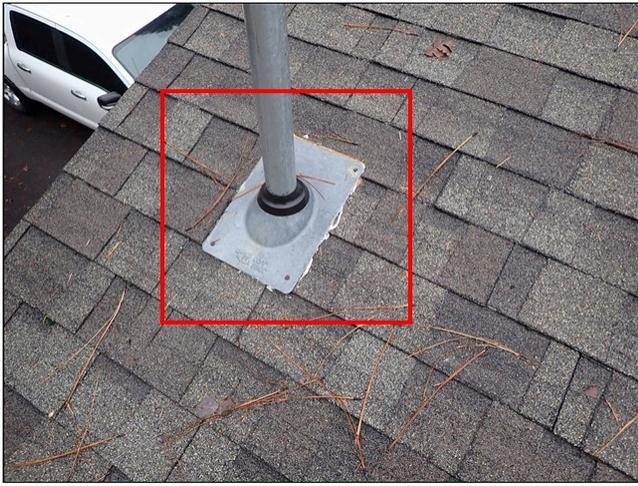
11.0 SERVICE PANEL / ENTRANCE LINE (Picture 1)

●					<p>11.0 SERVICE PANEL / ENTRANCE LINE</p> <p>Roof flashing boot connection to roof is improper. Exposed edges noted. Typically roofing should cover upper 2/3 of all flashing. Recommended further evaluation and repair as needed by a qualified roofing contractor.</p>
●					<p>11.1 DISTRIBUTION PANEL</p>
		●			<p>11.2 MAIN DISCONNECT</p> <p>Some panels are designed with multiple main disconnects; ensure proper de-activation of all service before work is done. Consider upgrade to single main.</p>
●					<p>11.3 SUBPANEL 1</p> <p>Wire grommet is missing at base of panel. Recommend adding to protect wire sheathing from damages.</p>
	●				<p>11.4 SUBPANEL 2</p> <p>Main disconnect in panel is oversized for current wiring. This is a potential safety hazard. Recommend conditions be further evaluated and repaired as needed by a qualified electrical contractor.</p>
●					<p>11.5 SERVICE GROUNDING PROVISIONS</p>

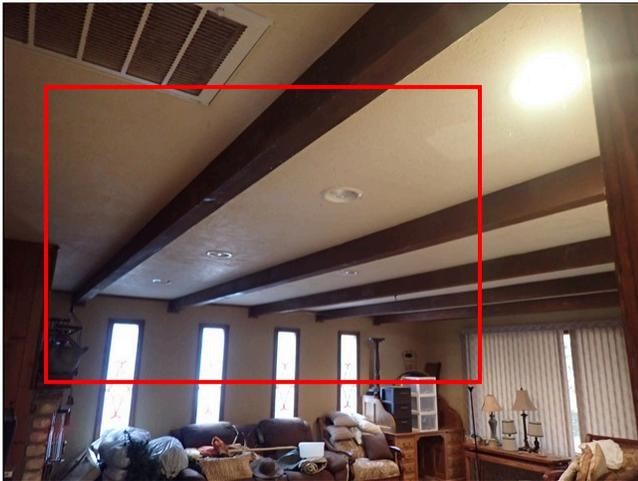
11.6 DEVICES (Picture 1)

●					<p>11.6 DEVICES</p> <p>Several lights were not operable. Any inoperative unit may be due to a defective fixture or bulb. Replace bulbs as first action; contact qualified electrician if issue persists.</p>
●					<p>11.7 WIRING / CONDUCTORS</p> <p>Open junction box and exposed wires observed under deck area at back of home. Recommend having area checked and sealed or repaired as needed by a qualified electrician.</p>

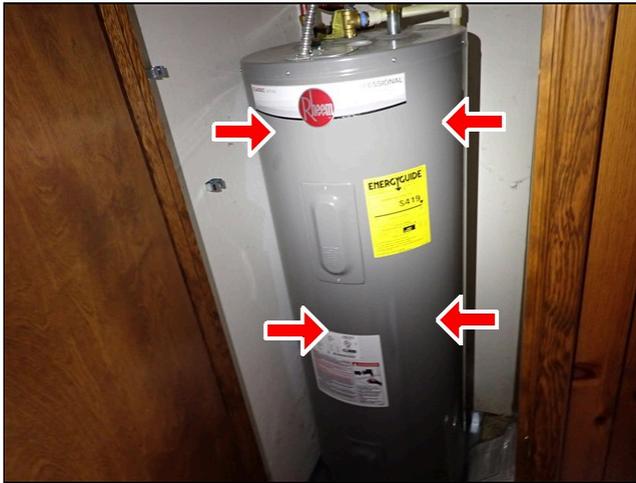
14.0 (Picture 1)

Restraining straps are generally required on all water heaters. Straps should secure the unit to the structure. Contact a local plumber or the building department for current requirements.
