HERNANDO COUNTY  
BUILDING PERMIT APPLICATION

Describe work to be done: FOUNDATION STABILIZATION AND/ OR REPAIR

Address of job site: No.: 2441 Street: DUSTIN CIRCLE City: SPRING HILL, Hernando County

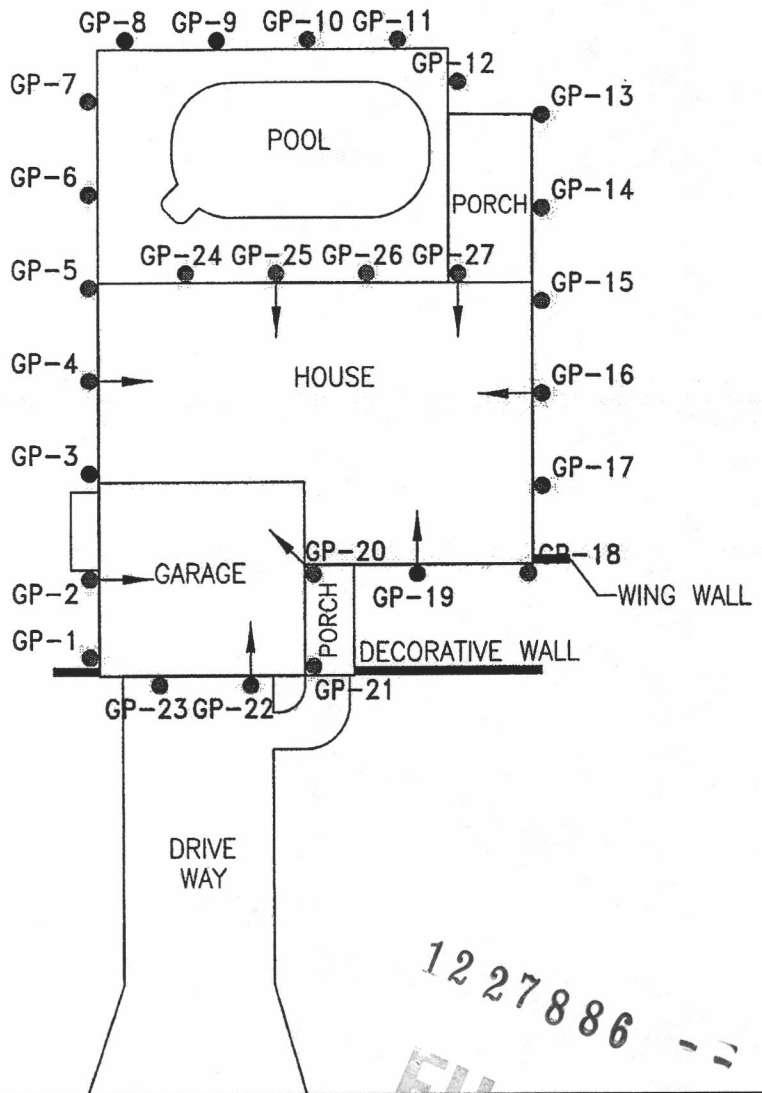
1. BASE MAP GENERATED FROM FIELD TAPE MEASUREMENTS AND ESTIMATED DIRECTIONS.
2. BUILDING OUTLINE & LOCATION ARE APPROXIMATE.
3. GROUT POINT LOCATIONS ARE APPROXIMATE AND MAY BE ADJUSTED IN THE FIELD.
4. GROUT INJECTION PIPES SHOULD BE INSTALLED BY MEANS OF ROTARY WASH DRILLING.
5. ANGLED GROUT POINTS TO BE INSTALLED AT 4:1(V:H) INCLINATION FROM PLUMB, UNLESS OTHERWISE NOTED.

Recommended Injection Point Location Plan – Based on past experience in this locality, knowledge of local geology, and considering areas that were not explored with test borings, it is our opinion that subsurface grout injection operations should be performed through injection points that are installed around the entire perimeter of the home and pool deck. In doing so, the operations will both provide qualitative confirmation that sinkhole activity conditions do or do not underlie the structure at frequently checked locations and will remediate sinkhole activity conditions where these are found. Preliminarily, we recommend that 27 grout injection pipes be installed at relatively equally spaced (approximately 10 foot) intervals around the perimeter of the home and pool deck. The recommended grout pipe locations are shown on **Figure 6**. Some of the grout pipes should be installed at an angle, to intercept the bedrock and direct the flow of grout below interior areas of the home.

We recommend that grout injection cease at a depth no shallower than 20 feet, at any location, to avoid disturbing the surficial sand deposits that support the home's foundations and floor slab. Exception to this restriction may be granted by the engineer, who reviews the grout injection operations, in the event that injection records indicate that very weak soil deposits exist above depths of 20 feet. To reduce excessive grout flow away from the injection location, grout quantities should be limited to 20 cubic yards per location per day, unless otherwise directed by the engineer.
