Survey Details

Project	Neil Creek 2.0 Phase 1
Survey Start Date	June 5, 2025
Survey Start Time	12:33
Weather	Clear
Antecedent Conditions	Dry
Discharge at Time of Survey	13.42 cfs (data from NCDO stream gage)
Discharge Characterization	Summer Flow-High
Restoration Actions Applied	LWM, Reveg, Fencing, OCW
Surveyors	Katelyn Detweiler, Taylor Owen, Sarah Elvington

LW Performance Assessment

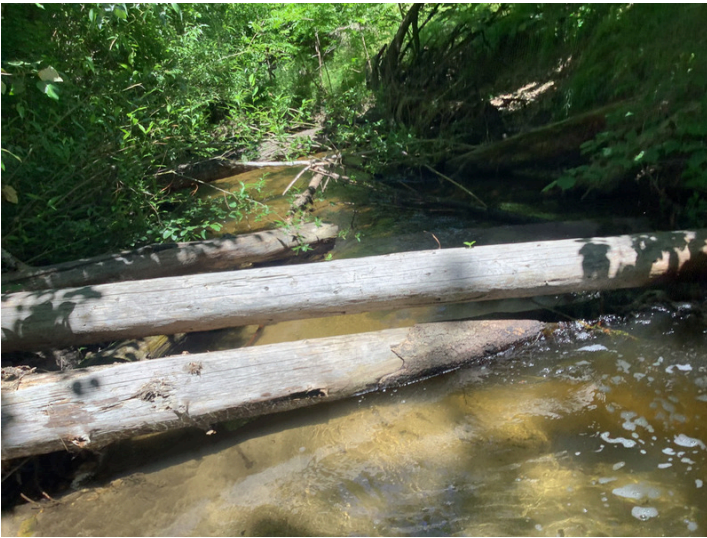
Representative Project Reach Photo

Naturally recruited LW with root fan attached is providing additional habitat complexity on downstream end of structure #132+45.
